**Snap Lake Environmental Monitoring Agency**  
**Main Floor, Lahm Ridge Tower**  
**4501 Franklin Avenue**  
**P.O. Box 95, Yellowknife, NT X1A 2N1**  
**Phone: 867-765-0961 FAX: 867-765-0963**  
**Website: www.slema.ca**

**RE: East Cell Spills 11-391 and 11-398**

The Snap Lake Environmental Monitoring Agency (SLEMA) has reviewed the Report on Snap Lake Spill 11-391 and 11-398 Monitoring Program, and would like to provide the Mackenzie Valley Land and Water Board (MVLWB) with the following comments.

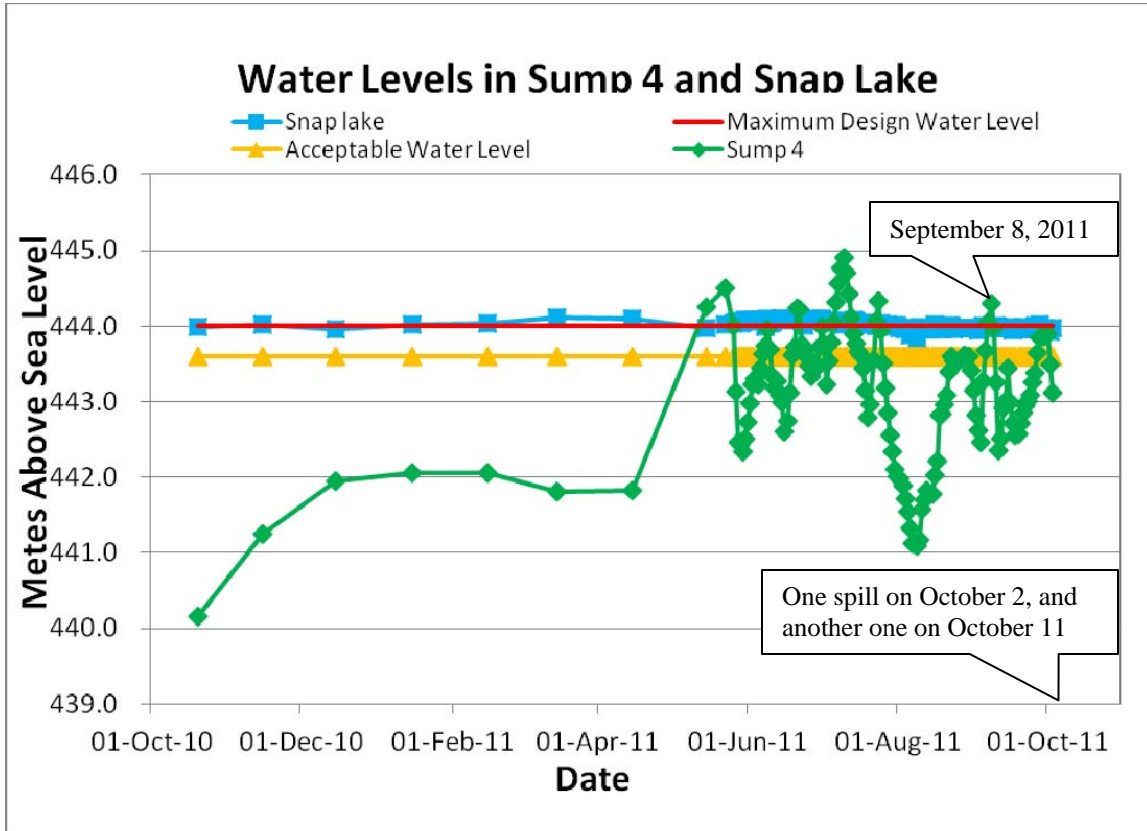
**Figure 1. Water Levels in Sump #4 and Snap Lake**

The two spills were preventable and should not be viewed as accidental. The following chart shows that since May 2011, the water levels in Sump #4 have been frequently above key water levels.

- 43 days that the acceptable water level of 443.6 meters above sea level (MASL) was exceeded.
- 17 days that the maximum design water level of 444 MASL was exceeded.

- 15 days that the water level was higher than the natural level of Snap Lake, against one of the design criteria of the East Cell Water Control Structures.

SLEMA staff observed water level in Sump #4 higher than that in Snap Lake on September 8, 2011 and asked for confirmation at the mine site on that same day and on September 15 during the Technical Session of Water Licence Renewal. However, the observation appeared to be ignored by De Beers.

- Current practices of water level control in the East Cell sumps appear to be deficient. Real-time water level control is recommended. It includes, but is not limited to, automated real-time water level monitoring and related dewatering schedule.
