May 2015
Environmental Update
for SLEMA Board

Zhong Liu
May 31, 2015

2.2 Water Licence Inspection

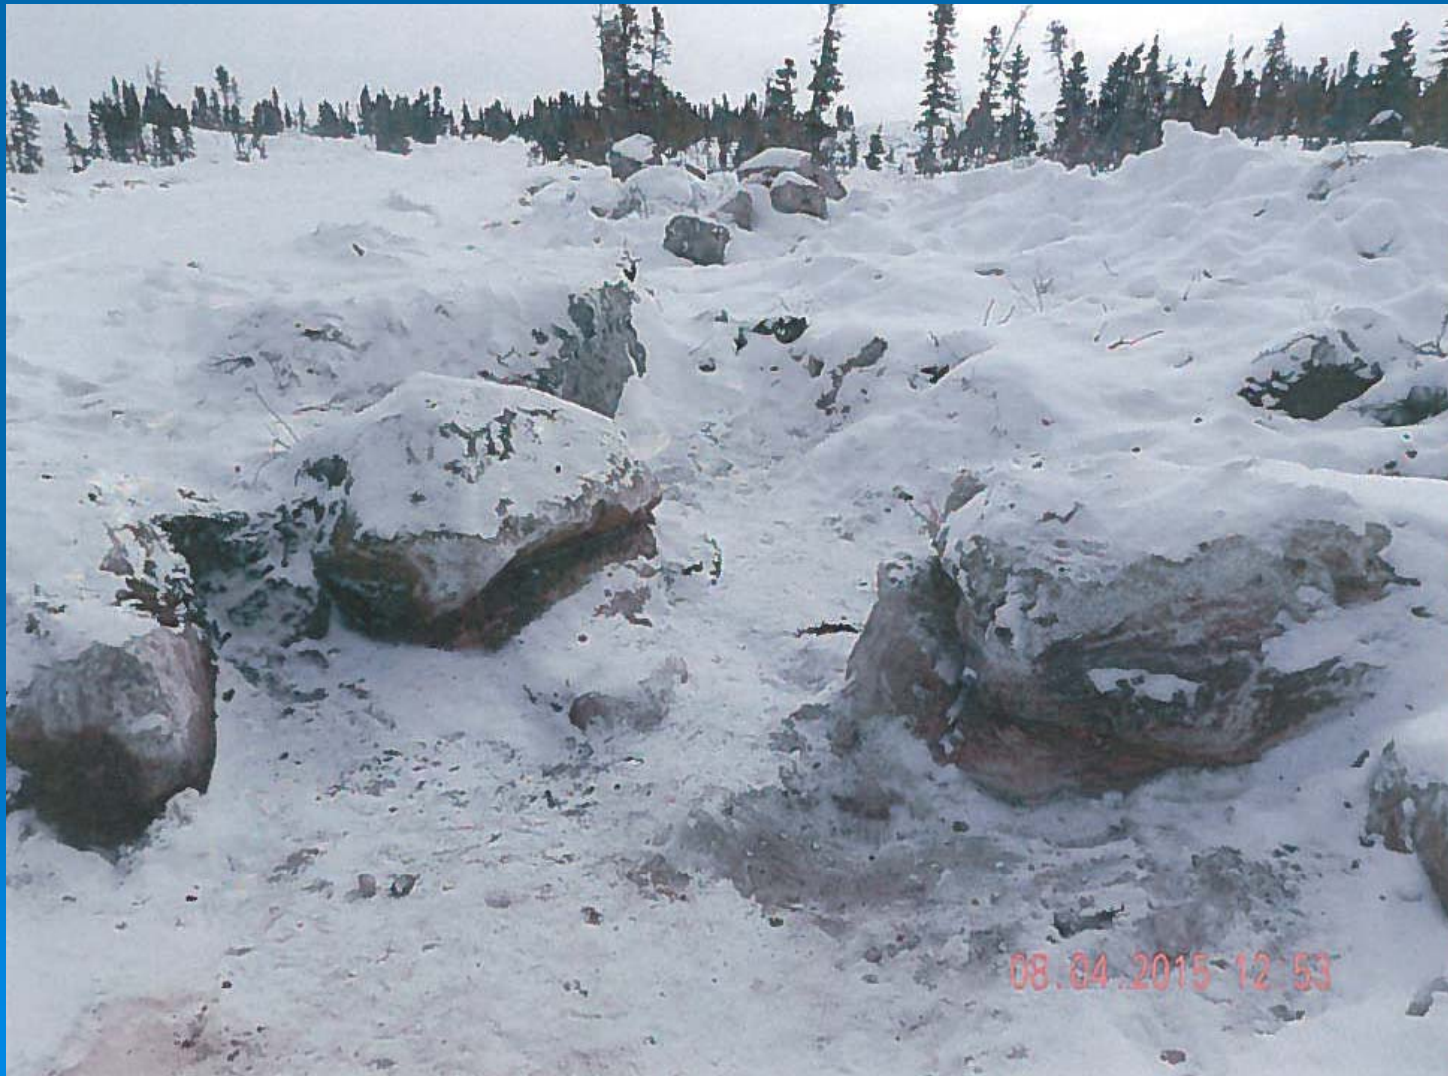
NT Spill #15-043 – Some hydrocarbon contaminated soil remains in between the rocks. The site will remain open until winter 2015 to allow for further assessment of the spill and possibly more clean-up activities once the ground thaws

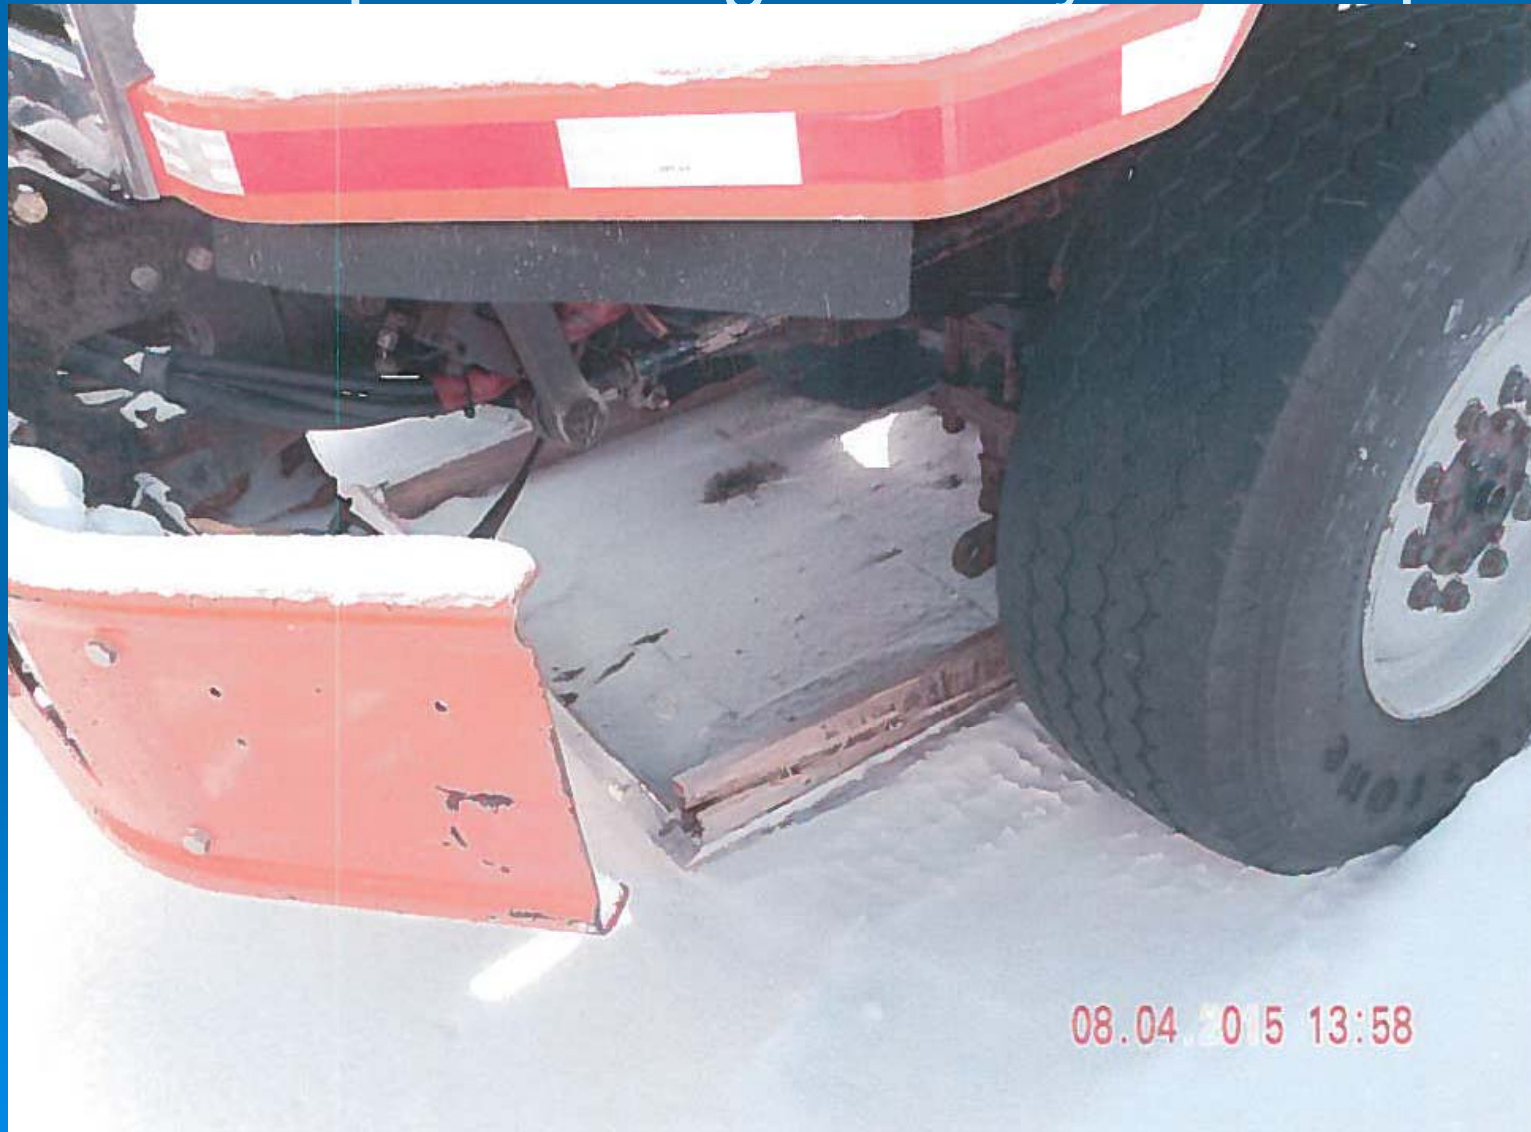
Winter Road Equipment Storage – Drip trays stored under equipment catch small leaks and drips allowing for easy clean-up

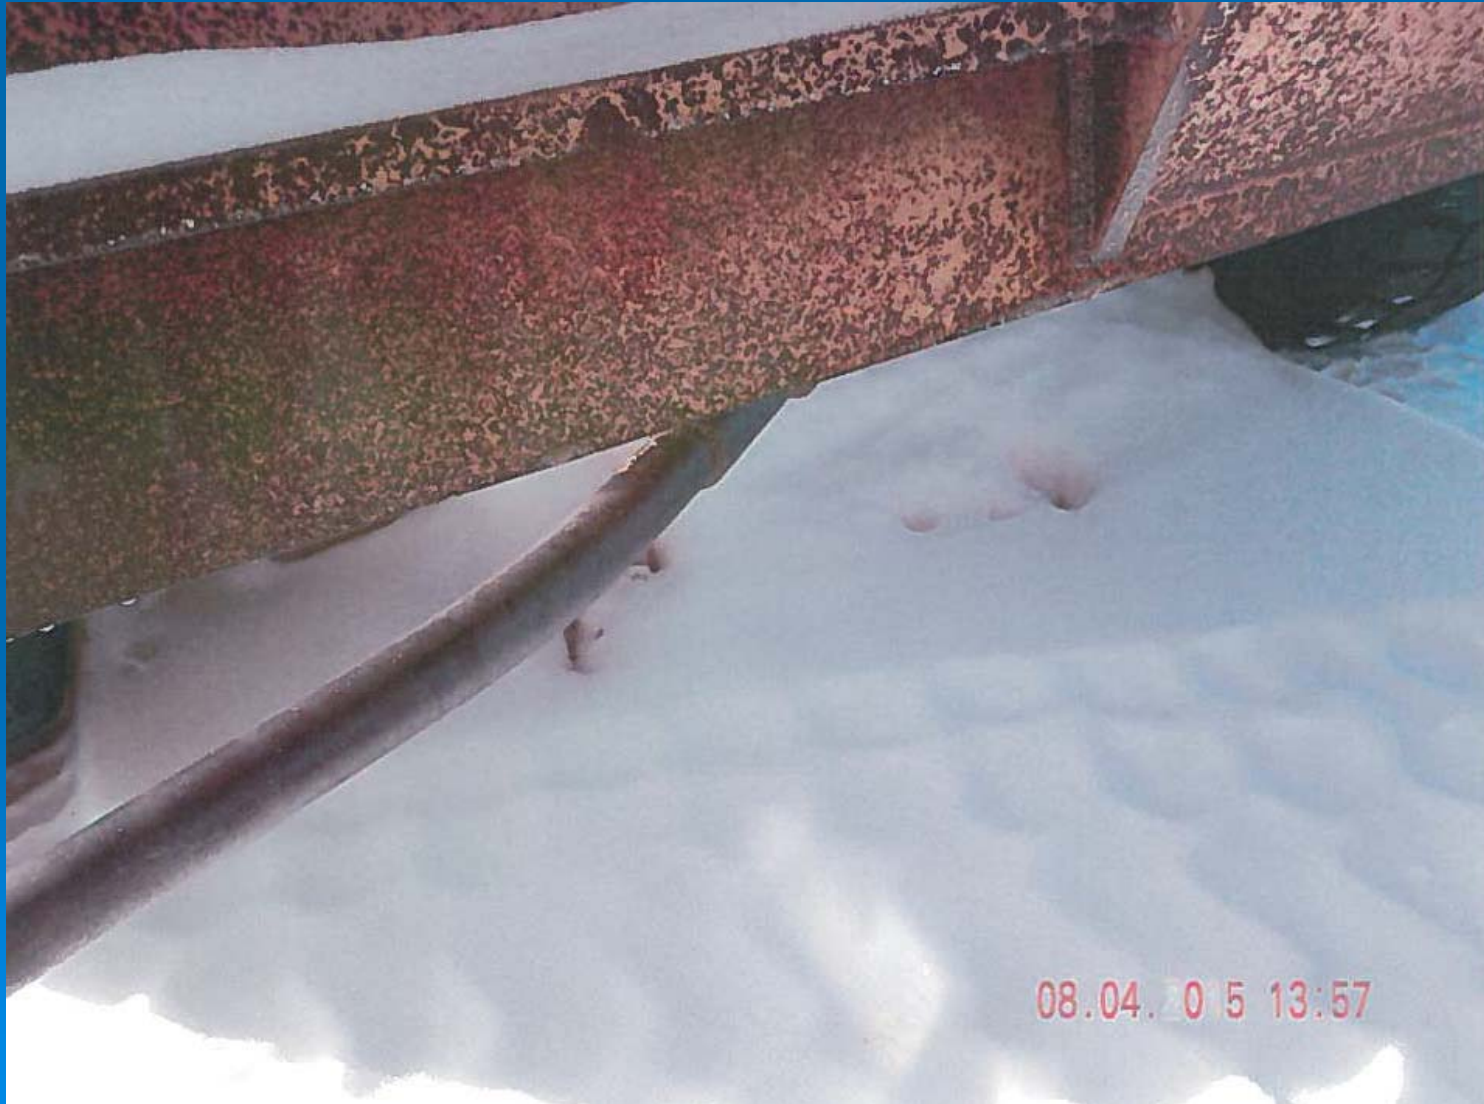
Winter Road Equipment Storage – Some of the equipment being stored are leaking fluids onto the ground requiring adjustment of the dip tray to ensure they are effective. Contaminated snow will need to be cleaned up and disposed of

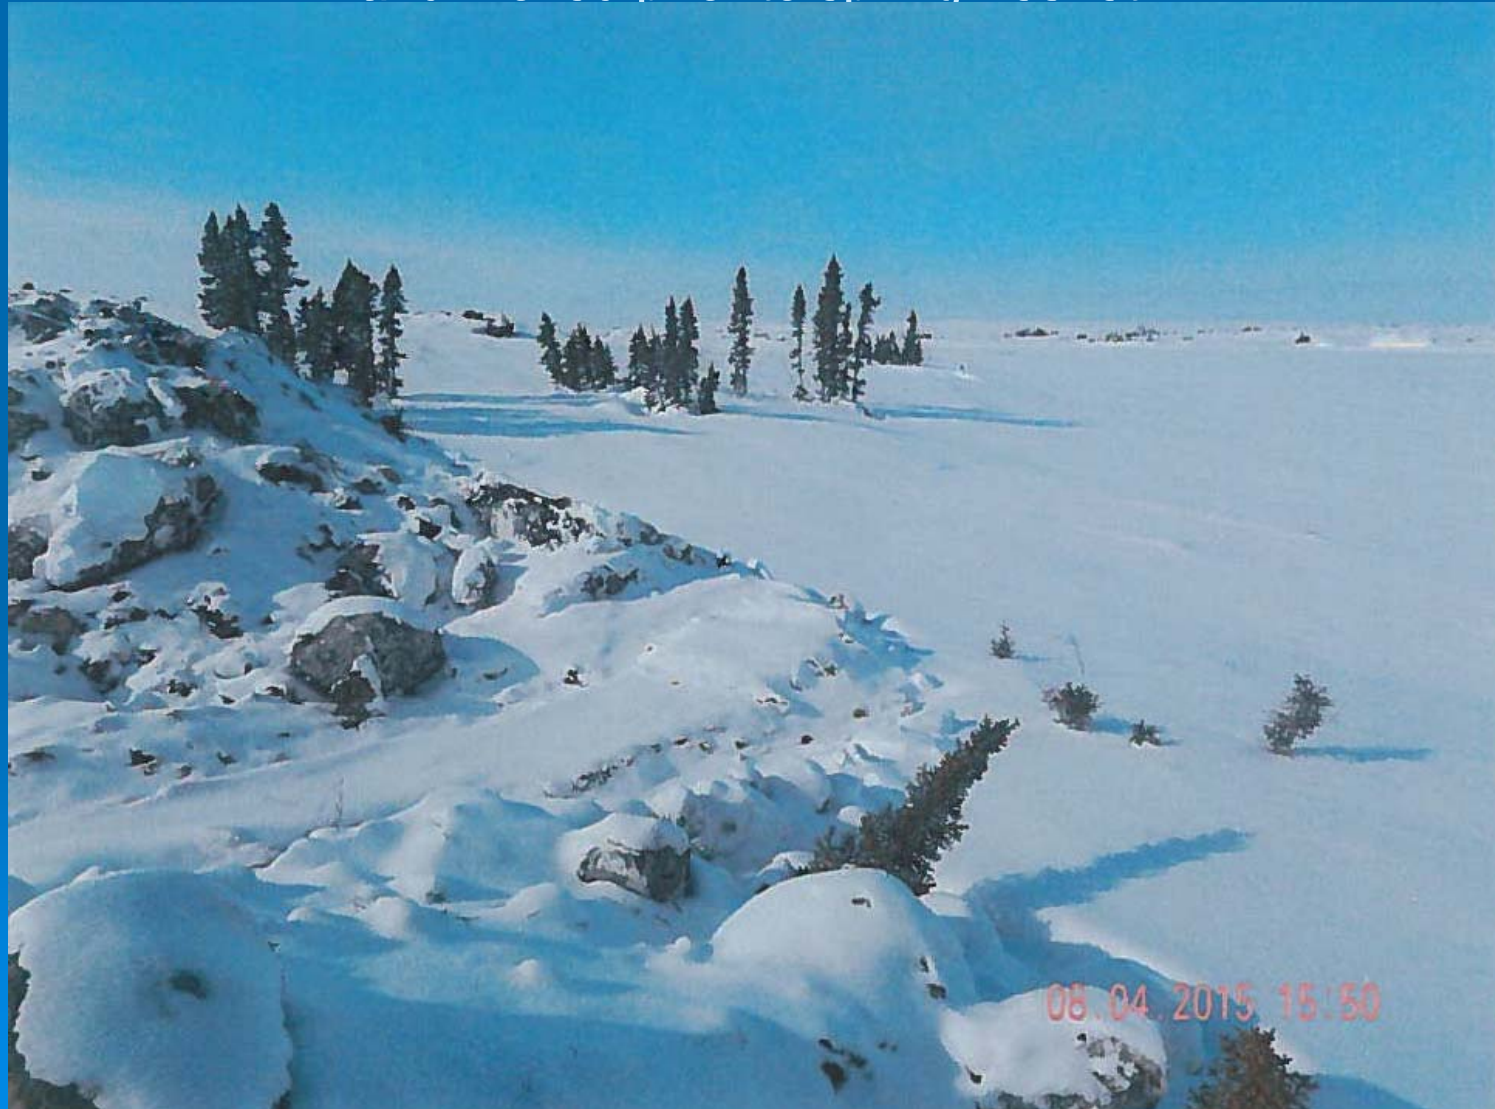
North Pile West Cell – Organics have been stripped back for the grouting program. Organics will eventually be collected and moved to the organics storage area. In this area, the organics have been placed in close proximity to Snap Lake. this material will need to be collected and moved prior to spring freshet

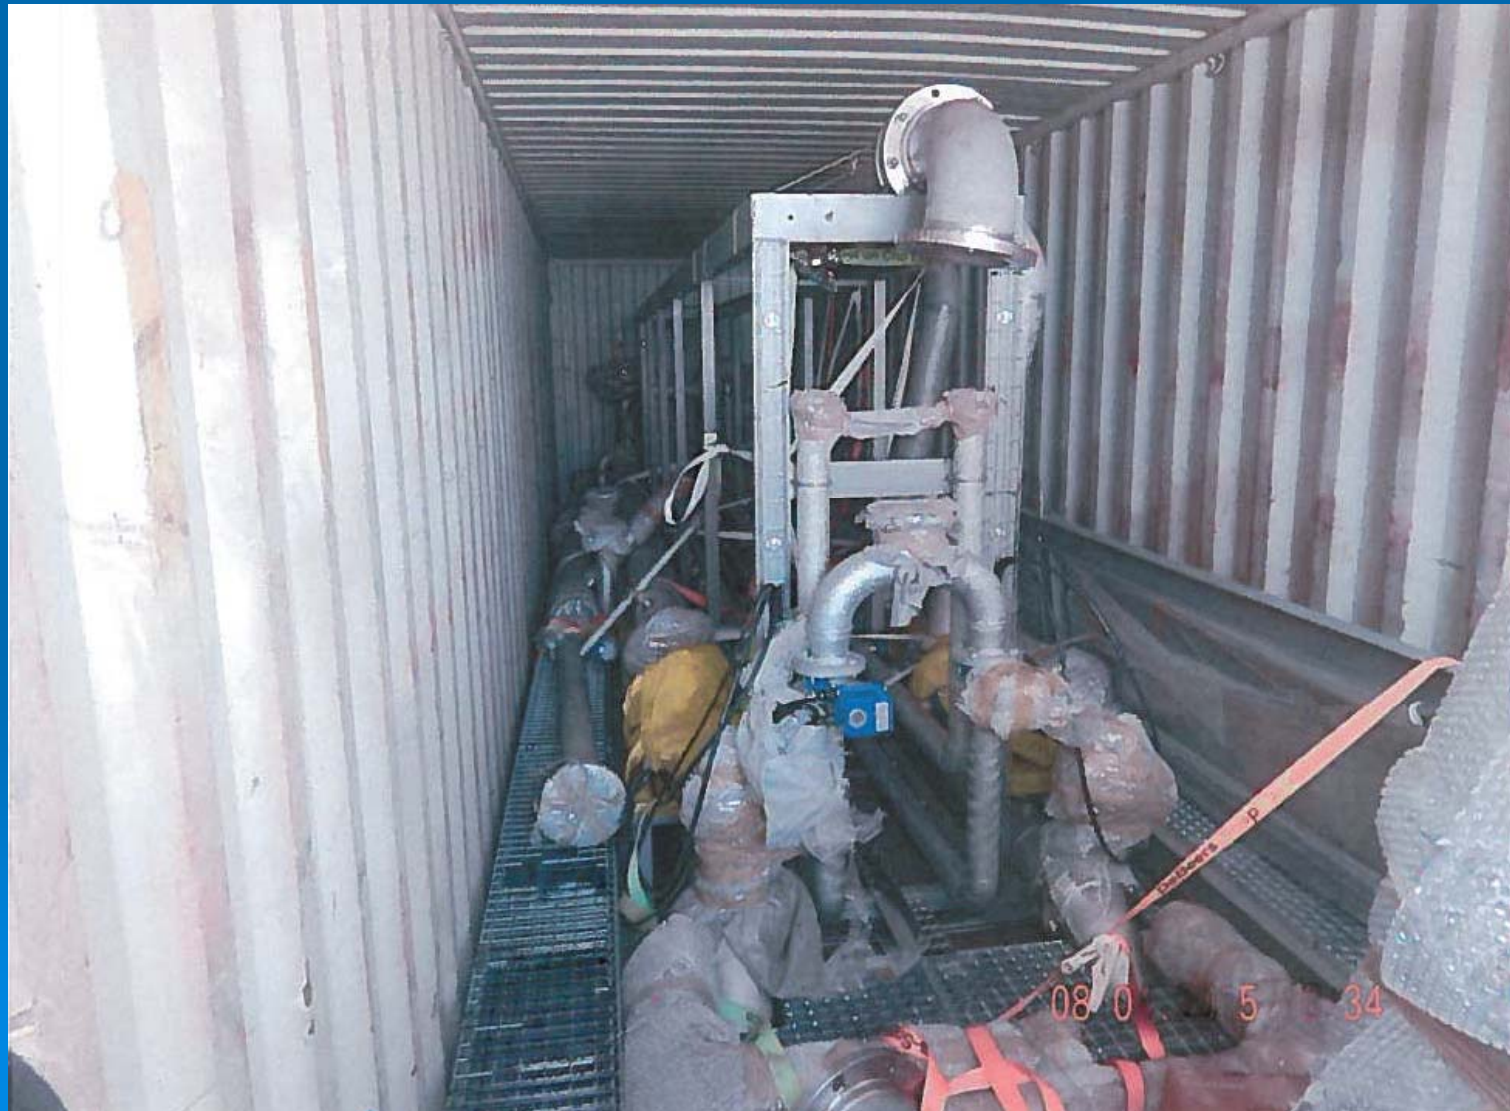
Reverse Osmosis Water Treatment Plant – Inside one of the seacan shipping containers

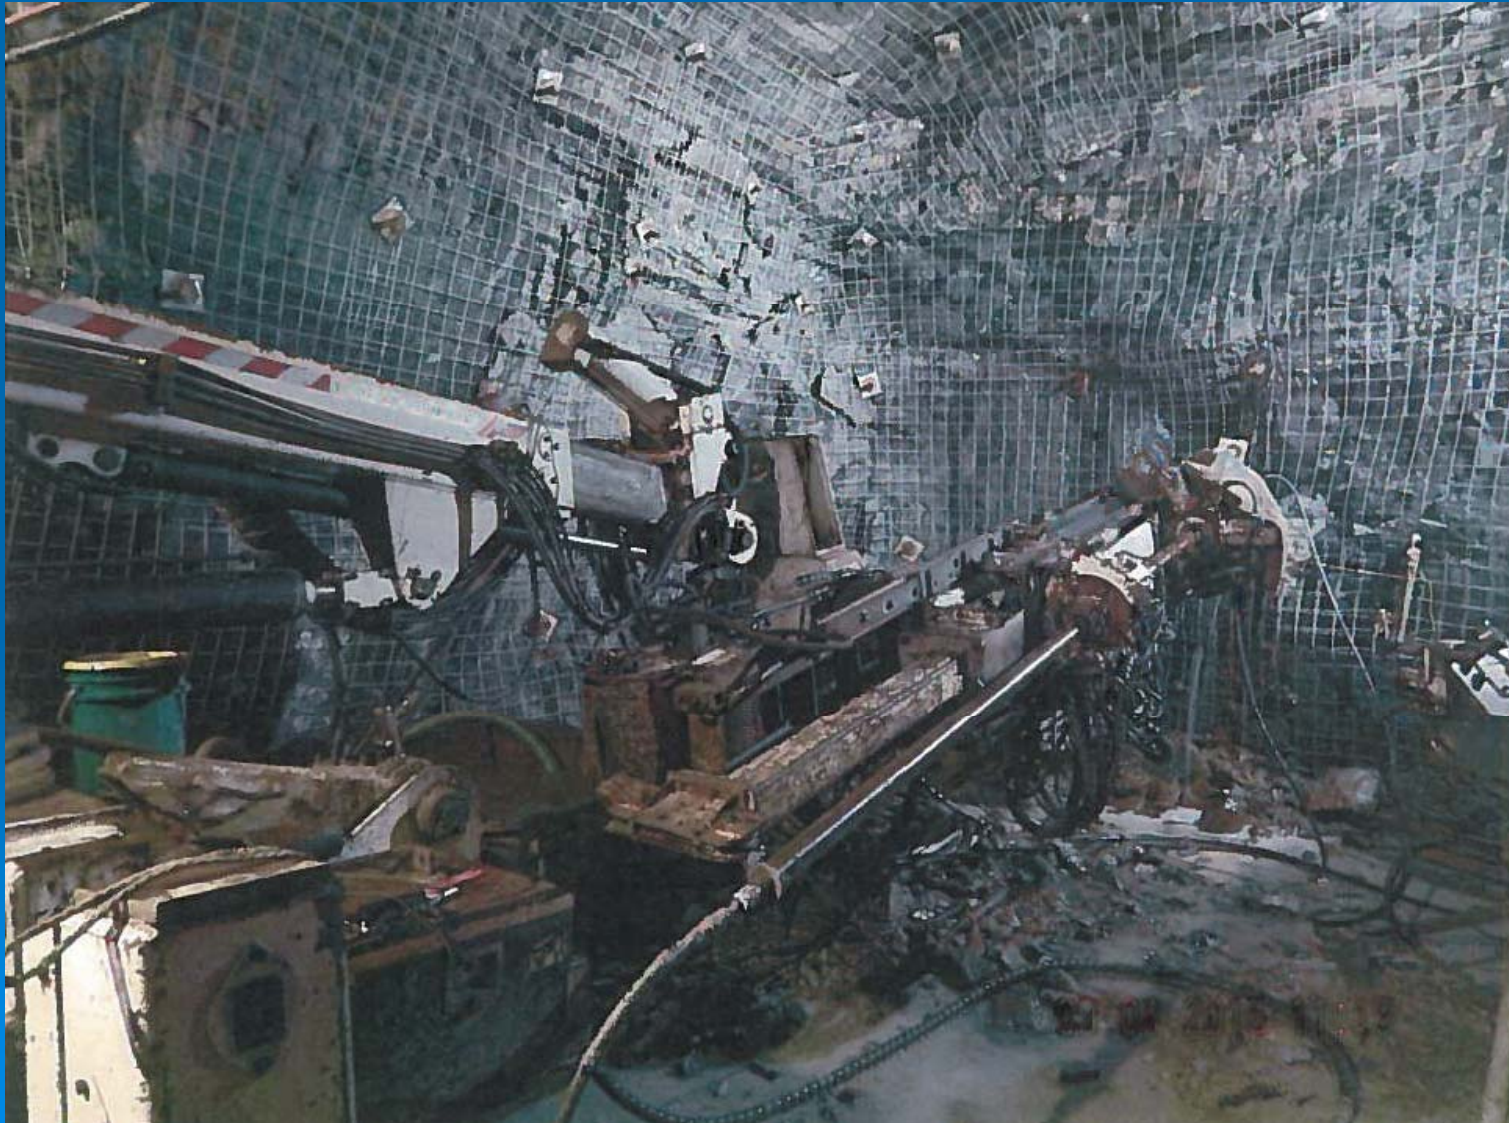
Underground 4950 S2 Ramp North – MDR drill set up at the lower ore development. This drill is used for the grouting program underground as well as for delineation of ore in the mines footwall

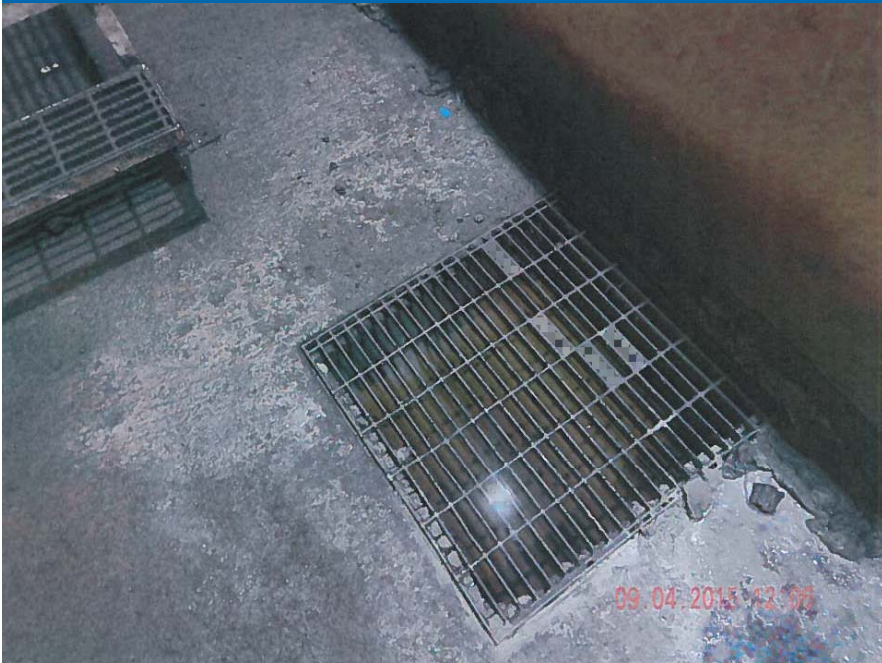
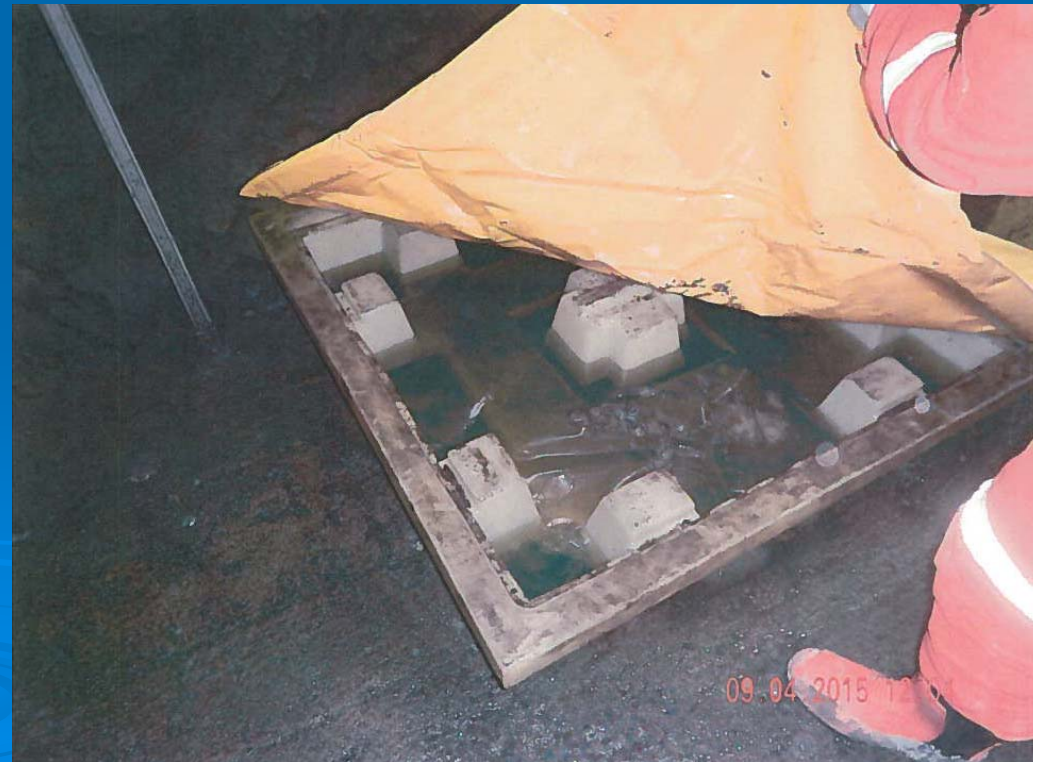
Underground Refueling Bay – Containment sump in the floor and overflow containment tray are full of diesel fuel and need to be emptied to ensure that it is available to contain potential spills

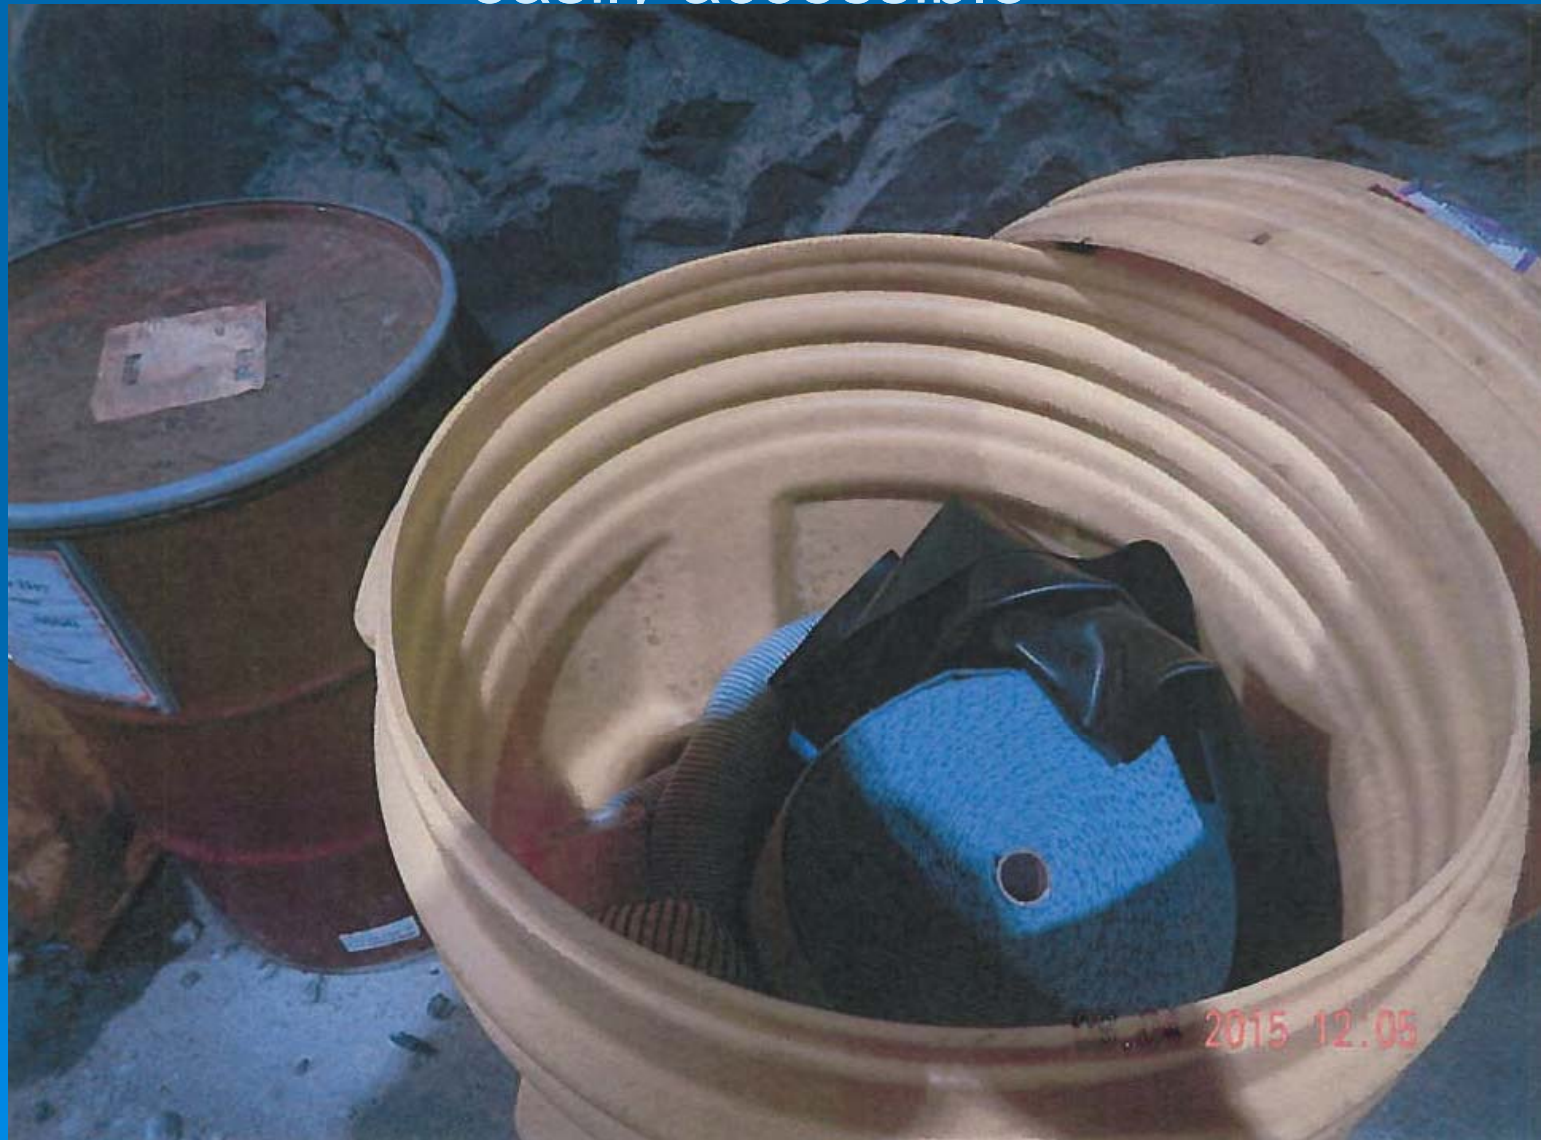
Underground Refueling Bay – Spill kit in the area was stocked with absorbent materials and was easily accessible

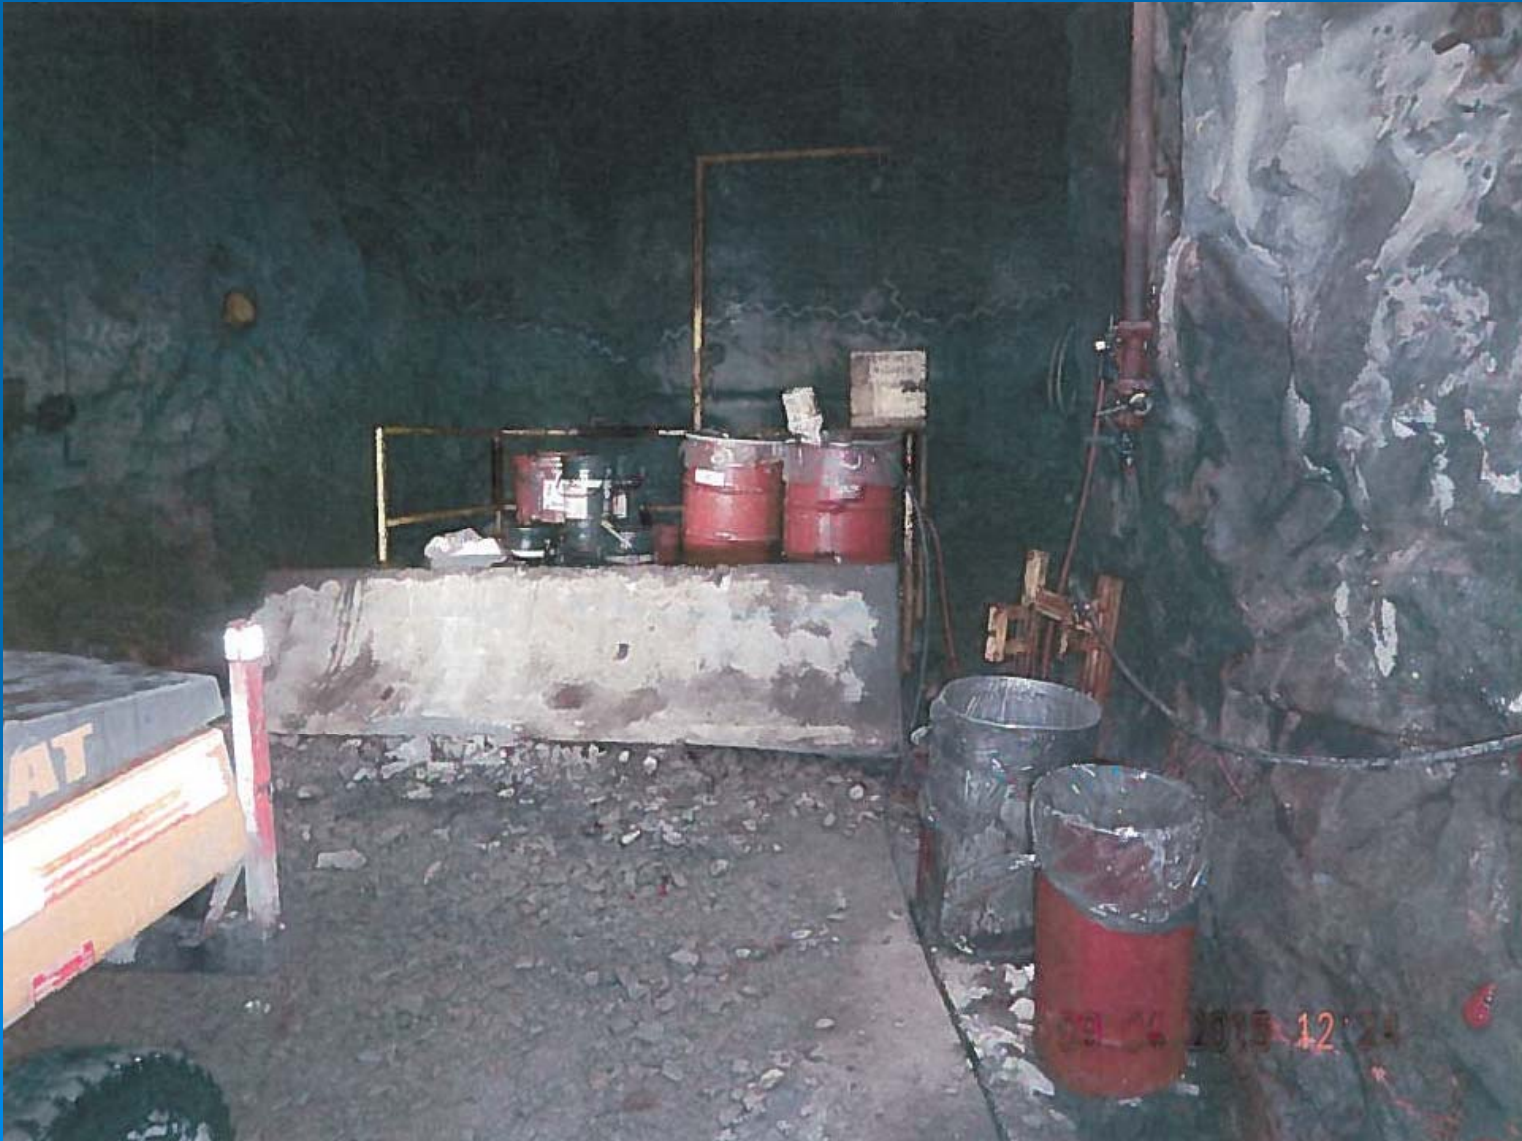
Underground Lube Bay – Barrels of different lubricants are stored on a large containment tray behind a concrete barrier. The area was neat and clean

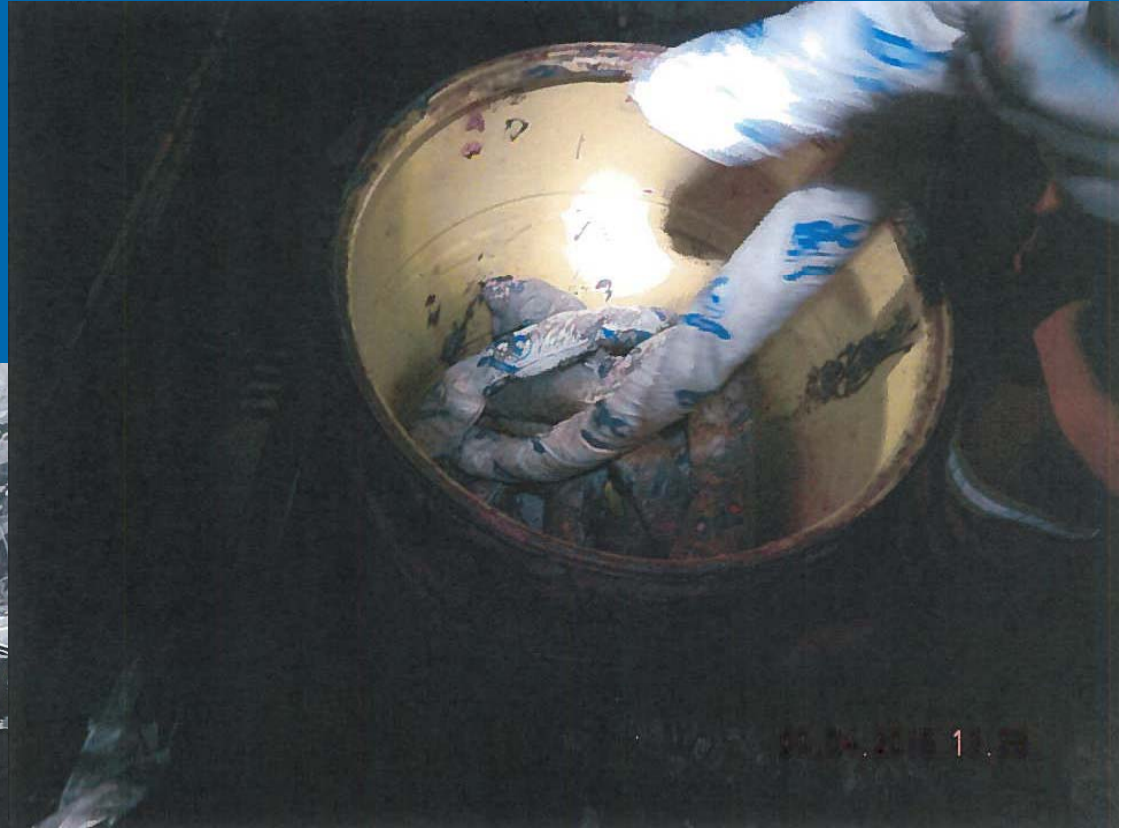
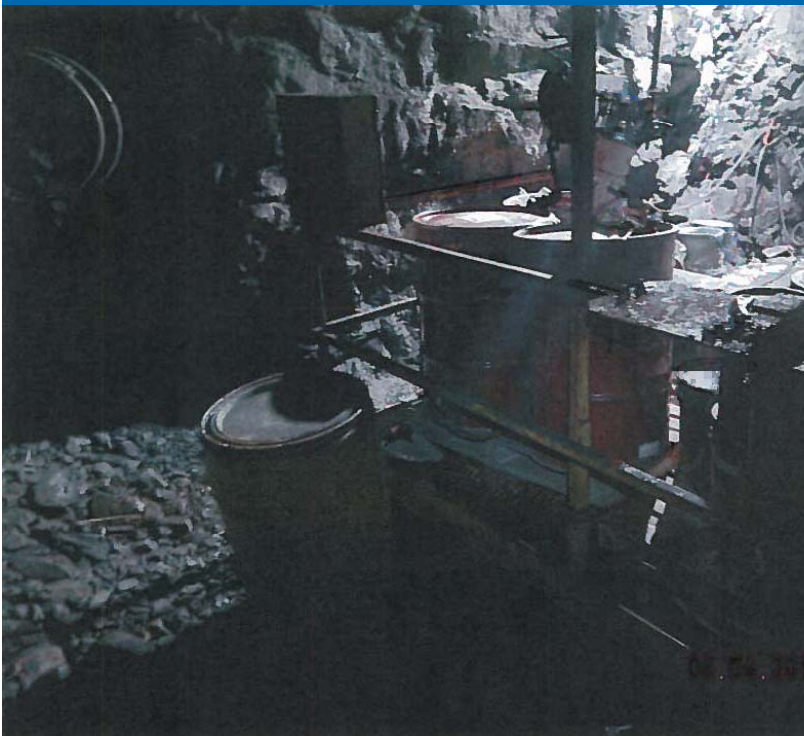
Underground Lube Bay – Spill kit was located behind the containment tray and was not easily accessible. The Kit appeared to be used as a waste container. This waste will need to be dealt with appropriately. The Kit will need to be restocked and moved to an area where it can be easily found and accessed

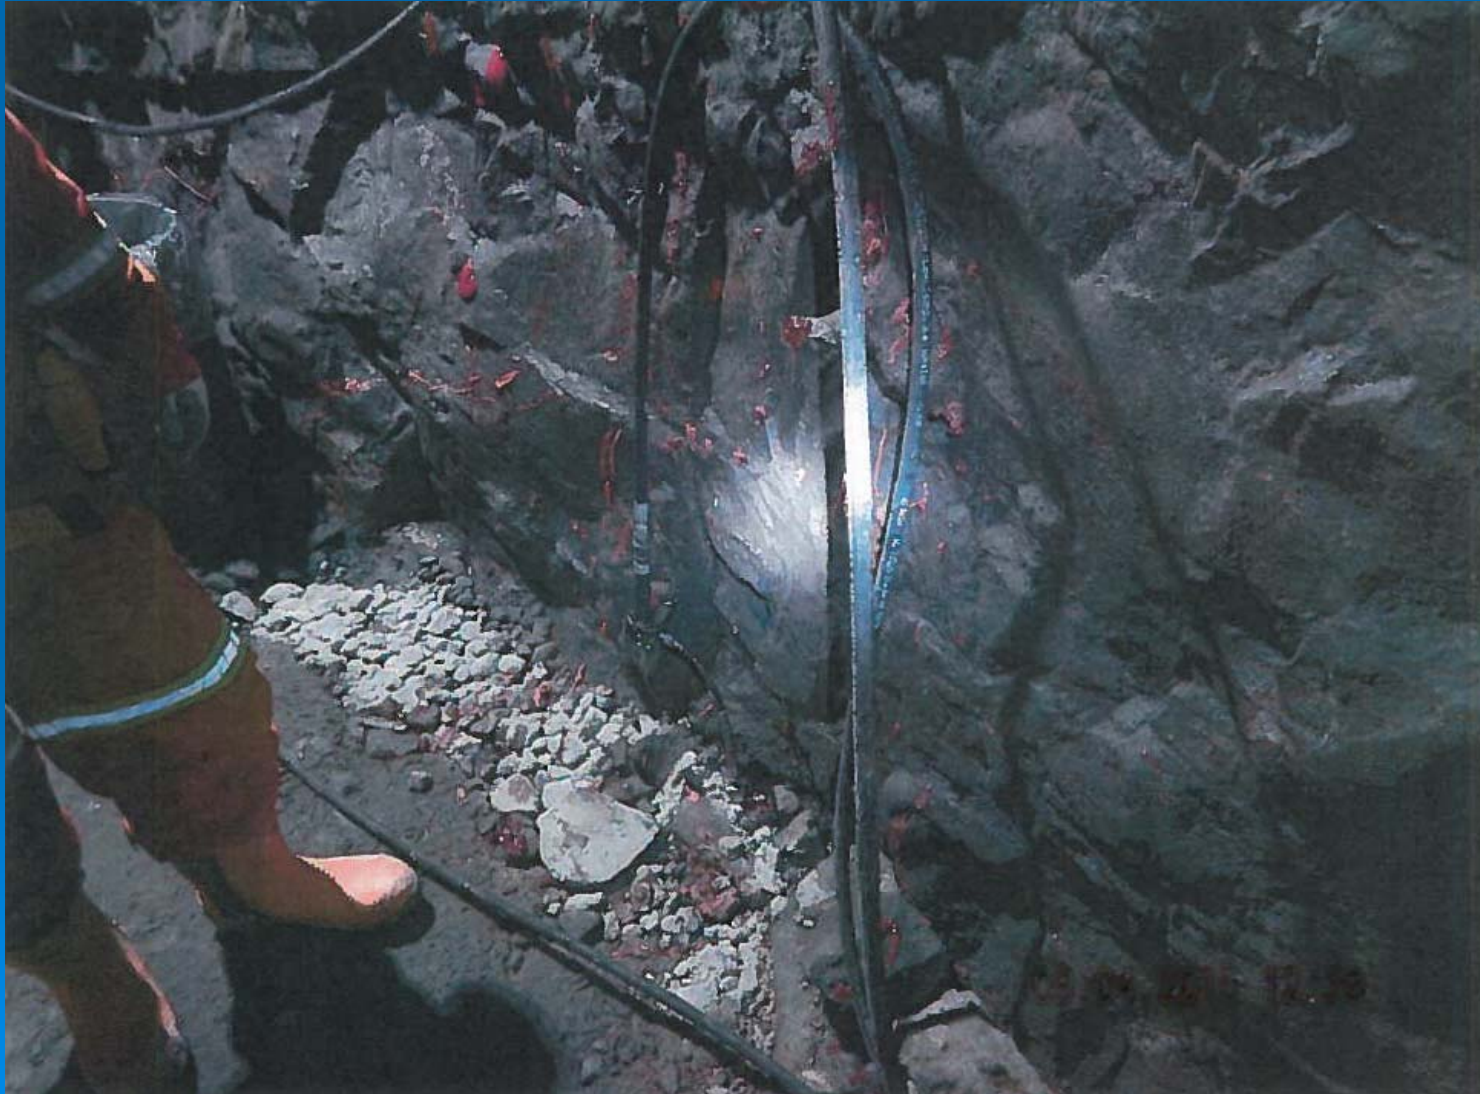
Underground Lube Bay – Grease drippings along the wall and ground. These drips will need to be cleaned up and some of containment set up to collect the grease dripping from the hanging hoses

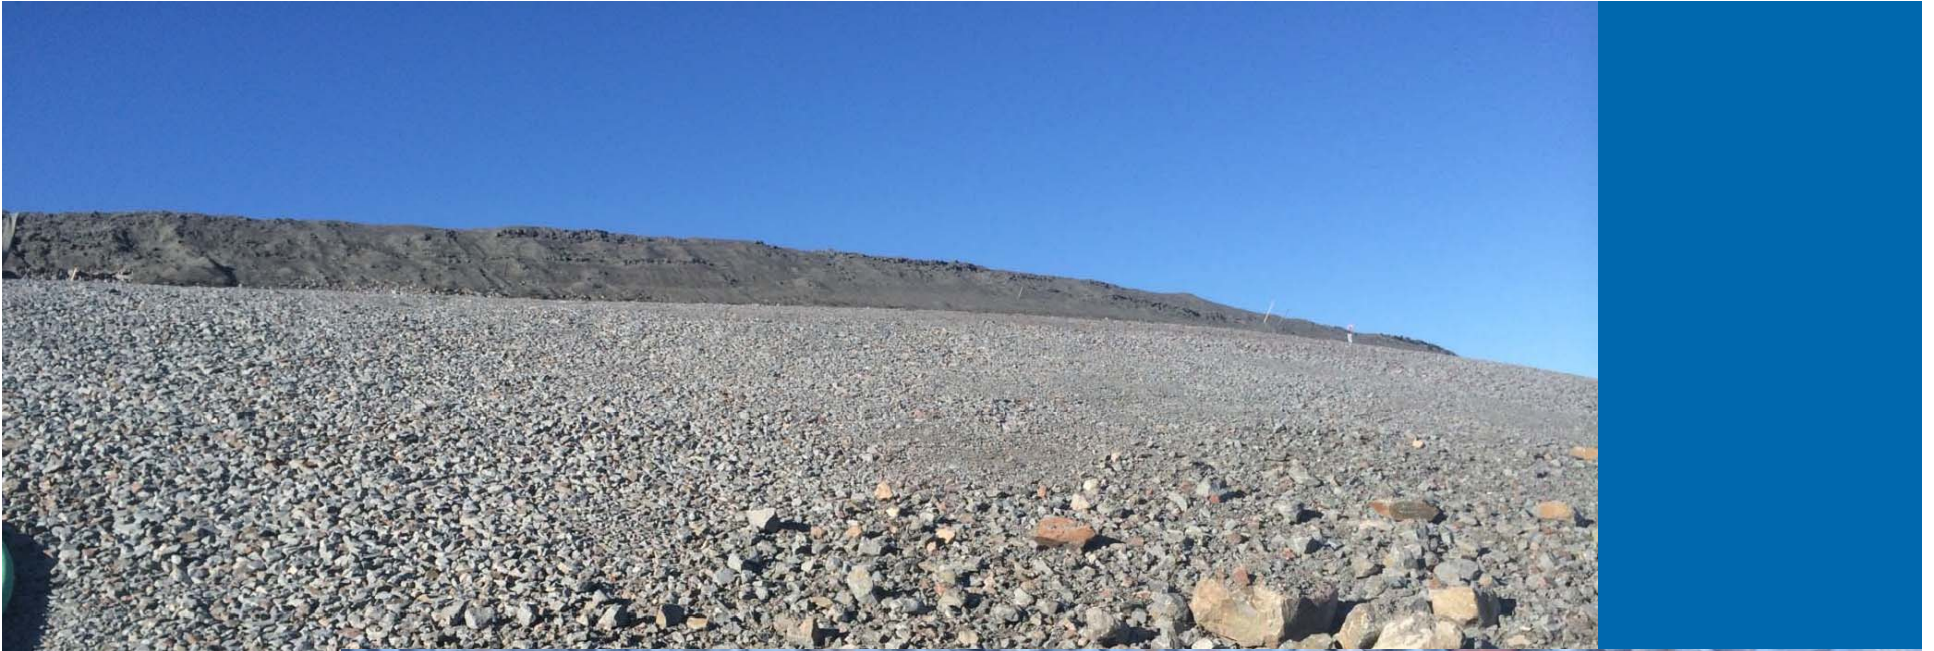
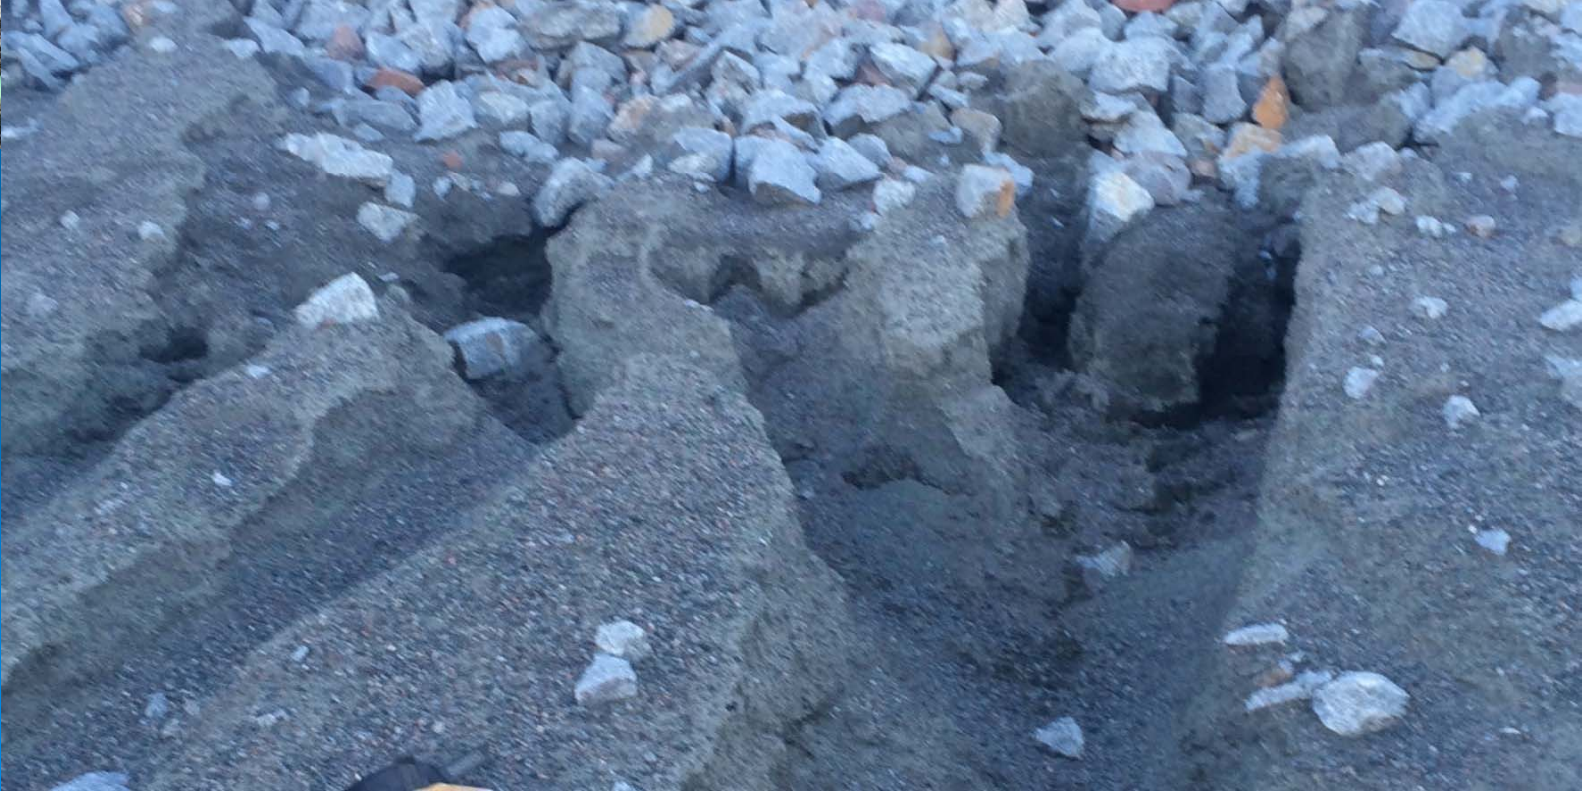
Placement of the Erosion Protection Layer in the Ease Cell

- The placement of the erosion protection layer is lagging for the majority of the embankments; most notably, those of the East Cell. It is recommended that this layer be placed to properly protect the completed embankments as erosion channels have formed and scoured the embankment slopes. If not rectified, erosion may continue to form or enlarge scoured areas and result in localized or larger instability issues. Further, it is recommended that the erosion protection layer be placed coincidently with embankment construction. The placement of this layer and its placement in conjunction with embankment construction: reduces the risk of embankment erosion; reduces effort; improves schedule; enhances safety; and reduces the cost to do the work. De Beers stated (also see De Beers 2014) that the placement of the erosion protection layer will start immediately and will, as progress is made, be placed concurrently with embankment construction

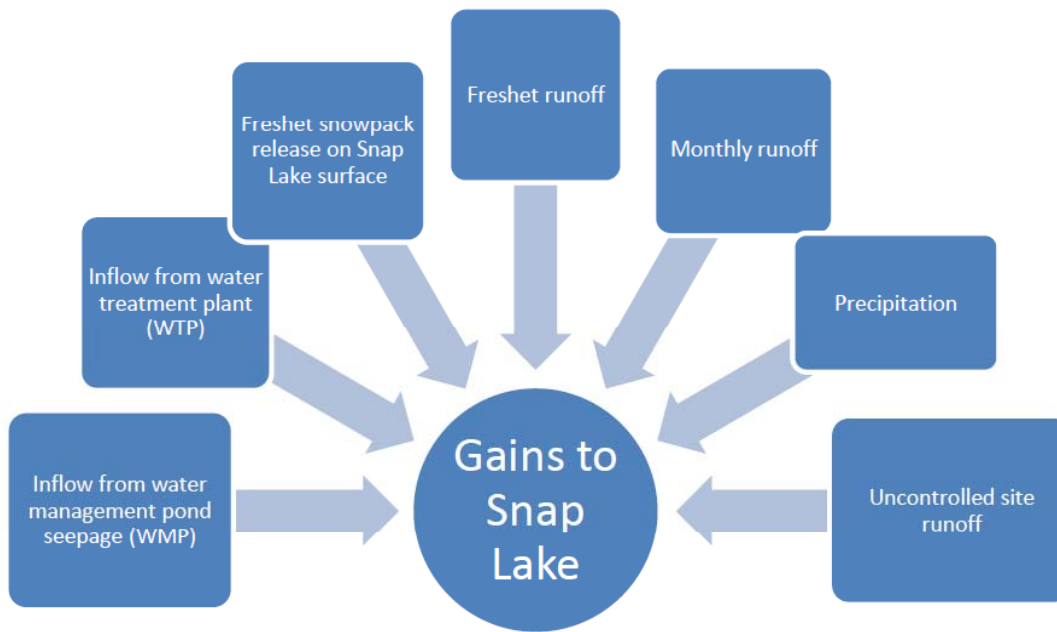
Figure 4: Schematic Displaying Gains from Snap Lake.

- The inflow from the North Pile seepage is missing Figure 4, whereas it is showed as SE 11 in Figure 5
- Is the Freshet snowpack release on Snap Lake surface part of the precipitation in Figure 4?
- What are the differences among Freshet runoff, monthly runoff and uncontrolled site runoff in Figure 4?
- There are two SE11 in Figure 5. One is the inflow from the North Pile seepage to Snap Lake, another is the losses from Snap Lake via groundwater recharge
 - Correction is requested
