June 2018 Environmental Update for SLEMA Board

Zhong Liu
June 30, 2018

2.1 Water Licence Inspection on May 25, 2018

2.2 Water Licence Inspection on June 8, 2018

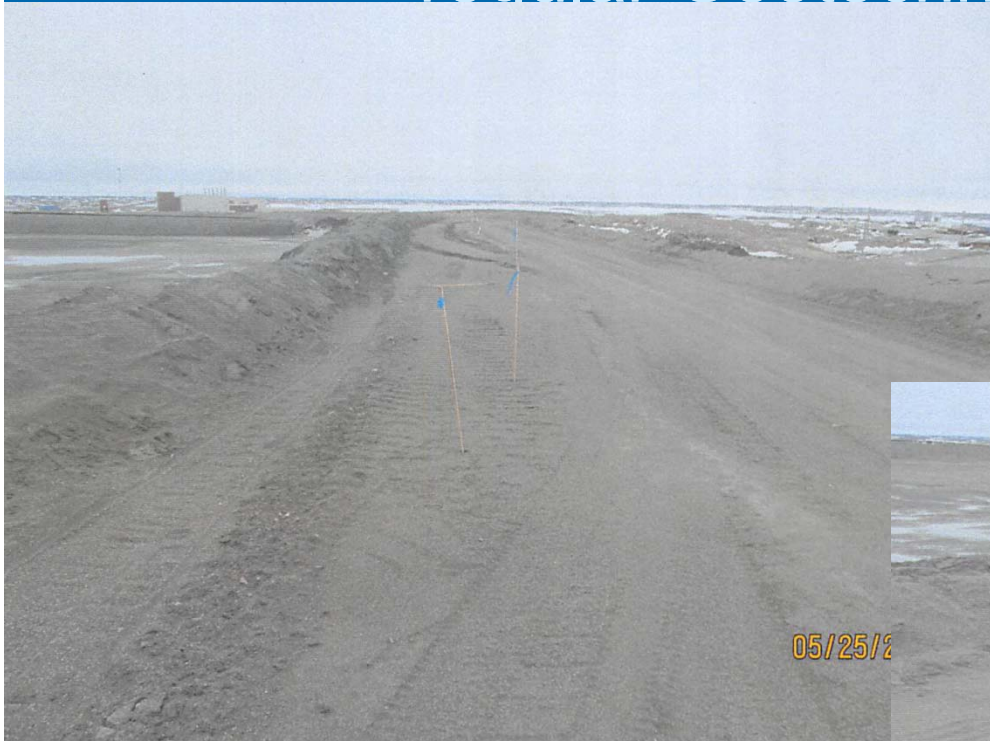
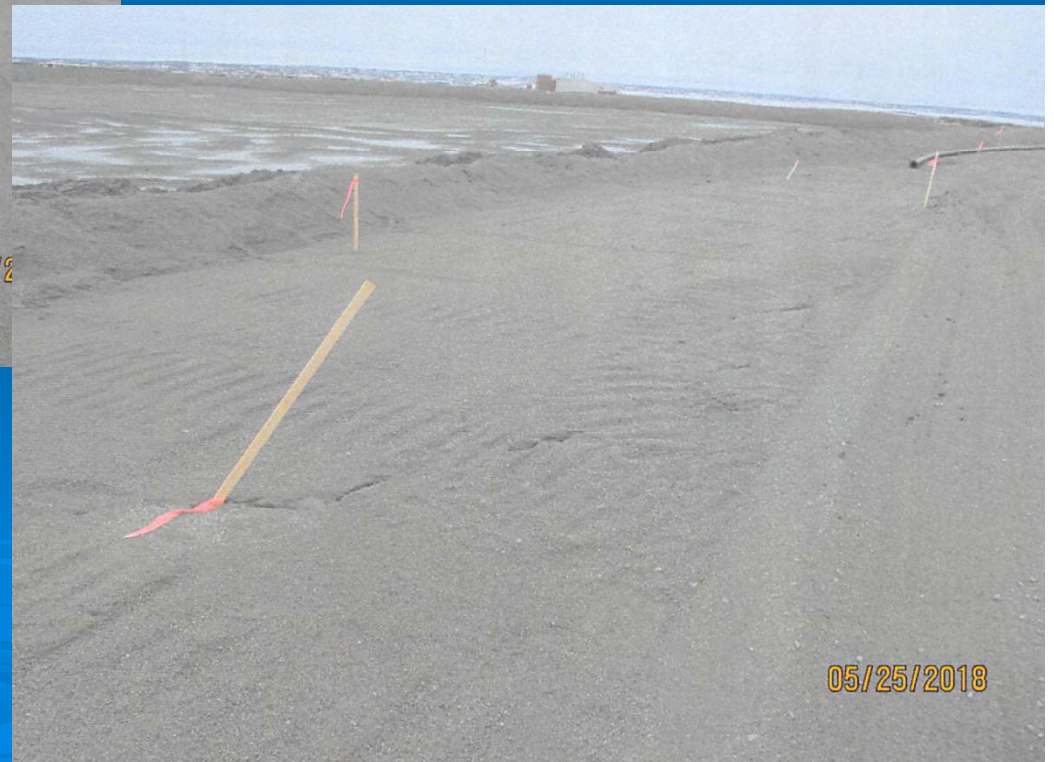
Starter Cell, Cell F (left photo) and South Quarry Cell, Cracks documented/investigated as part of regular Geotechnical Inspections

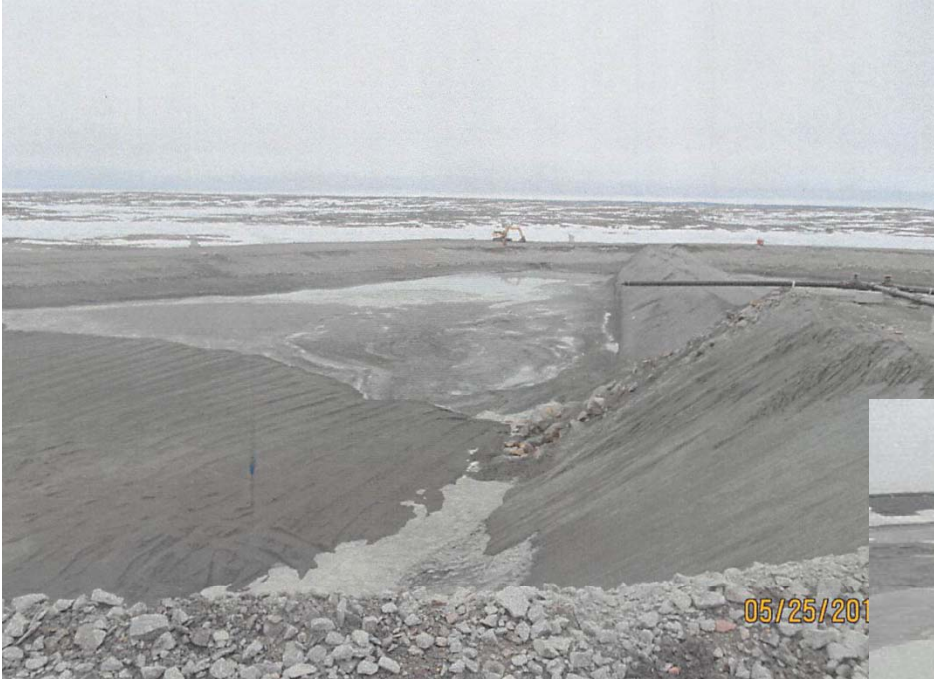
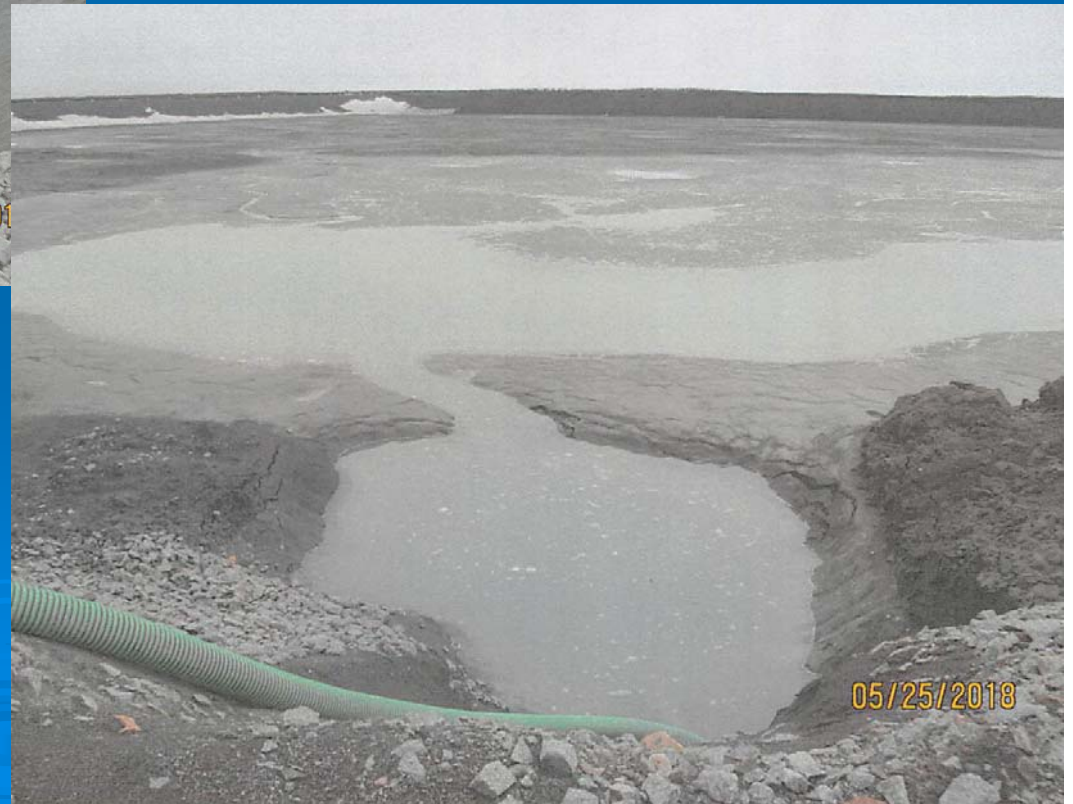
East Cell, Cell D, Dewatering

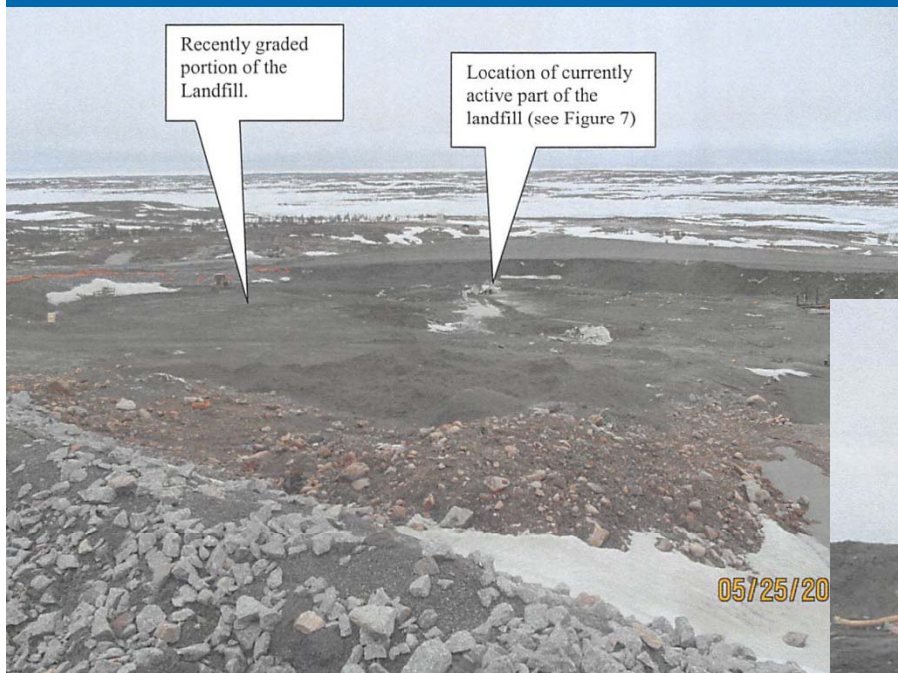
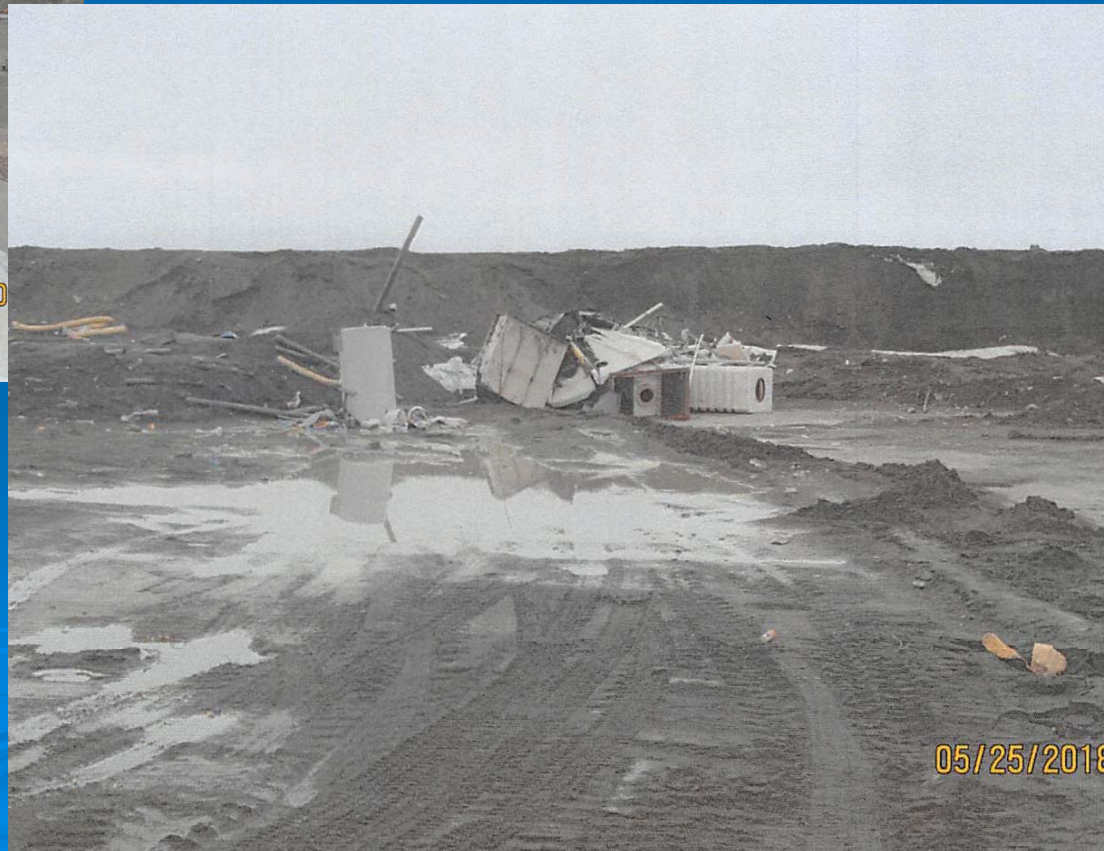
Landfill in East Cell, Cell 1

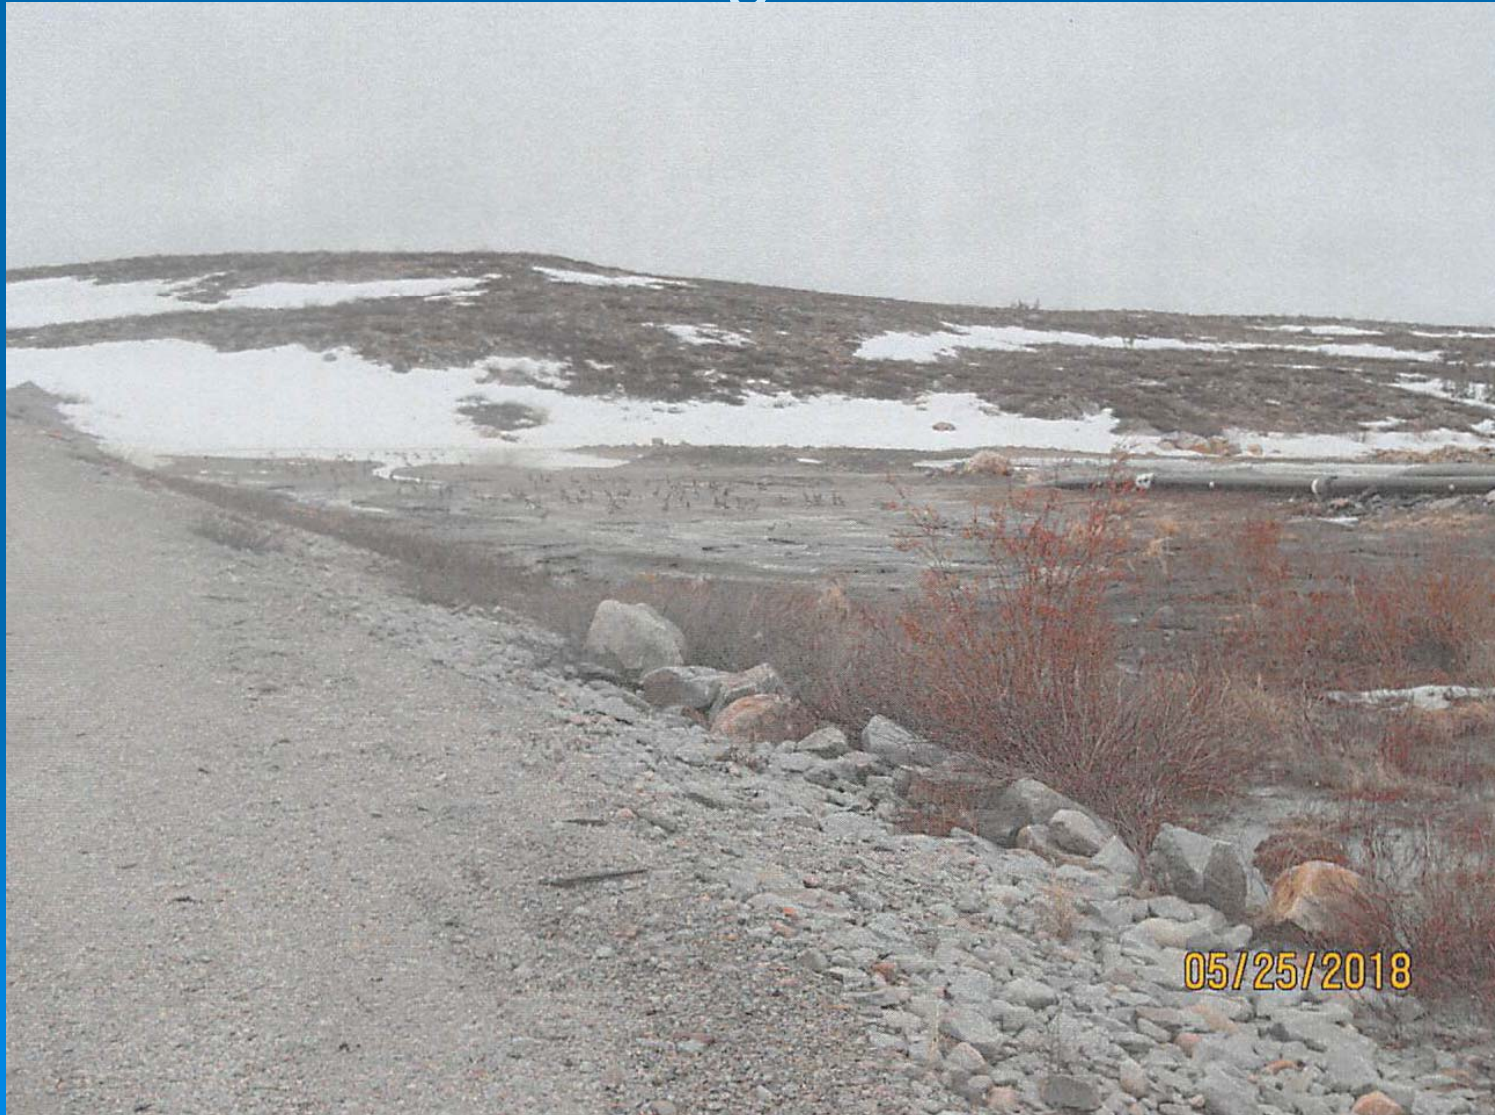
A flock of Canada Geese was observed feeding on the exposed sediment of the Water Management Pond

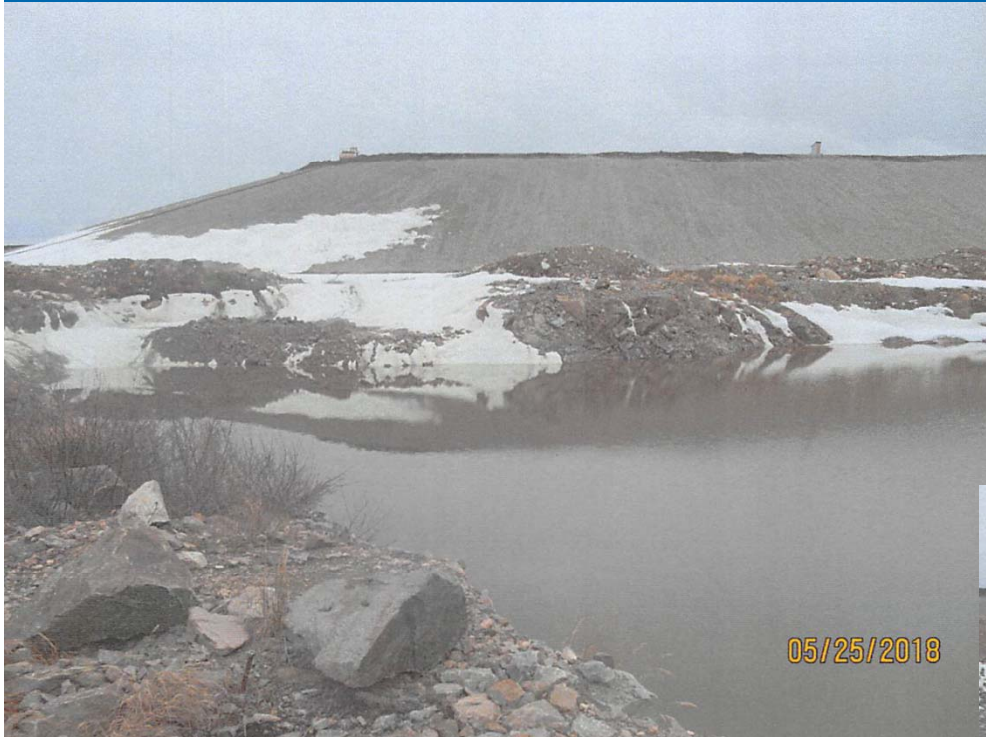
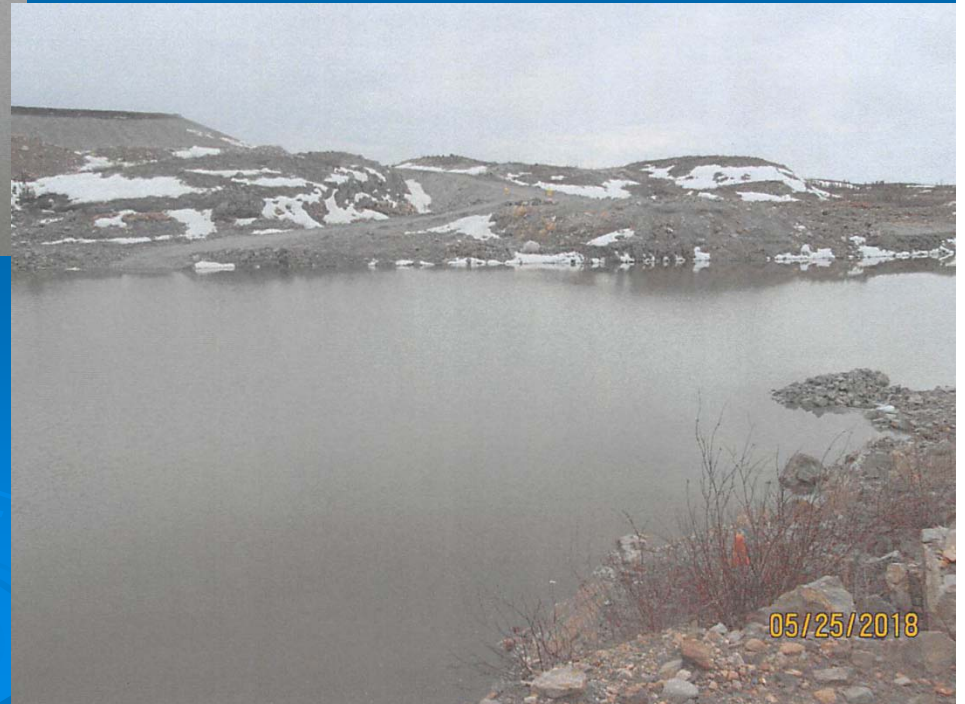
The Water Level in Sump 5 was high

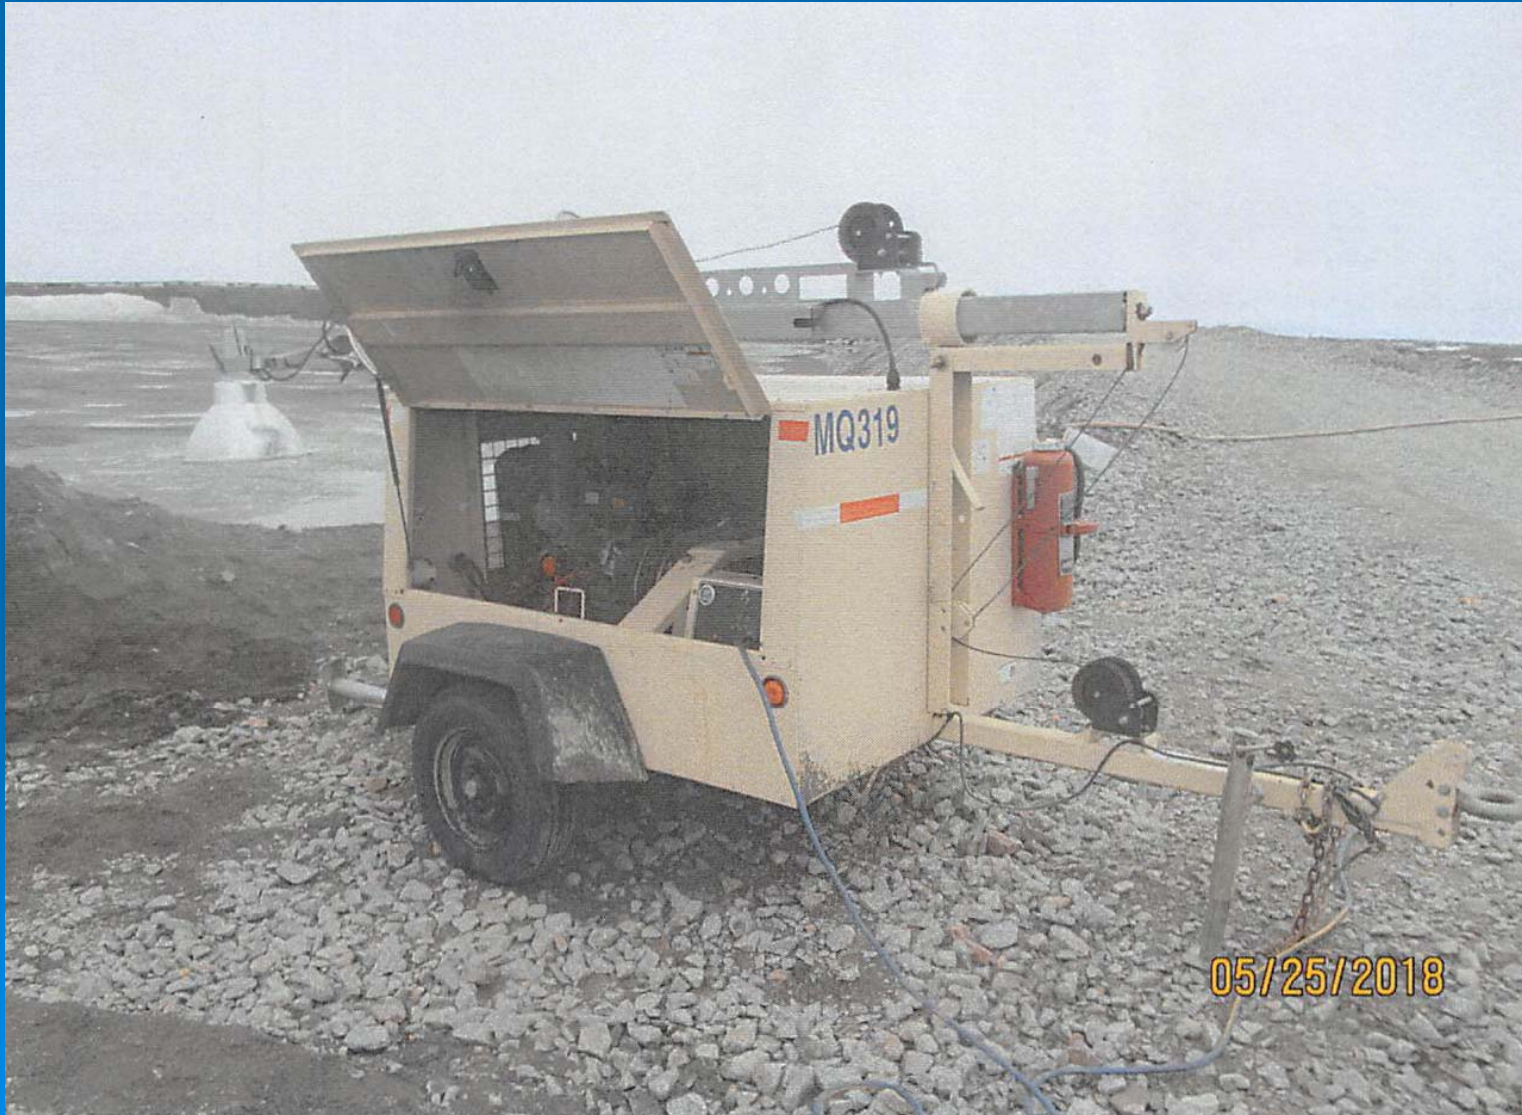
The inspector reminded De Beers staff that industry best practices dictate that portable pumps, heaters, lights, etc. should have drip trays placed underneath to capture any fuel or oil drips which might occur over time

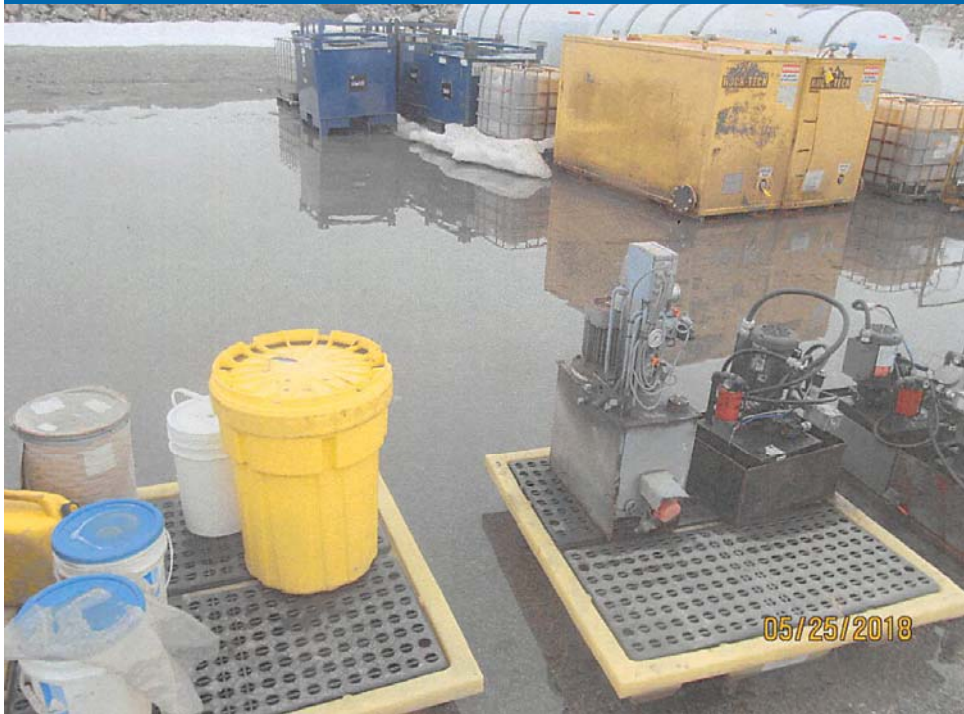
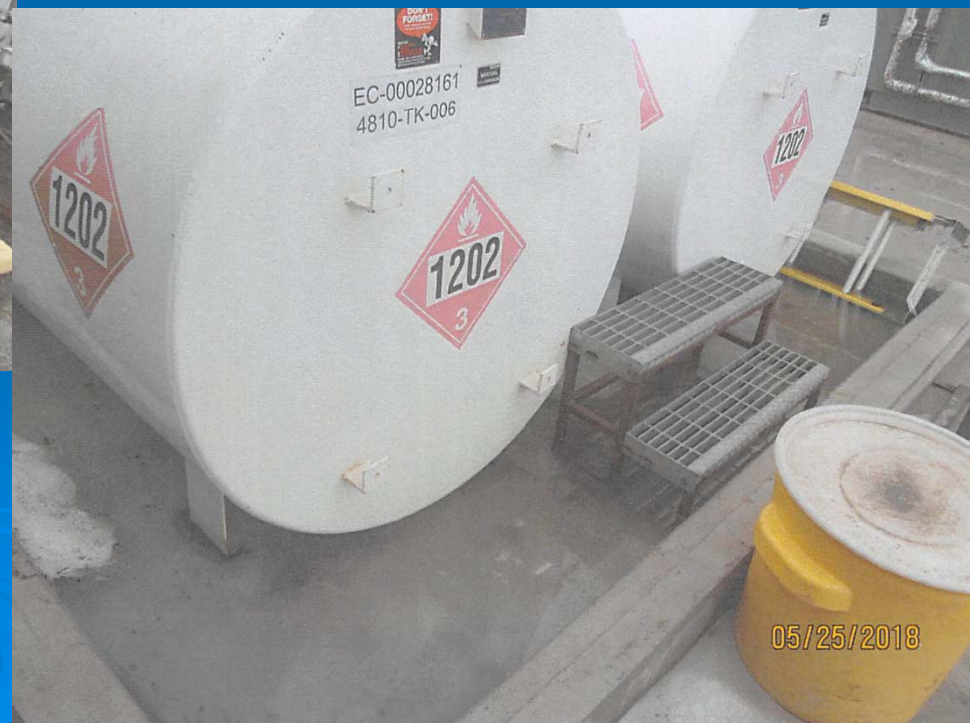
Snow melt has created significant ponded water inside the following lined sumps at the minesite. Such water needs to be tested and removed from all bermed areas

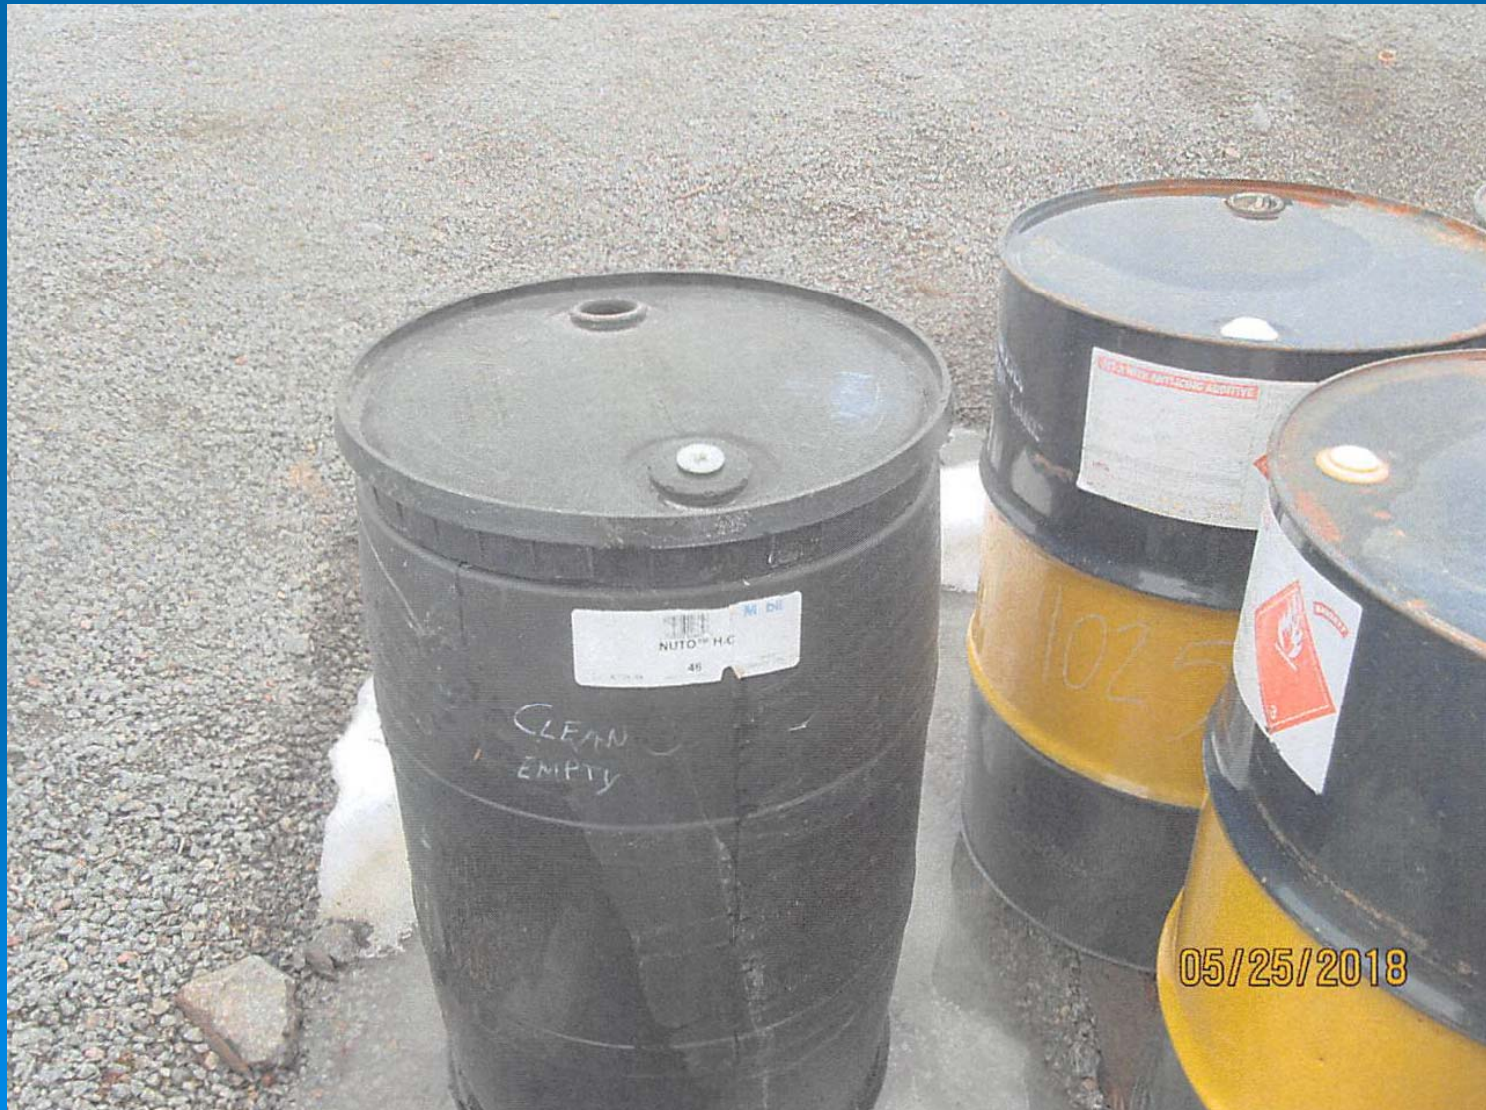
Drum needing a new bung/labelling

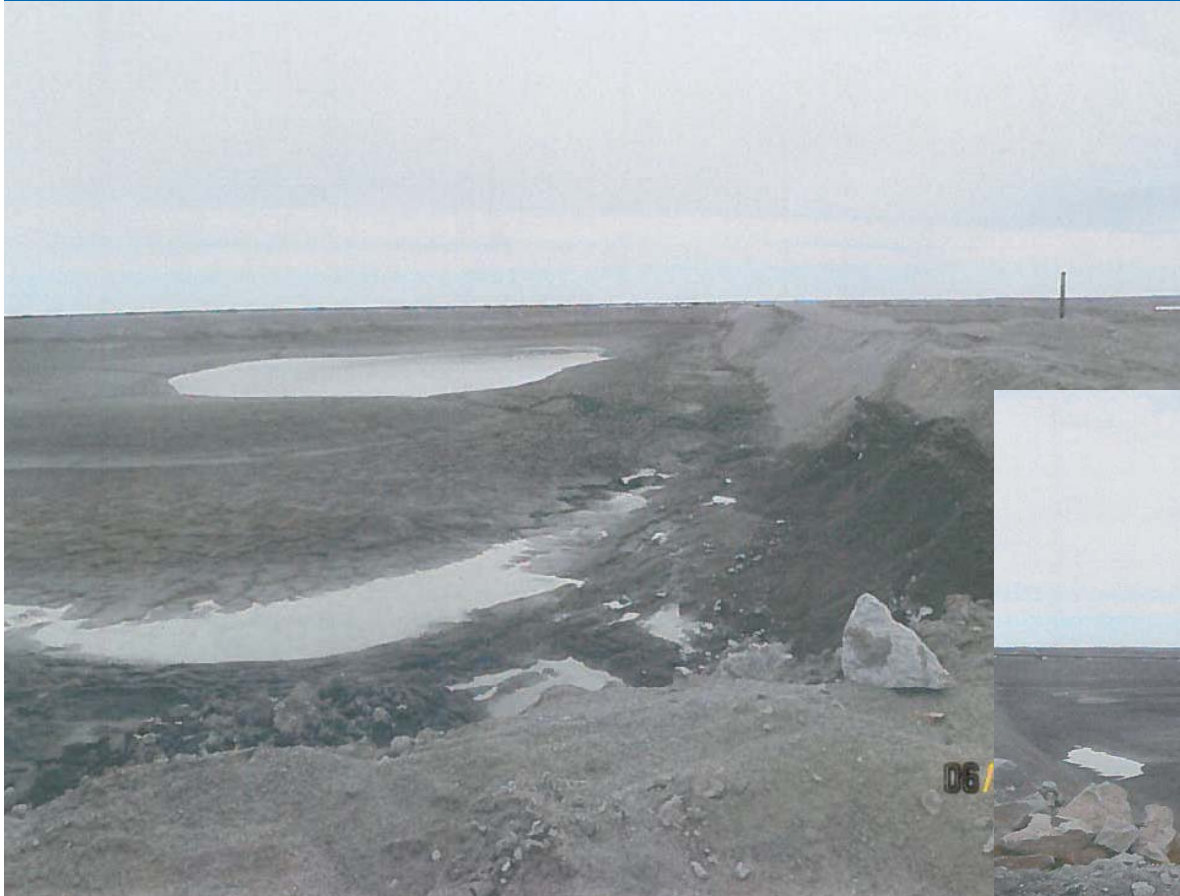
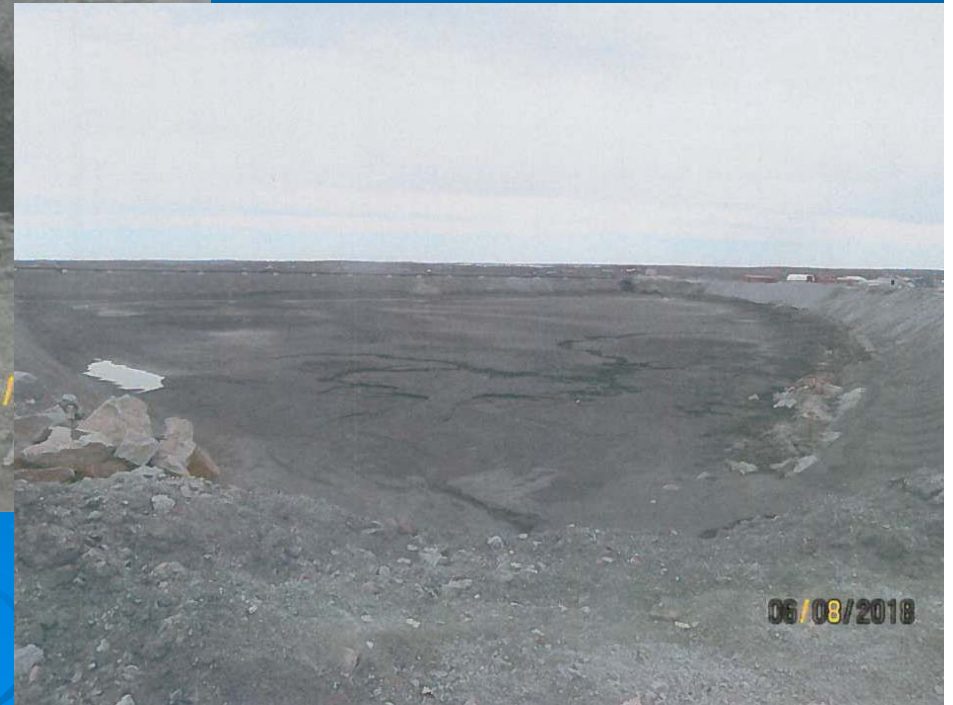
Presence and absence of ponded water in the Starter Cell: pumping out of water has been happening intermittently

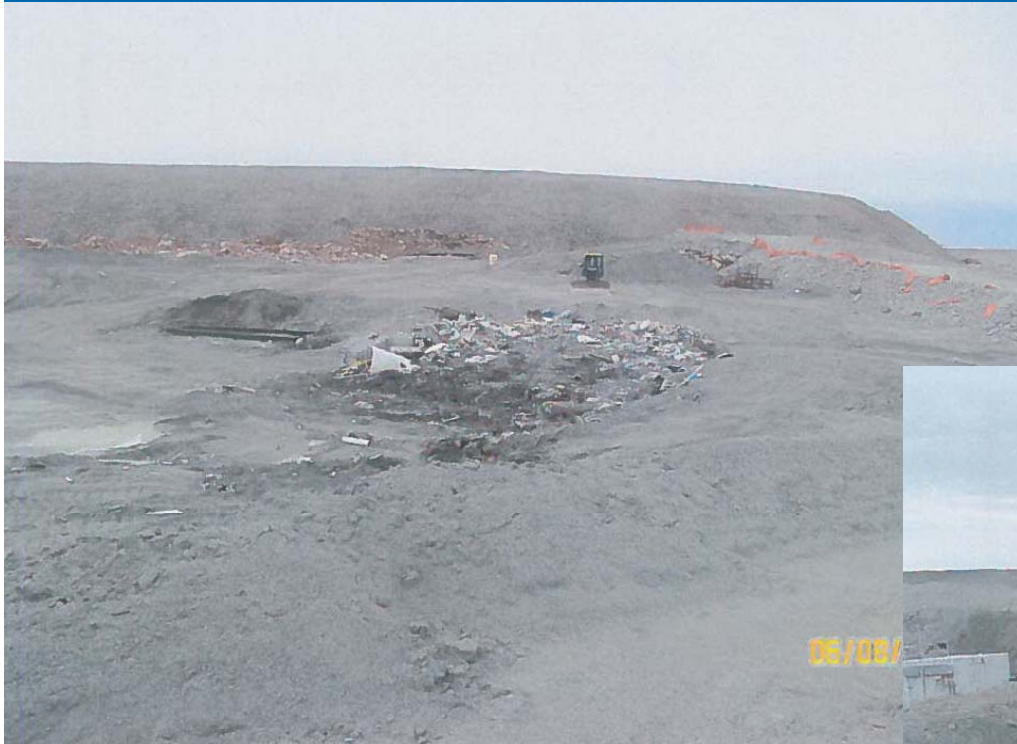
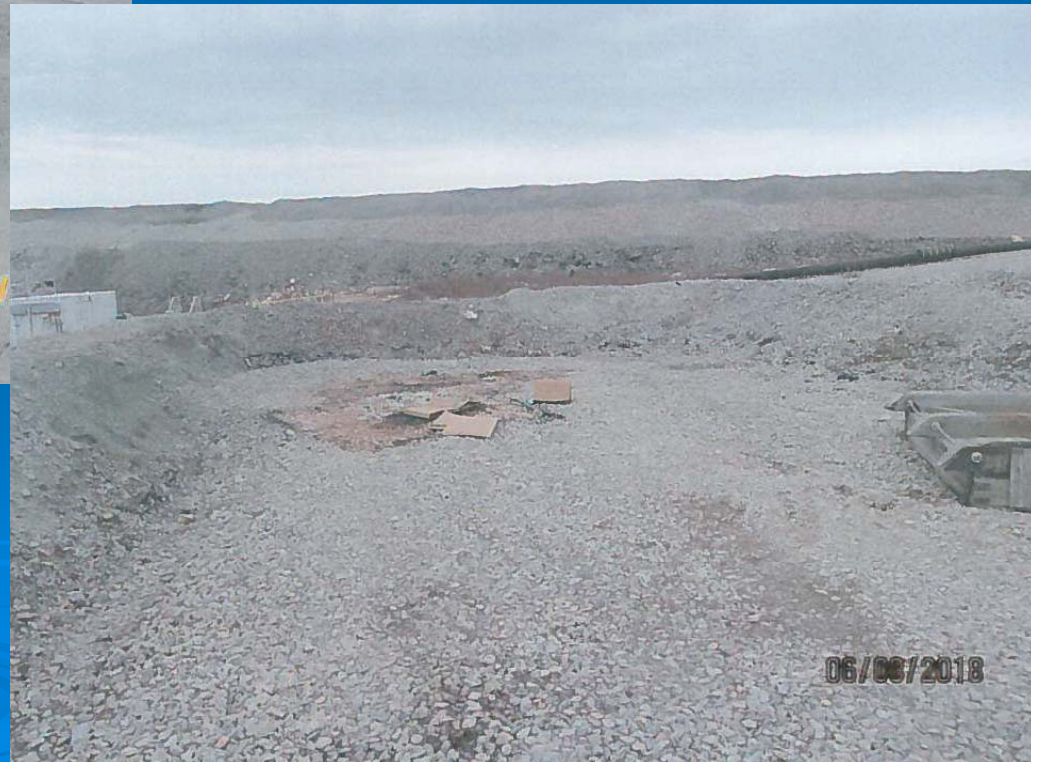
Landfill (left photo) and Burn Pit

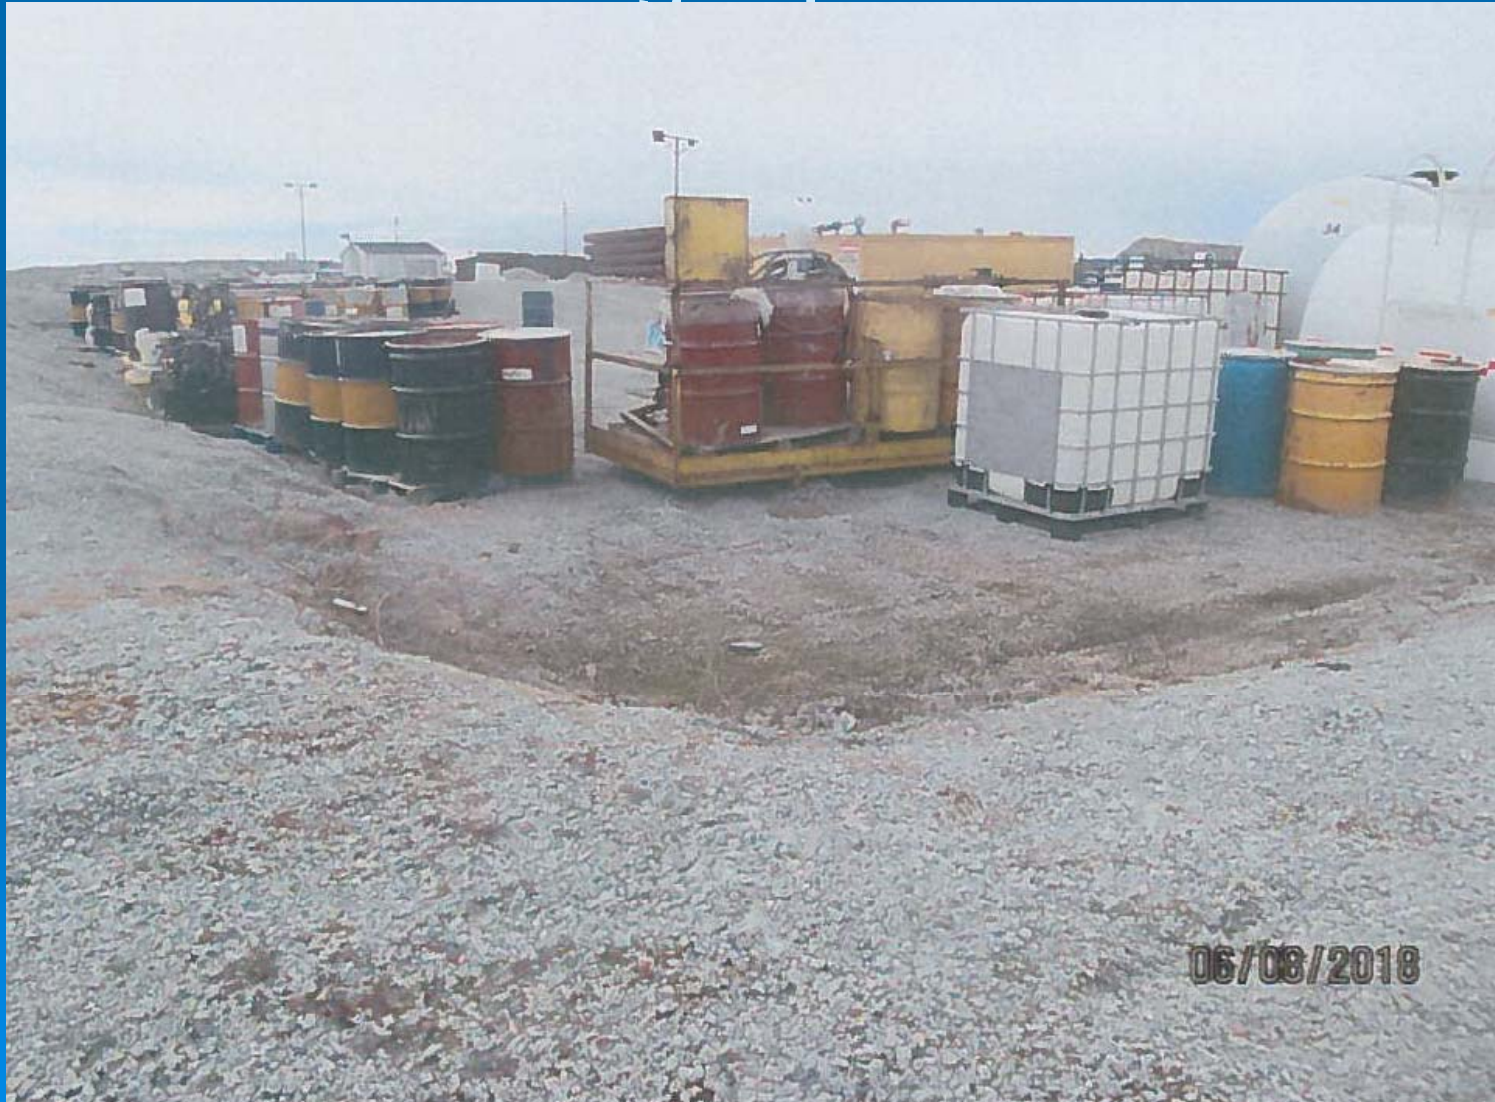
Ponded water which was present in the
Waste Transfer Area two weeks ago is
no longer present

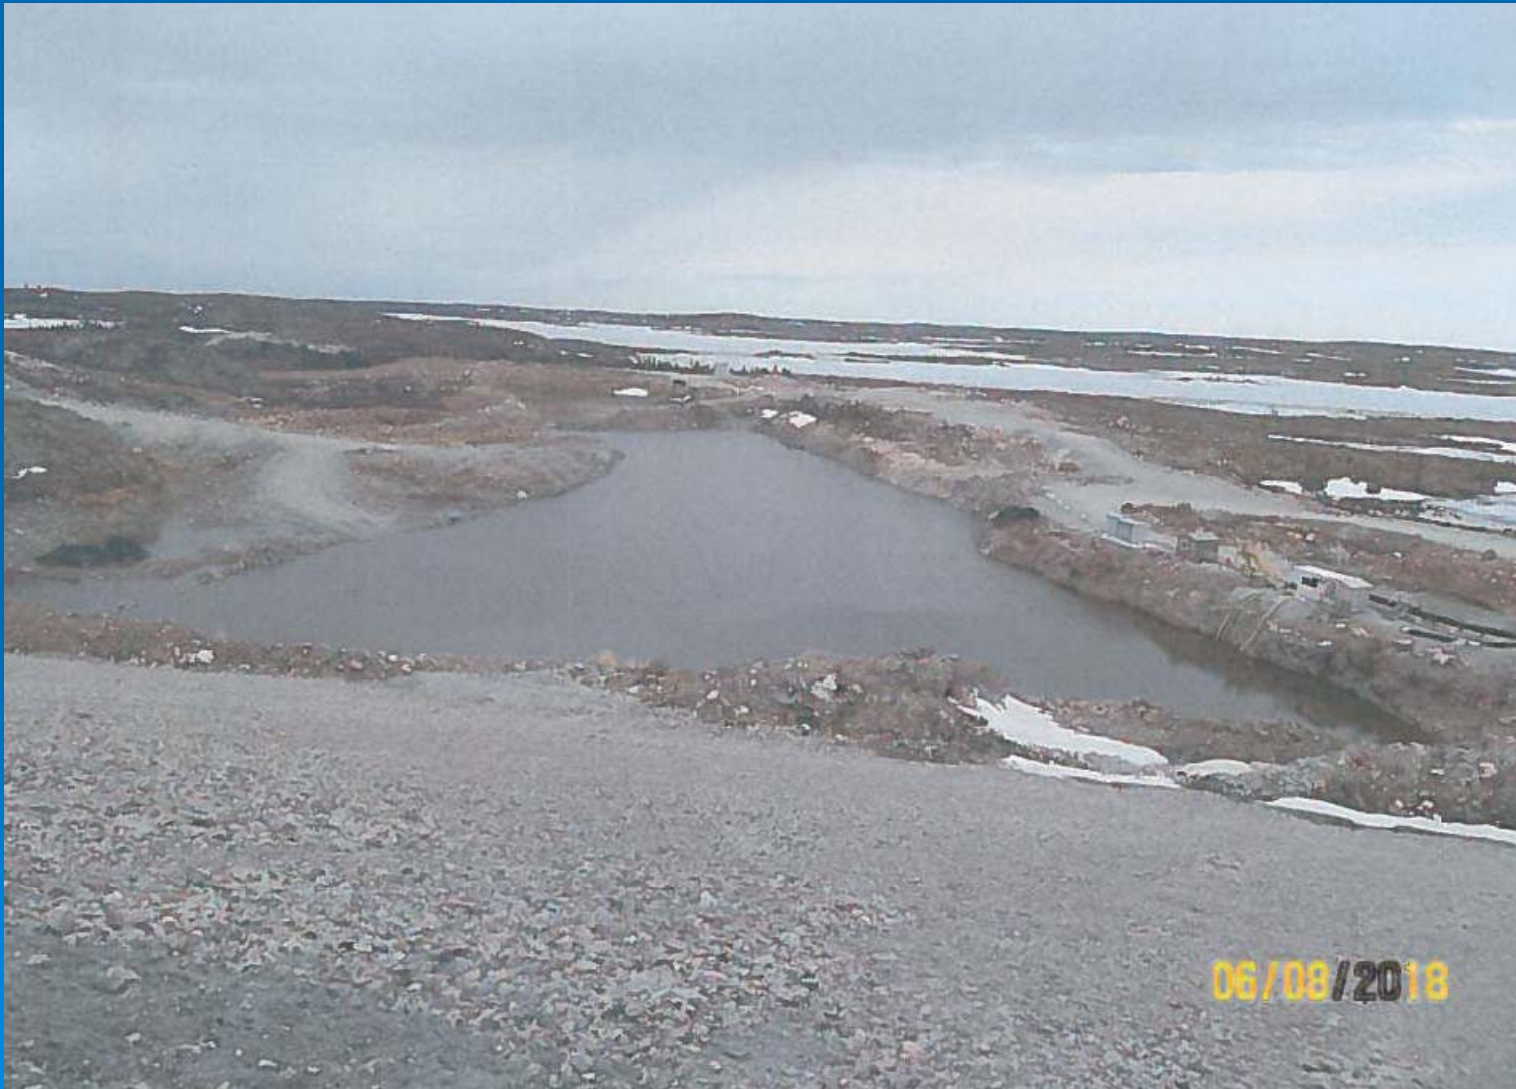
Water level of Sump 5 was high at the time of inspection

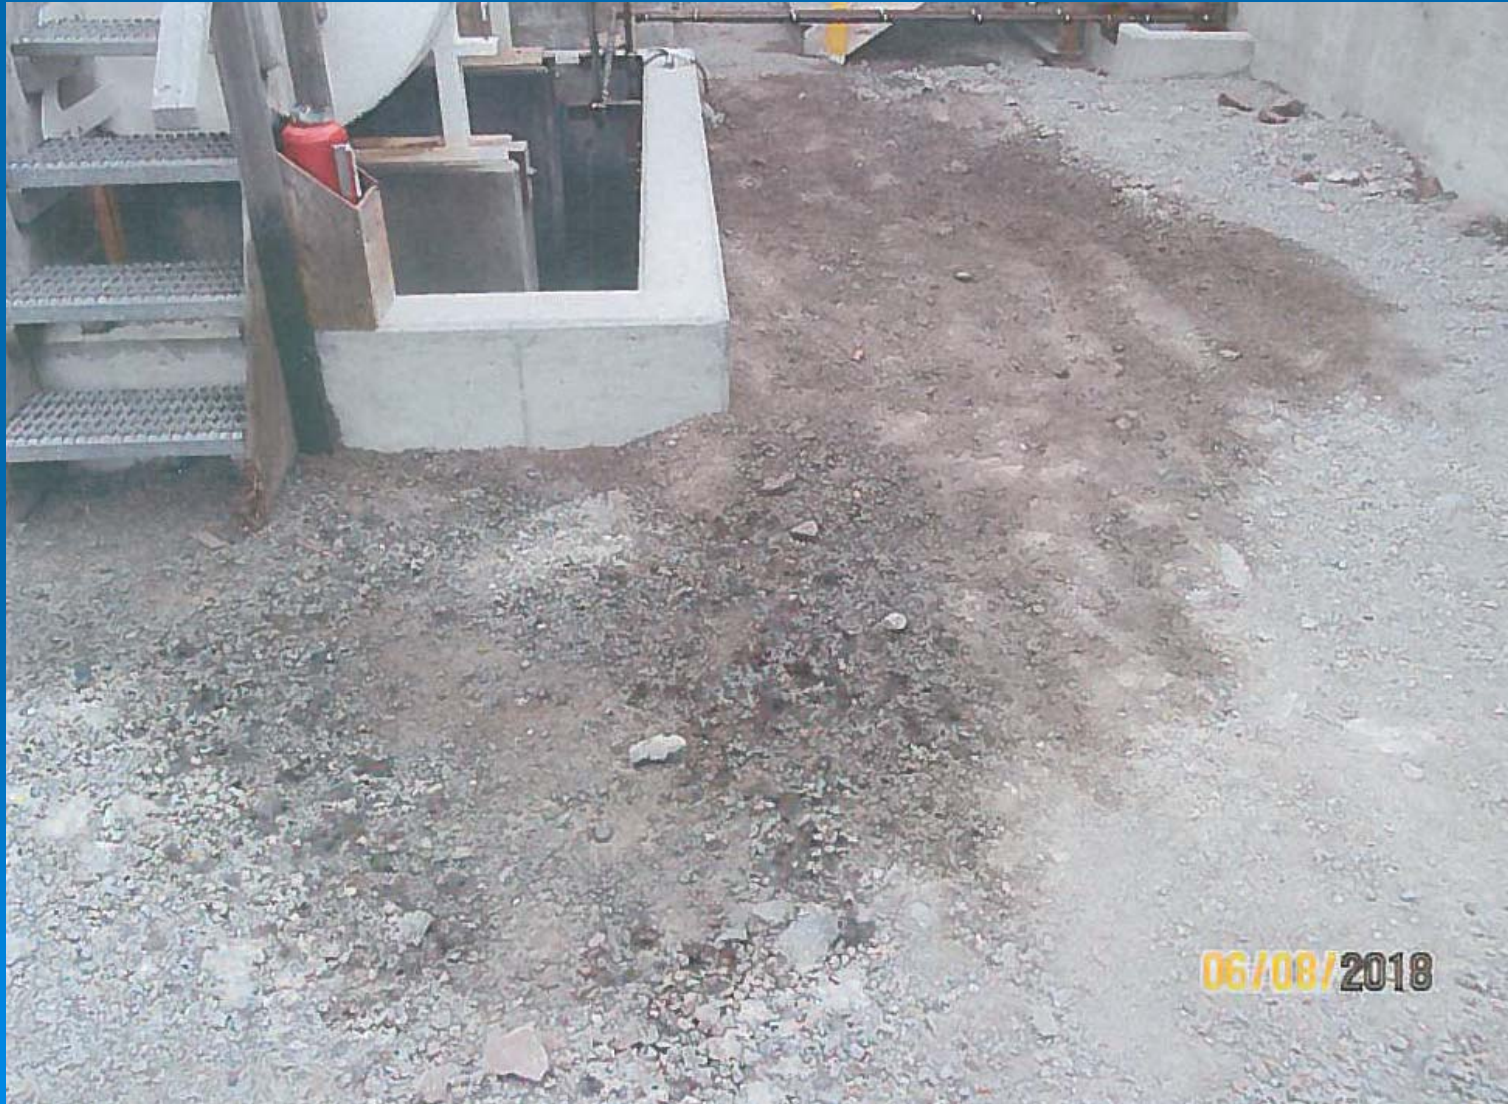
06/08/2018

Day Tank 2 (spill 17-440 spill site): staining on the ground indicates the extent to which diesel overtopped the sump and infiltrated the ground. De Beers will remove this material soon

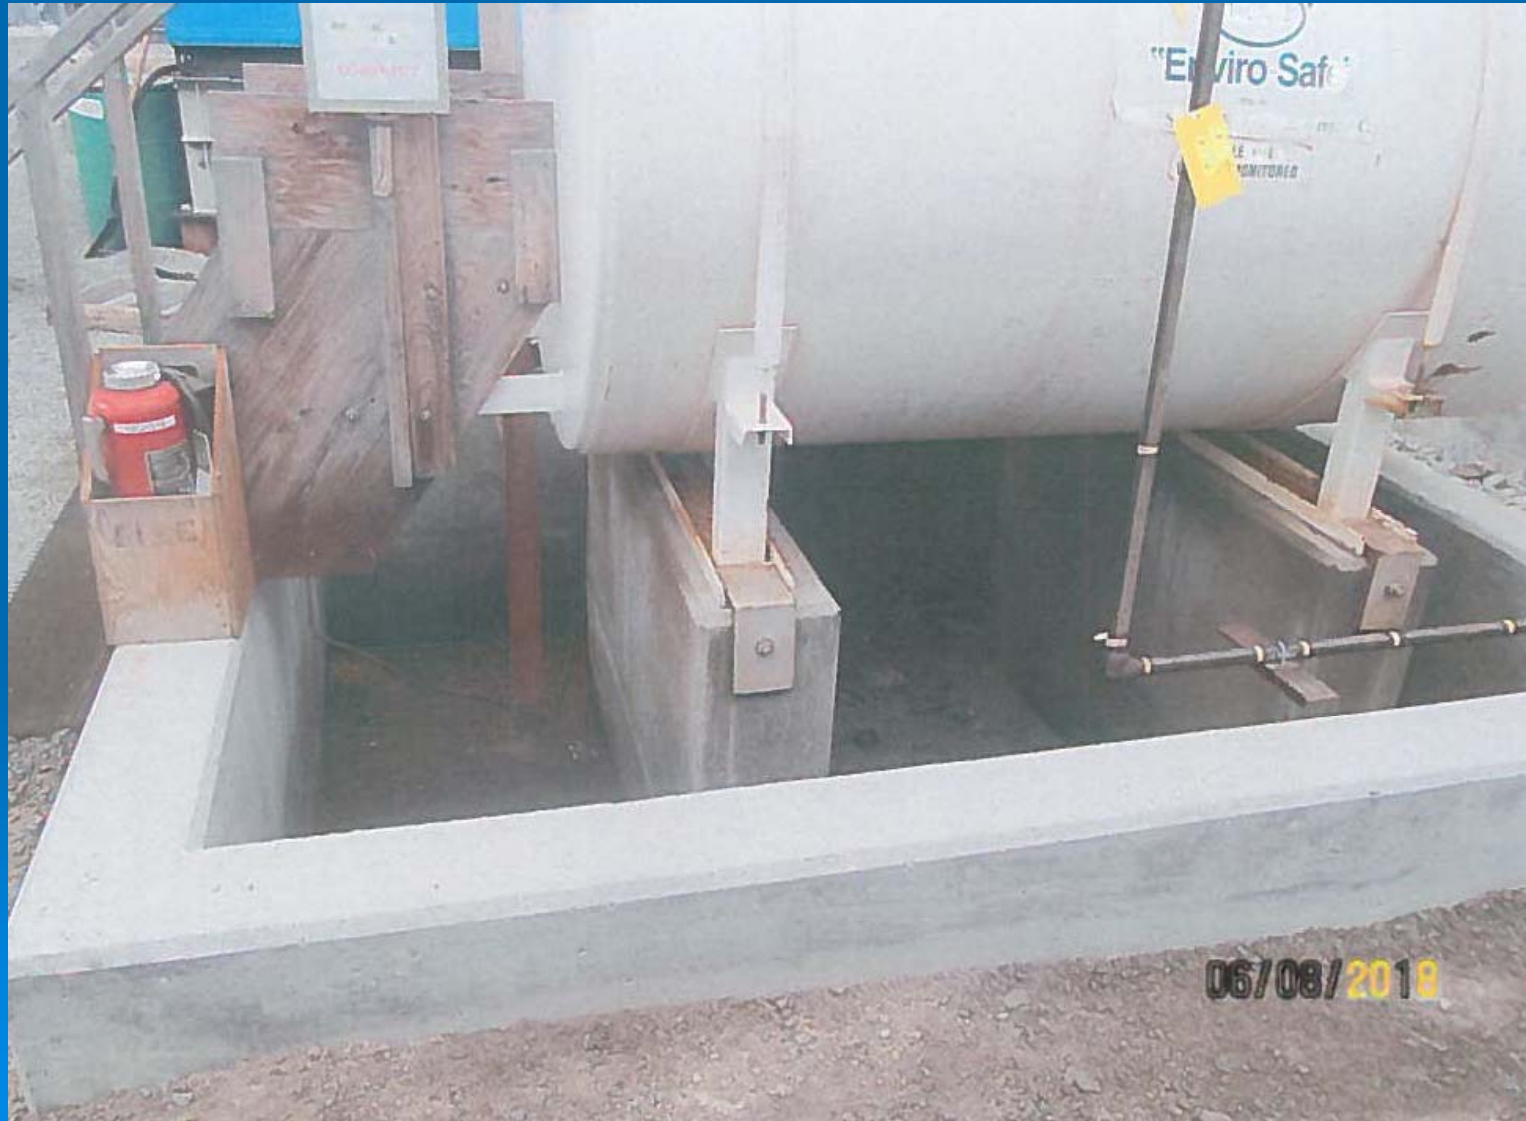
The sump for Day Tank 2 had been cleaned and was water-free
