June 2018 Environmental Update for SLEMA Board

Zhong Liu
June 30, 2018

2.1 Water Licence Inspection on May 25, 2018

2.2 Water Licence Inspection on June 8, 2018

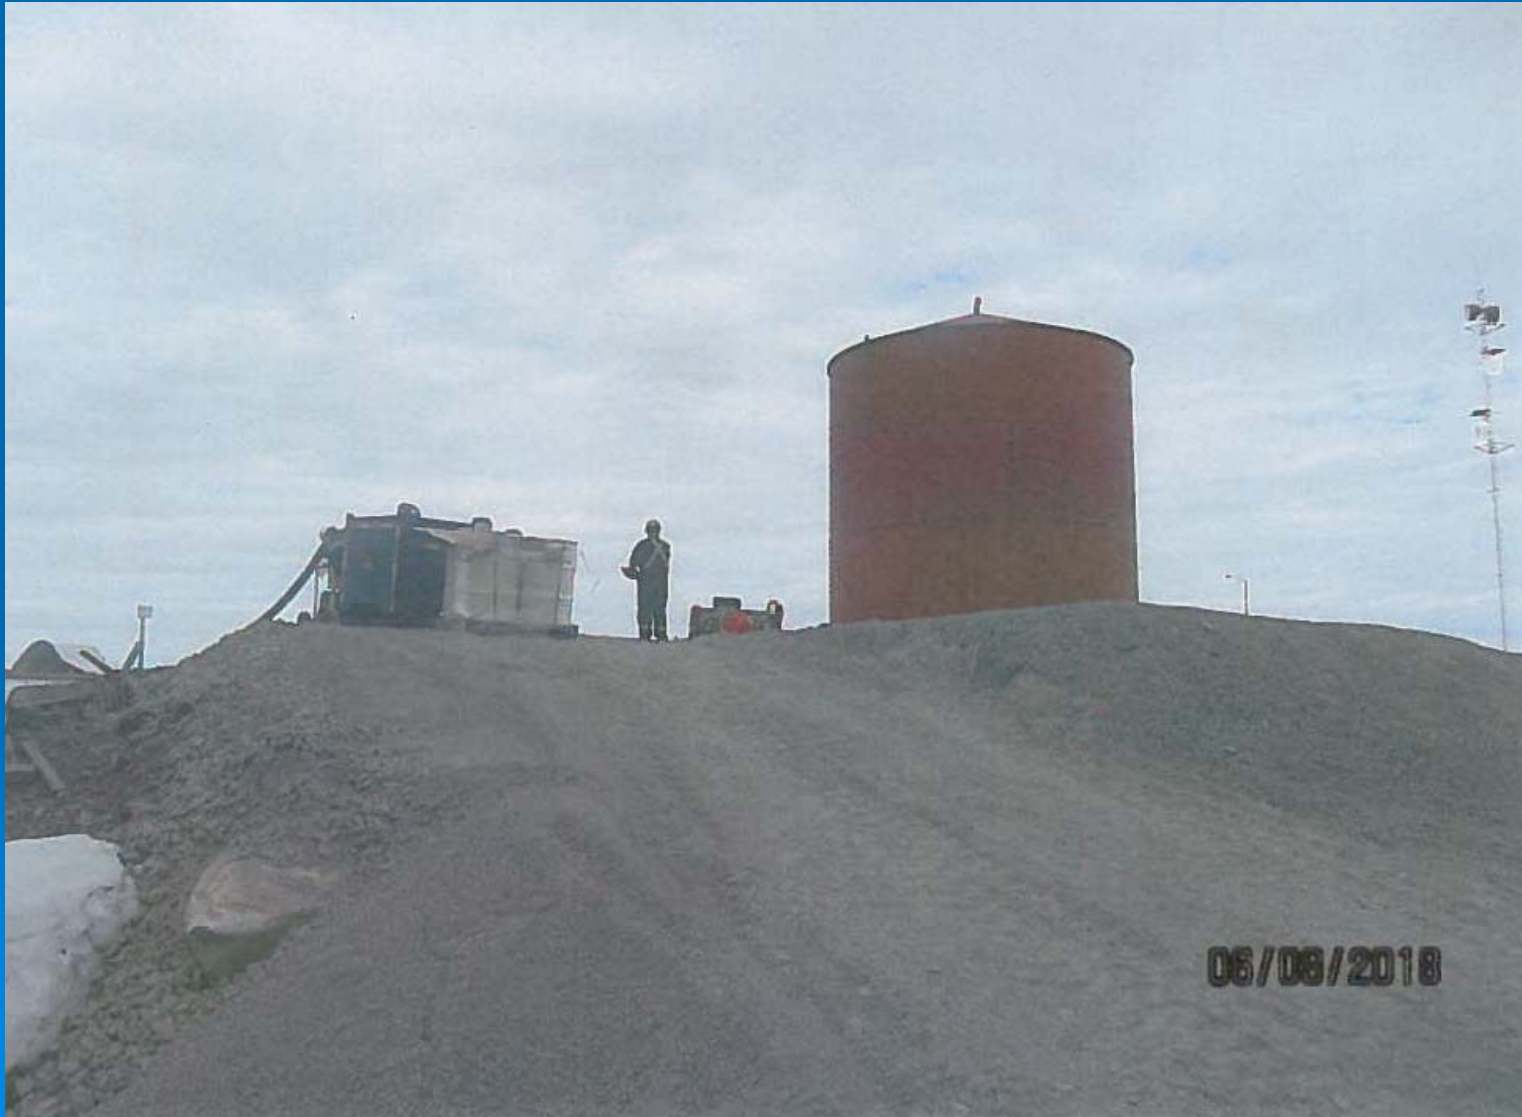
Maintenance/certification work at the Utility Tank (500,000 L diesel tank)

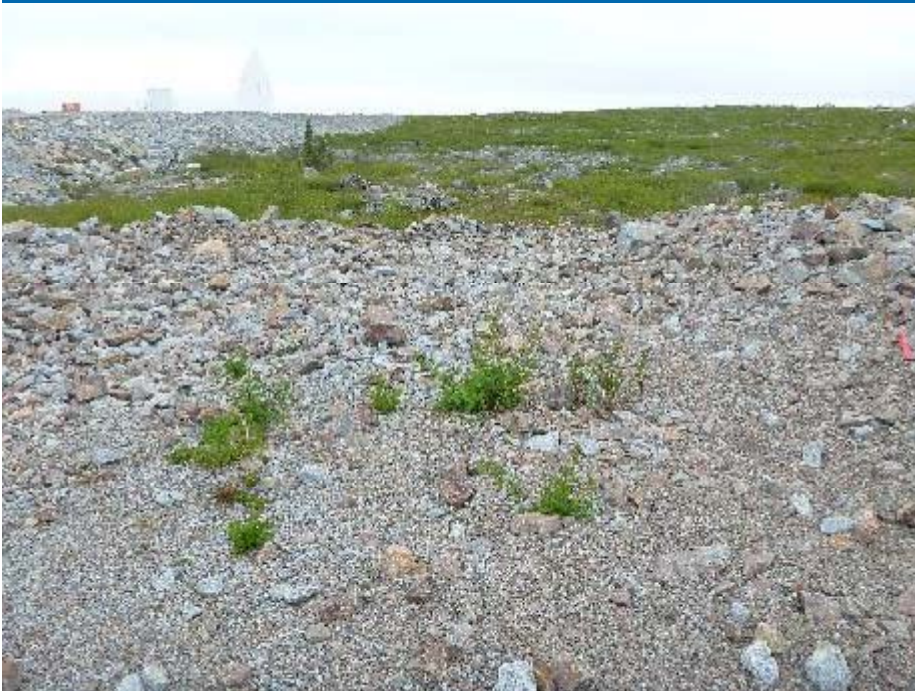
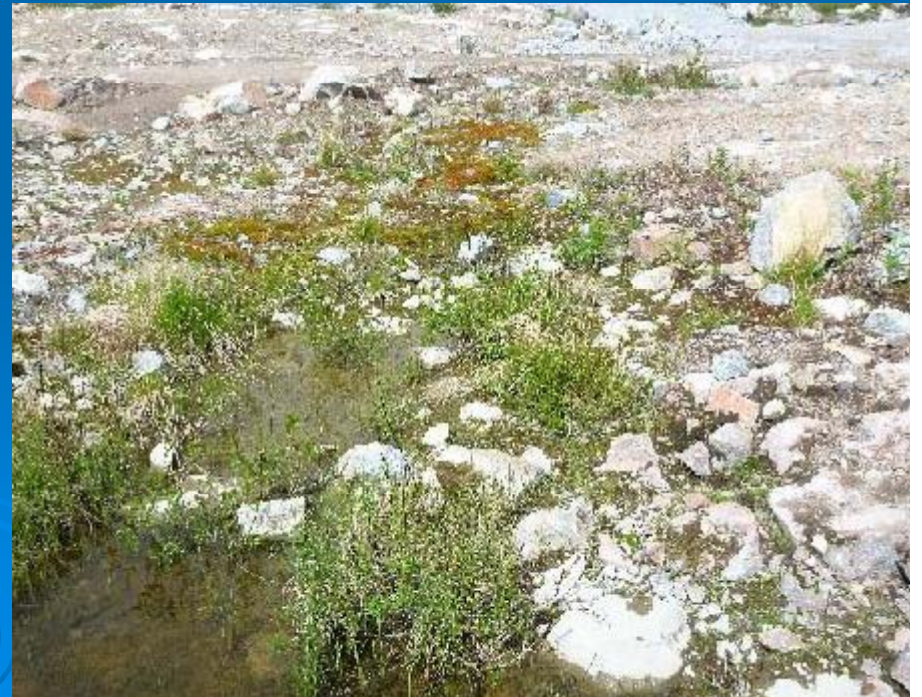
NR-2 (AN Storage) vs. NR-3 (Quarry-wet)

- Initial observations regarding the natural revegetation disturbed areas were as follows:
 - Seventeen locations were assessed. Thirteen of those had at least 30% plant coverage
 - Species most found included: dwarf birch, fireweed, moss, grasses and crowberry
 - NR-10 (WMP shore) and NR-16 (Starter Cell, south ditch) both had areas with 100% plant coverage and NR-3 (Quarry-wet) had 85% plant coverage. These three areas also had the highest percent of organics observed in the soil with 30 to 40%
