November 2012 Environmental Update for SLEMA Board

Zhong Liu
November 30, 2012

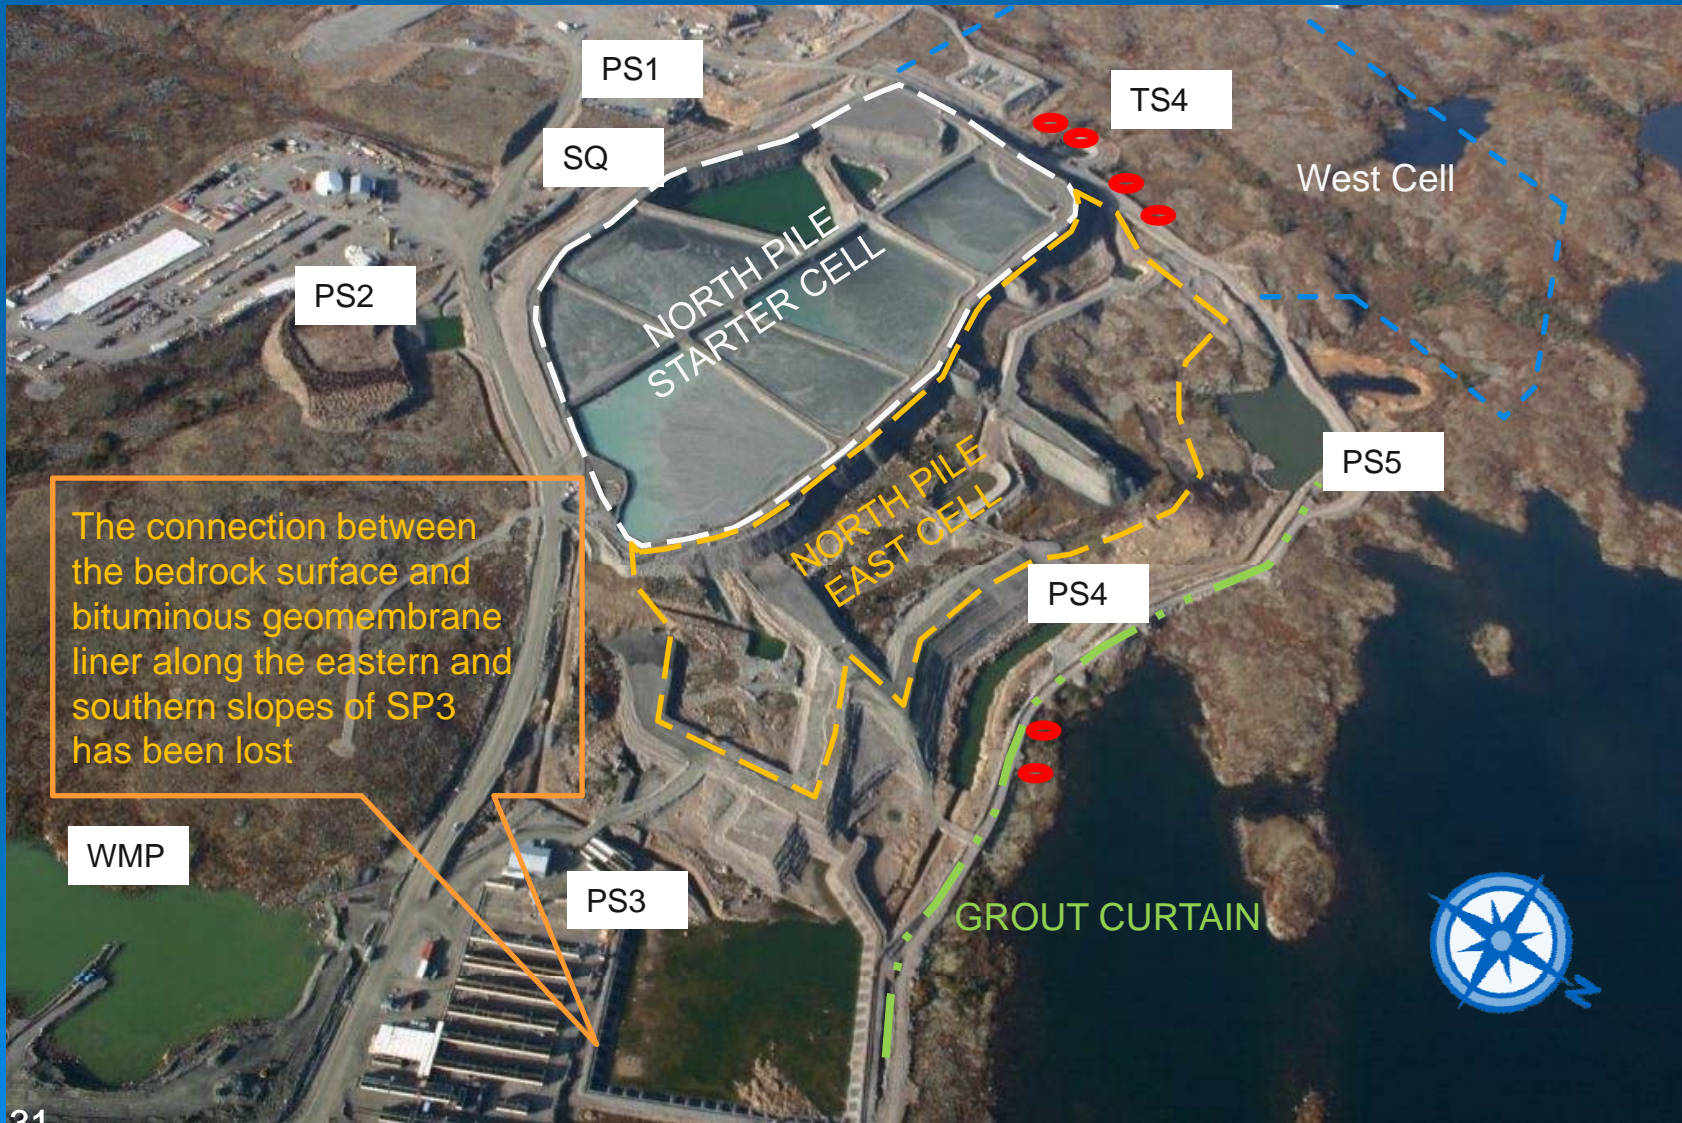
Snap Lake North Pile and Sumps

- The connection between the bedrock surface and bituminous geomembrane liner along the eastern and southern slopes of SP3 has been lost as a result of water flows below the sump by-passing relieve valve flaps near the bedrock contact interface. Replacement of the geomembrane liner bedding layer has been compromised as a result from the flow of water into SP3. The liner bedding system is to be evaluated, and repaired as necessary, at the time of liner replacement. Once the liner and liner bedding system have been re-established, granular fills are to be placed over the entire surface of the geomembrane liner to provide confinement as previously recommended by Golder
- De Beers Response – under review

- Inquiry e-mail about SP3 sent to De Beers on November 20, 2012
 - “Would you kindly explain the implications of the lost connection between the bedrock surface and bituminous geomembrane liner along the eastern and southern slopes of SP3?”
 - Is there any link between the October 2011 spills and the lost connection?
 - Will it impact the operation of SP3 as designed?”

- “The liner issues described by Golder along the southern and eastern slopes are to be repaired in March 2013
- The liner is compromised by inflow into PS3 and this is NOT related to the spills in October 2011
- Full scale repairs of liner with appropriate ballast, sealing (bentonite) etc is planned for July 2013 for ideal weather conditions and post freshet
- Currently we cannot operate PS3 to design until the above repairs have been done in July 2013. To mitigate any risks of leaks/spills, we will not allow the volume in the sump to exceed 13,000m³ (Elevation 445.757) even during freshet. This elevation/volume will ensure no seepage of water occurs”

- Further question from the Environmental Analyst
 - The water level maintained in PS3 (445.757) is still much higher than that in Snap Lake (444.1), is it safe to say “this elevation/volume will ensure no seepage of water occurs”?
- Response from De Beers
 - “Yes, it has been assessed by our water management team and it is well below the elevation in which problems can occur. I double checked on this concern before responding to your original questions”
