SLEMA  
January 2012  
Environmental Update

Zhong Liu  
January 31, 2012

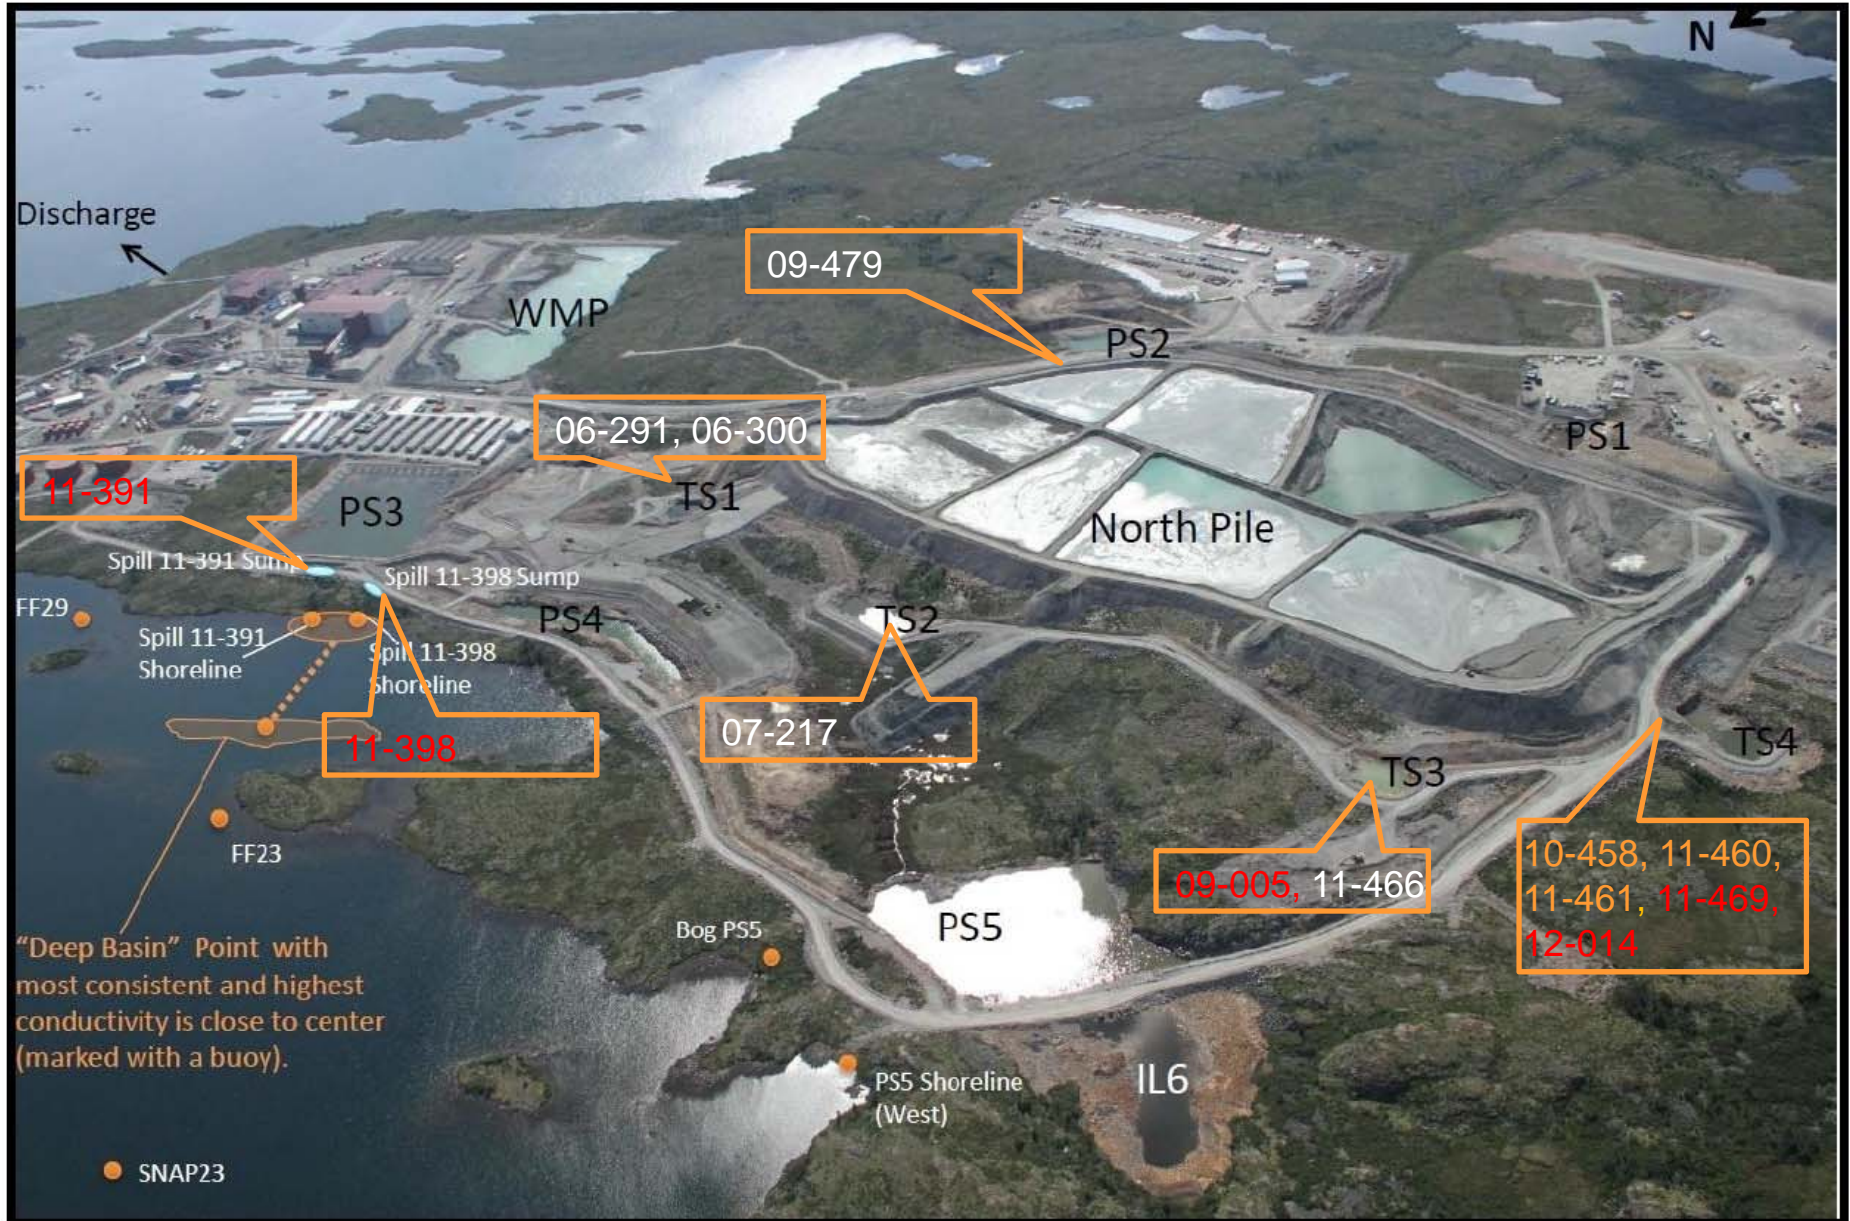
# Location of Spills within the North Pile

- Spills within the North Pile
  - 13 spills from 2006 to 2012
    - 5 resulted from pipe problems
    - 5 resulted from failed water level control
    - 3 possibly resulted from design defect of water collection system
  - 8 out of 13 spills occurred from December 2010 to January 2012
    - Resulted in the Inspector's Letter of Warning dated January 24, 2012
  - Recommendation – De Beers to revisit North Pile water management, including strategy, design and practices
