July 2015  
Environmental Update  
for SLEMA Board

Zhong Liu  
July 31, 2015

# 2.1 Water Licence Inspection

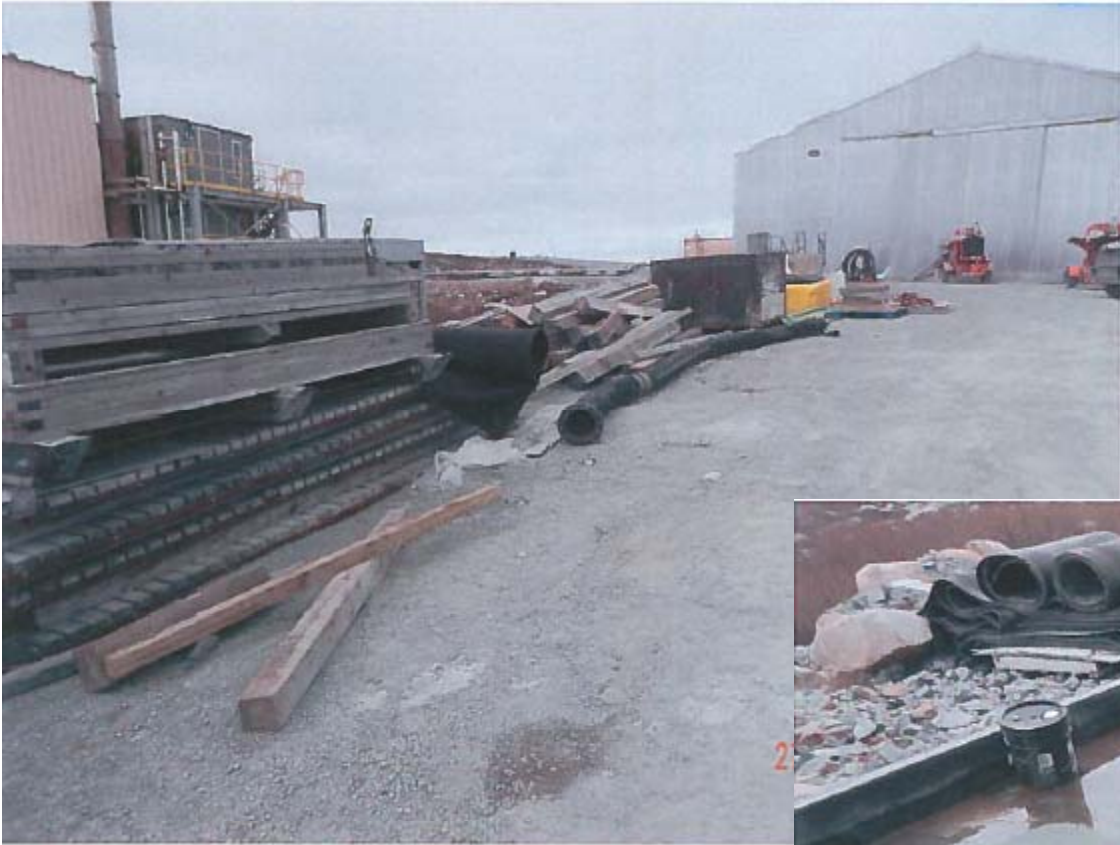
Photo 1 – Water World Building 53 – Laydown was clean and well organized. The pumps and evidence of spills in the area.

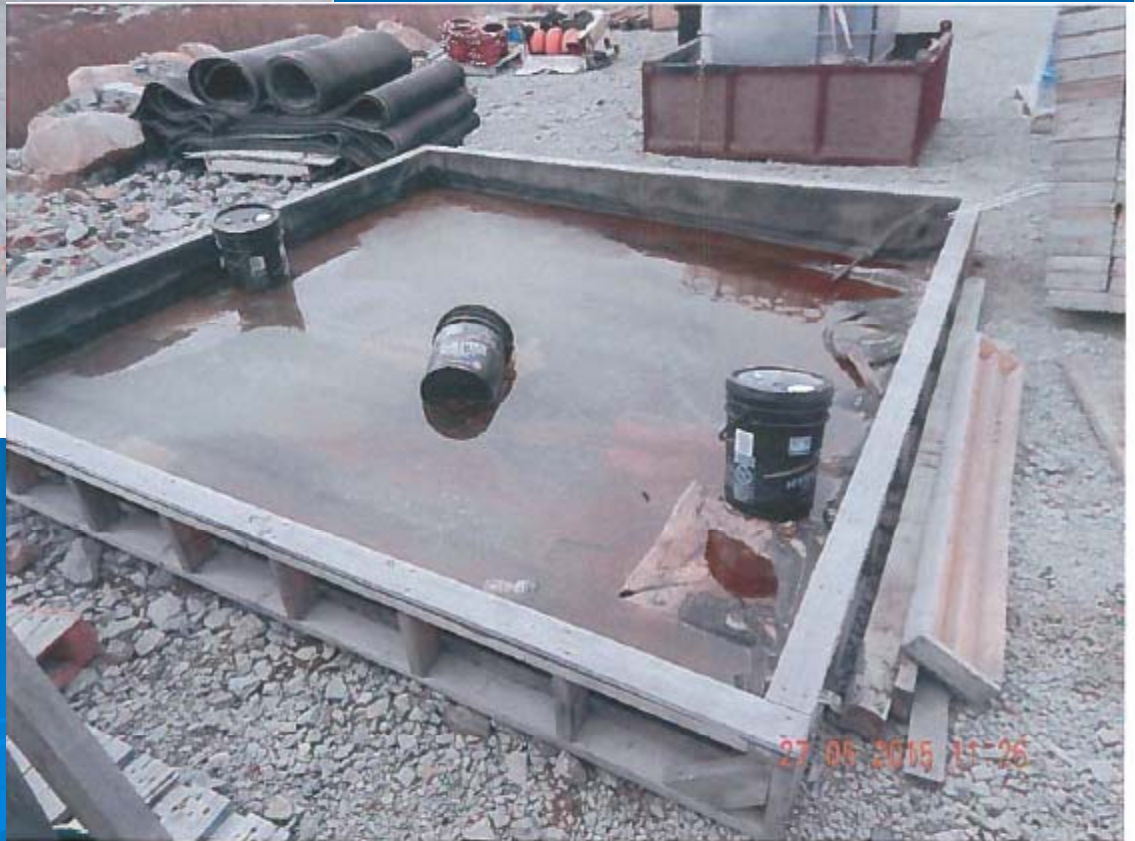
Photo 2 - Water World Building 53 – A containment tray used for hydrocarbon storage was filling with water and will need to be pumped out before it overflows.

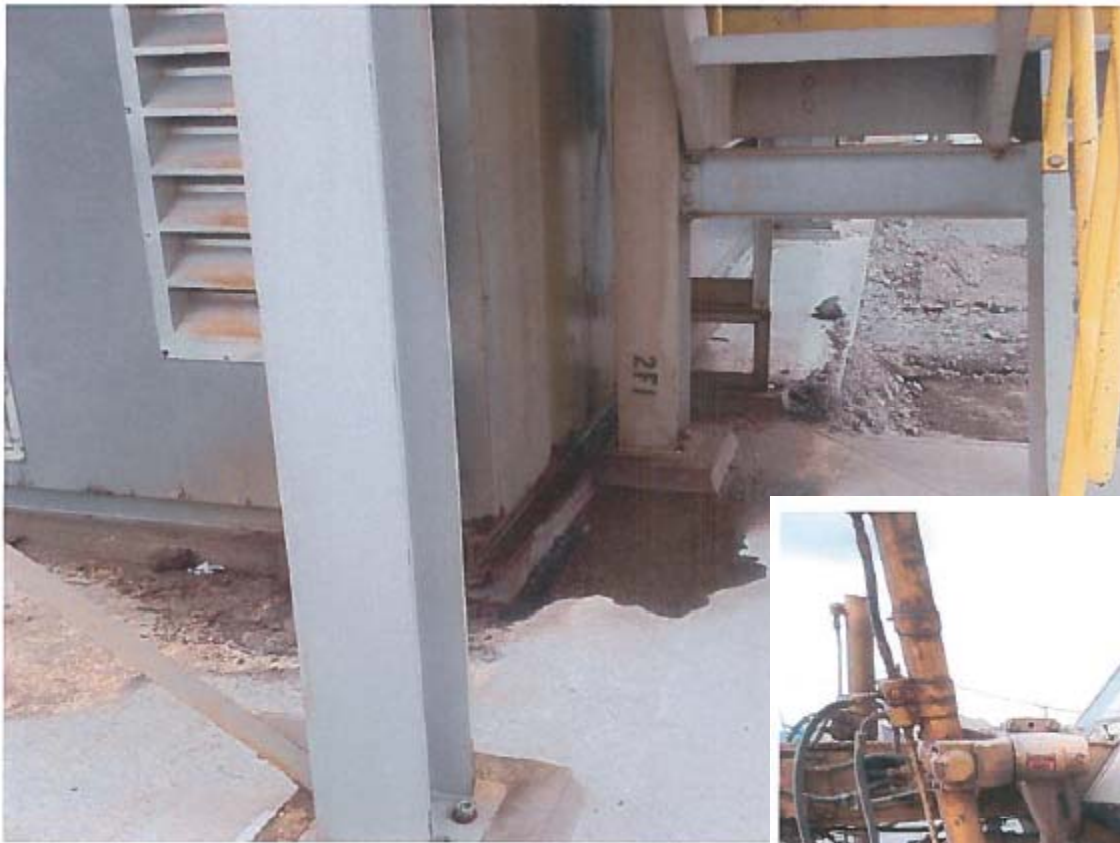
Photo 4 – Fresh Air Raise – Some seepage from the fresh air raise is pooling up outside. The source of the seepage is not known by De Beers at this time. The area is being acted on a regular basis.

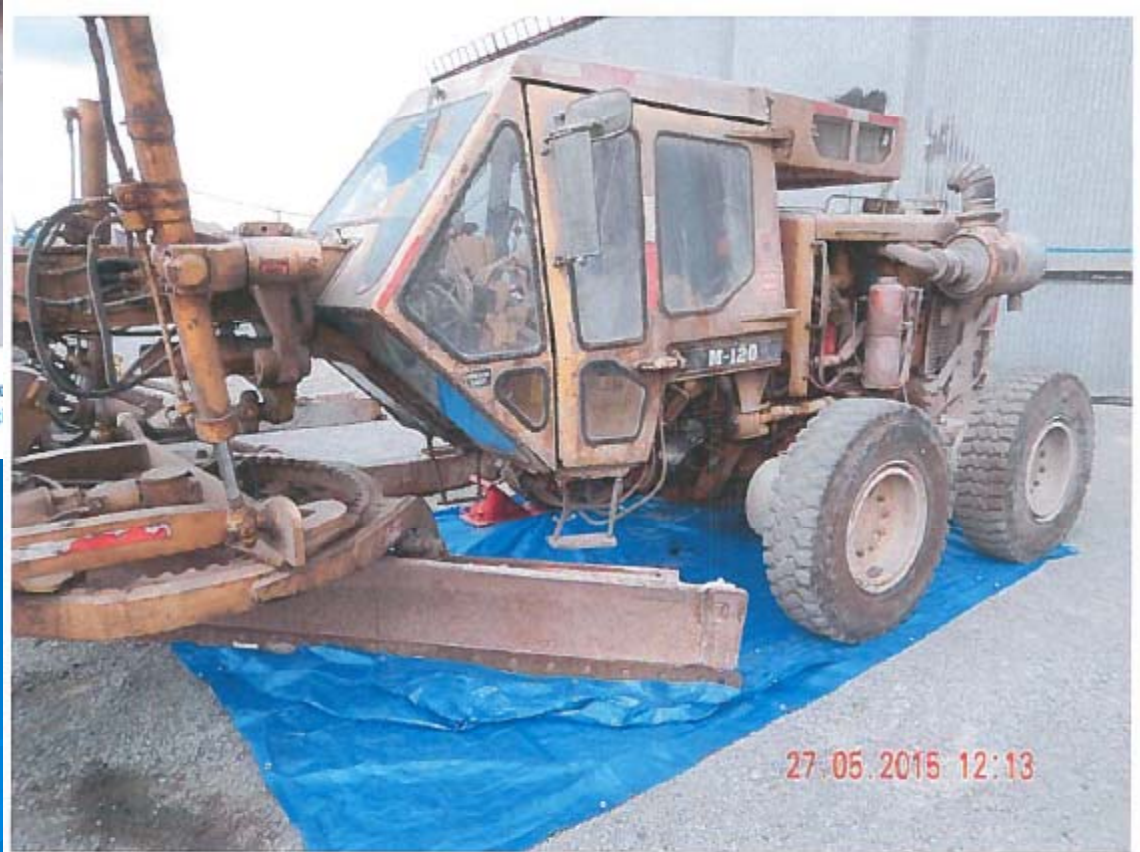
Photo 6 – Mechanical Shop 2 Building 51 – Equipment being parked outside the shop are placed on tarps as temporary containment to catch leaks.

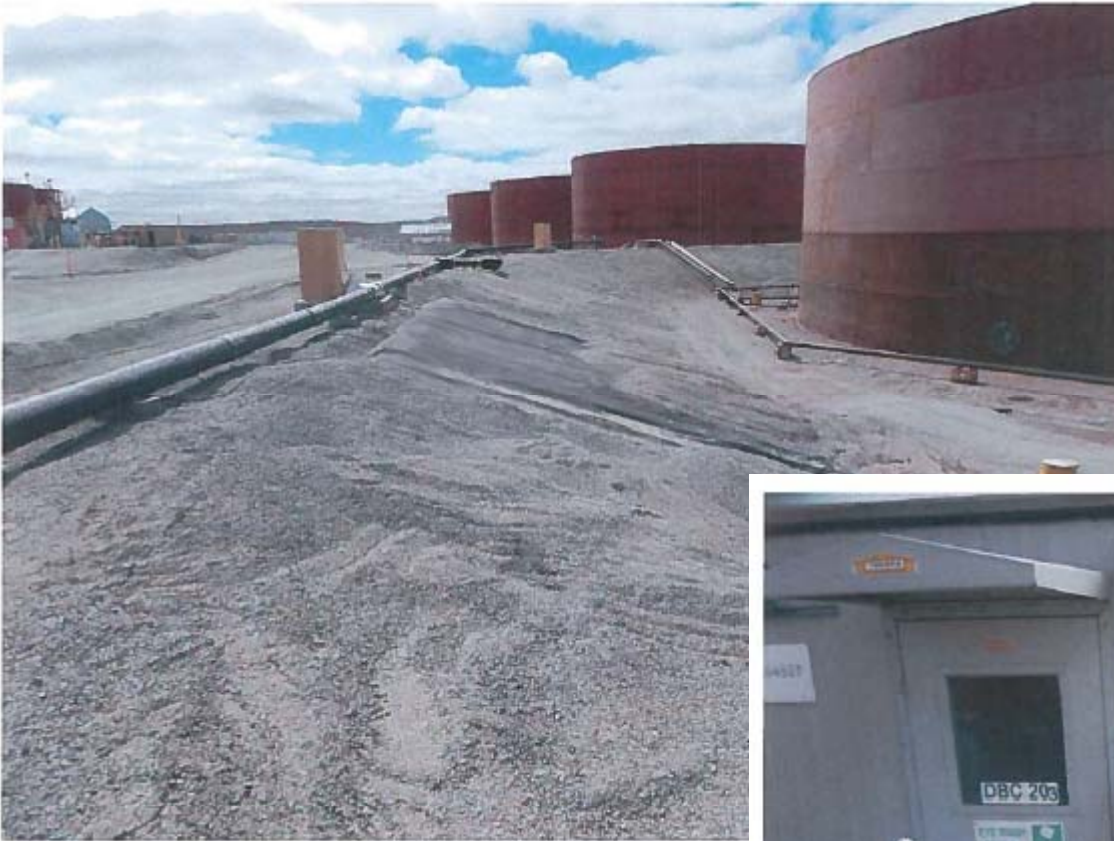
Photo 8 – 10 Million Liter Tank Farm – The containment area was dry and no concrete tank farm will need to be covered as per the liner design.

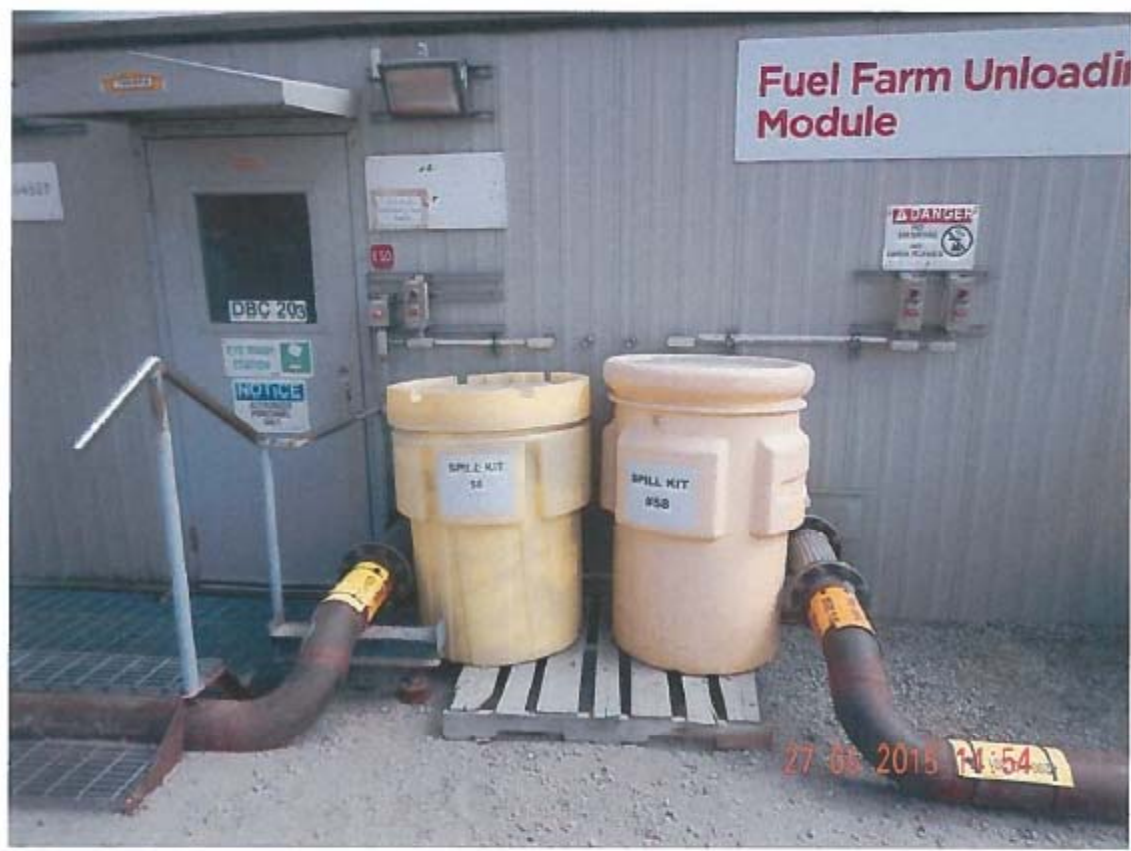
Photo 10 – Fuel Farm Unloading Module Building 31 – Spill kits in place are fully stocked and easily accessible.

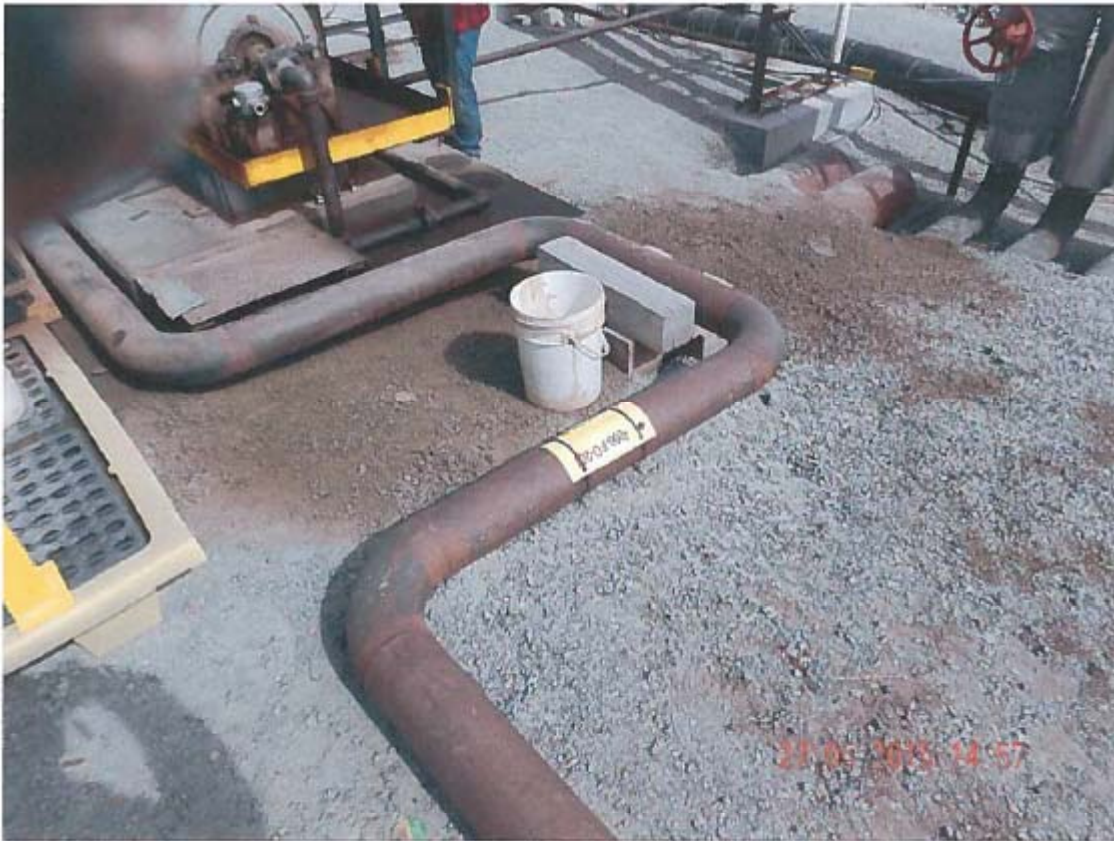
Photo 12 – Fuel Farm Unloading Module Building 31 – Area around the hose reel is heavily stained with hydrocarbons. Clean-up of the area is required.

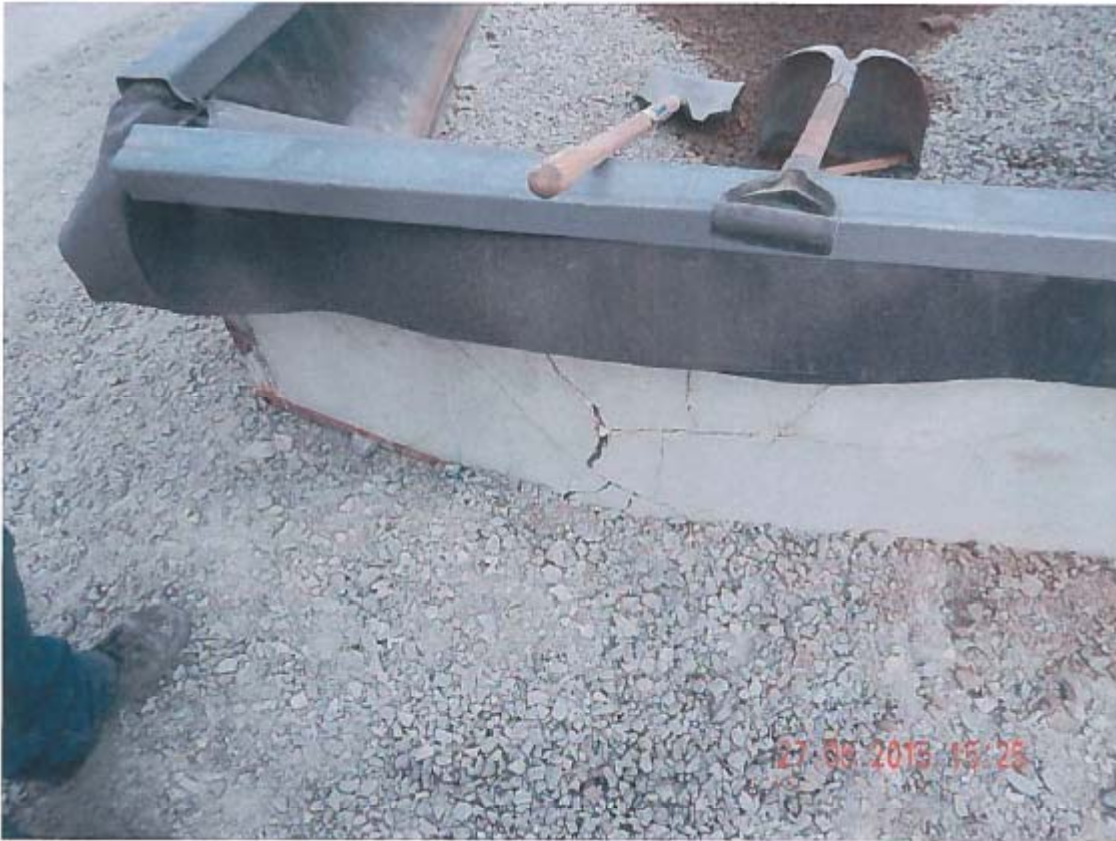
Photo 16 – 500,000L Tank Farm – Containment berm around the fill up module is significantly damaged.

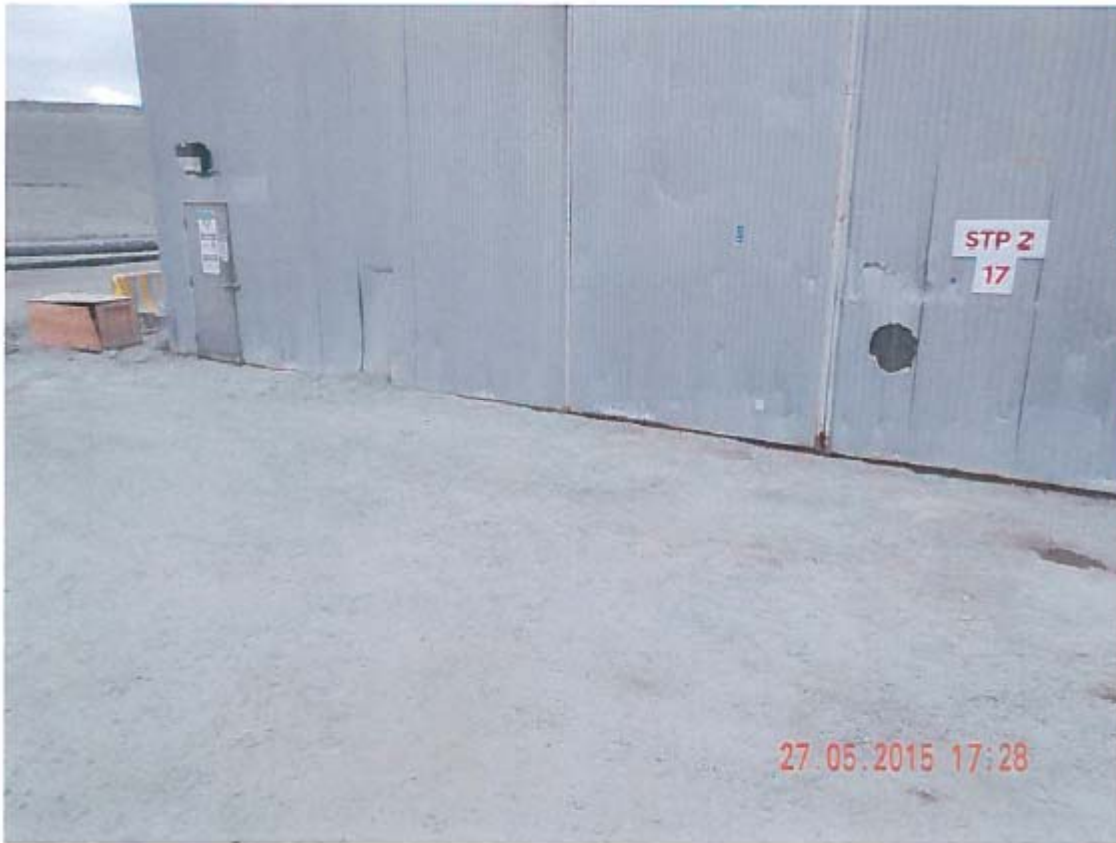
Photo 27 – STP 2 – NT Spill #15-176 - A 30 L sewage spill outside of the Sewage Treatment Plant resulted from a power outage. The spill site has been cleaned up.

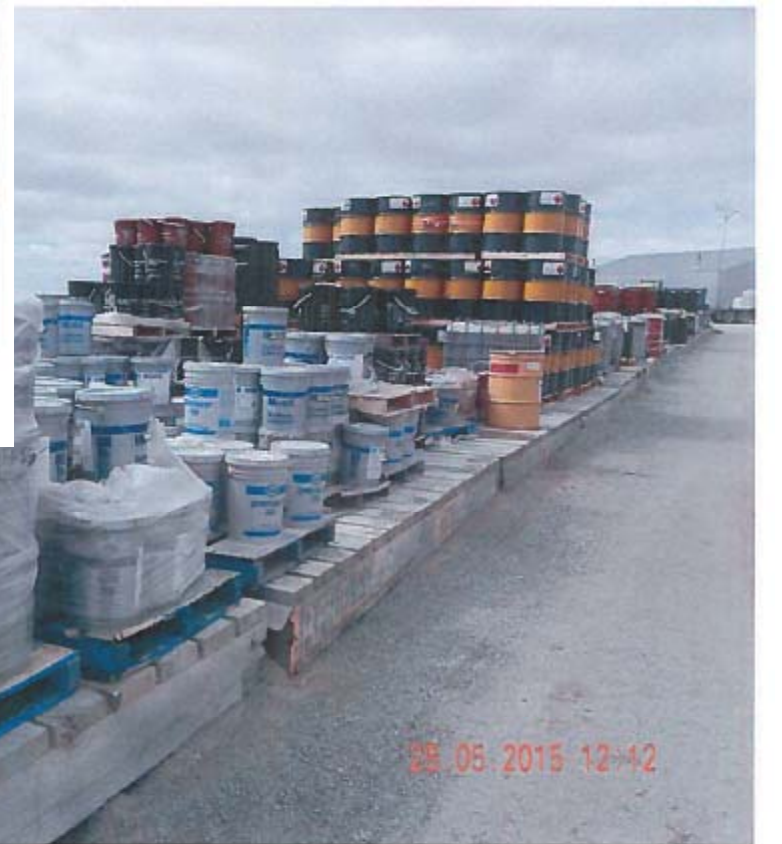
Photo 29 – Laydown 1 – The laydown was very clean and well organized.

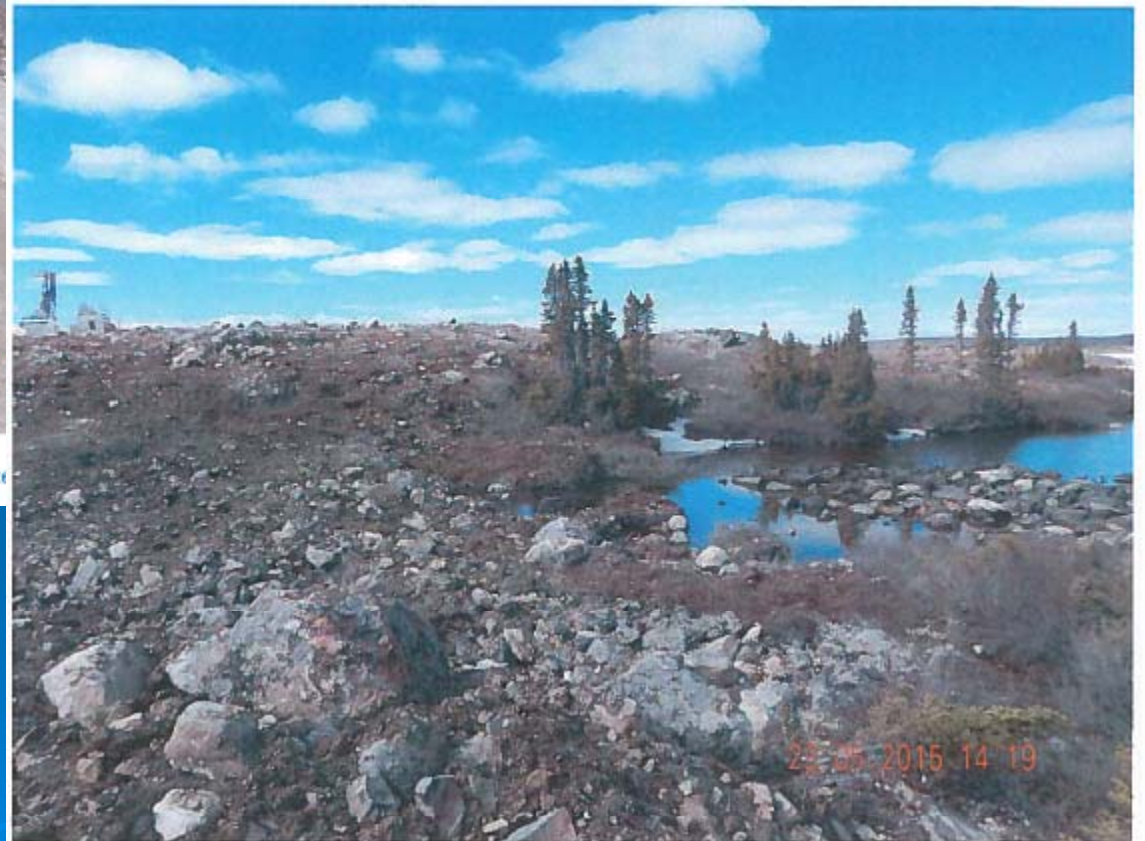
Photo 34 – North Pile West Cell – Organic soil removed from the West Cell Tote Road and grout curtain construction area had been placed within close proximity (<30m) of Snap Lake. The soil has since been removed and placed at the former AN storage pad to be used for reclamation research. Inspection showed that the soil did not get placed into the lake and there is no damage to the tundra underneath.

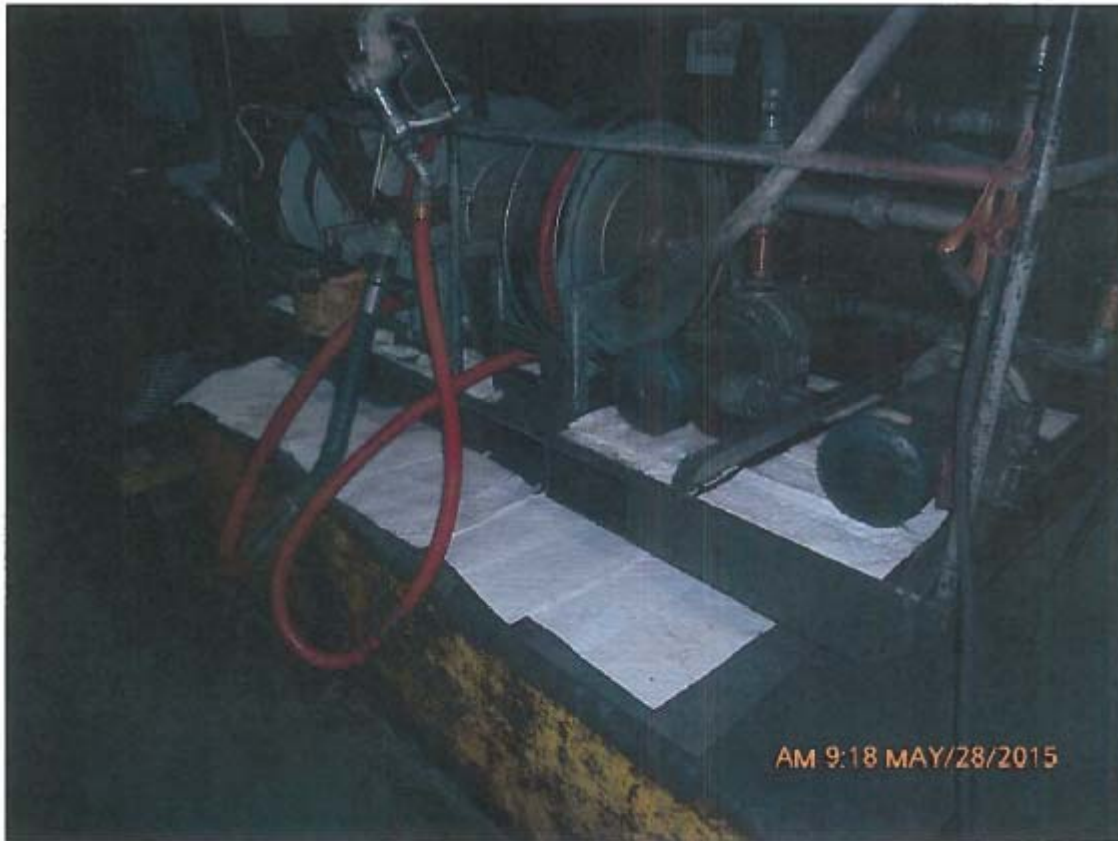
Photo 35 – Underground Refueling Bay – The Refueling Bay was clean and well organized. Fresh pads placed under the hose reels to collect any drips or leaks.

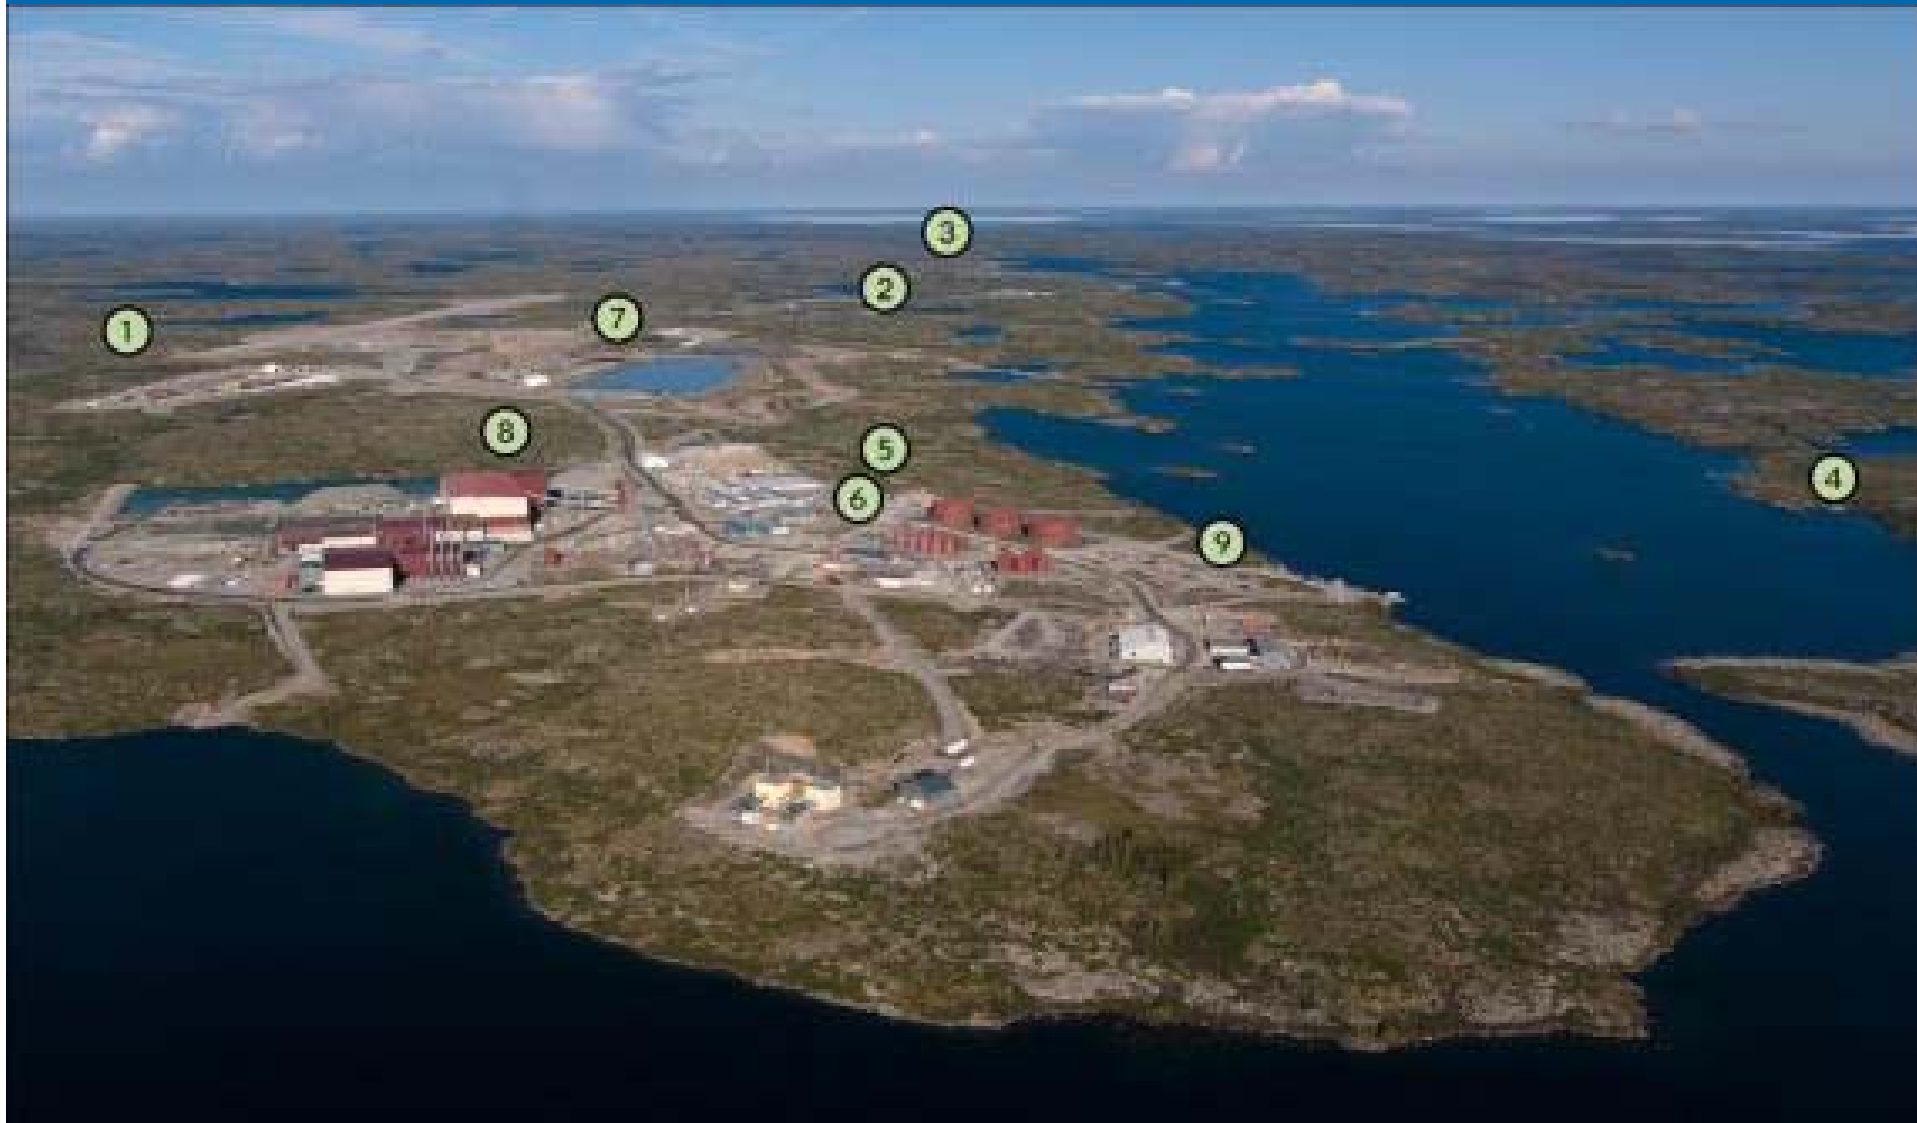
# Air Quality and Meteorological Monitoring Stations

1. TSP Partisol 1, Dichotomous PM10/PM2.5 Partisol 1 (pre-July 2014), 5030 SHARP PM2.5 Monitor PM001 (November 2014 onwards), Airstrip Passive Monitoring Site
2. TSP Partisol 2, Dichotomous PM10/PM2.5 Partisol 2 (pre-July 2014), 5030 SHARP PM2.5 Monitor PM002 (November 2014 onwards), Ammonium Nitrate Fuel Oil Area (Explosives Emulsion Plant) Passive Monitoring Site
3. West Shore Snap Lake Passive Monitoring Site
4. North Shore Snap Lake Passive Monitoring Site
5. TSP Partisol 3, Wetlands Passive Monitoring Site
6. Tank Passive Monitoring Site
7. Landfarm Passive Monitoring Site
8. Hill Meteorological Monitoring Station
9. Lake Hydro-Meteorological Monitoring Station
