Snap Lake Environmental Monitoring Agency

2015-2016
ANNUAL REPORT

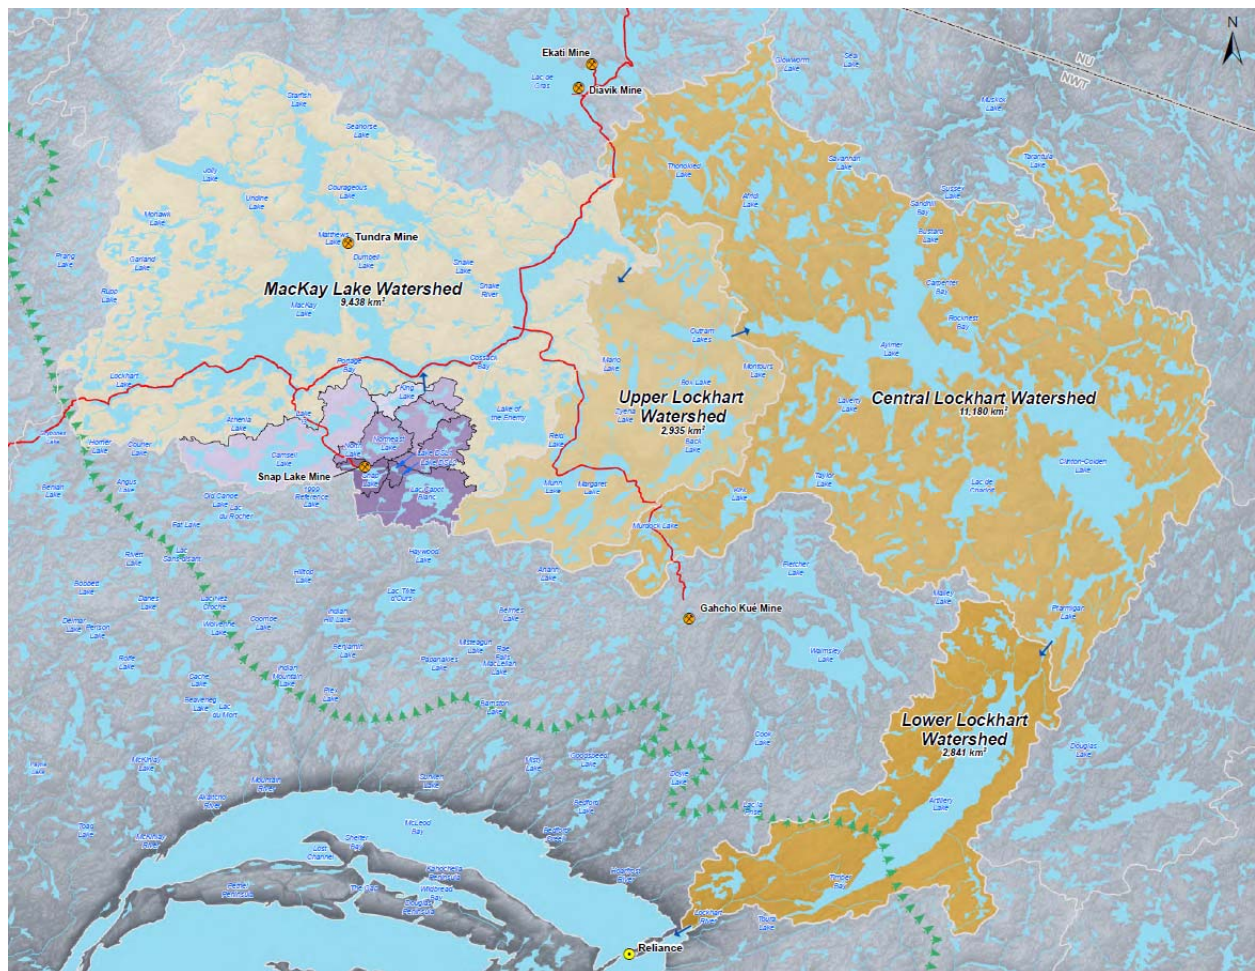
Map 2. MacKay Lake and Lockhart River Watershed

There will be two-year field study with up to five seasons (Freshet, Spring, Summer, Fall, Under-ice), and water quality and hydrological data will be monitored both on and off the potential flow path of the Snap Lake Mine treated effluent.

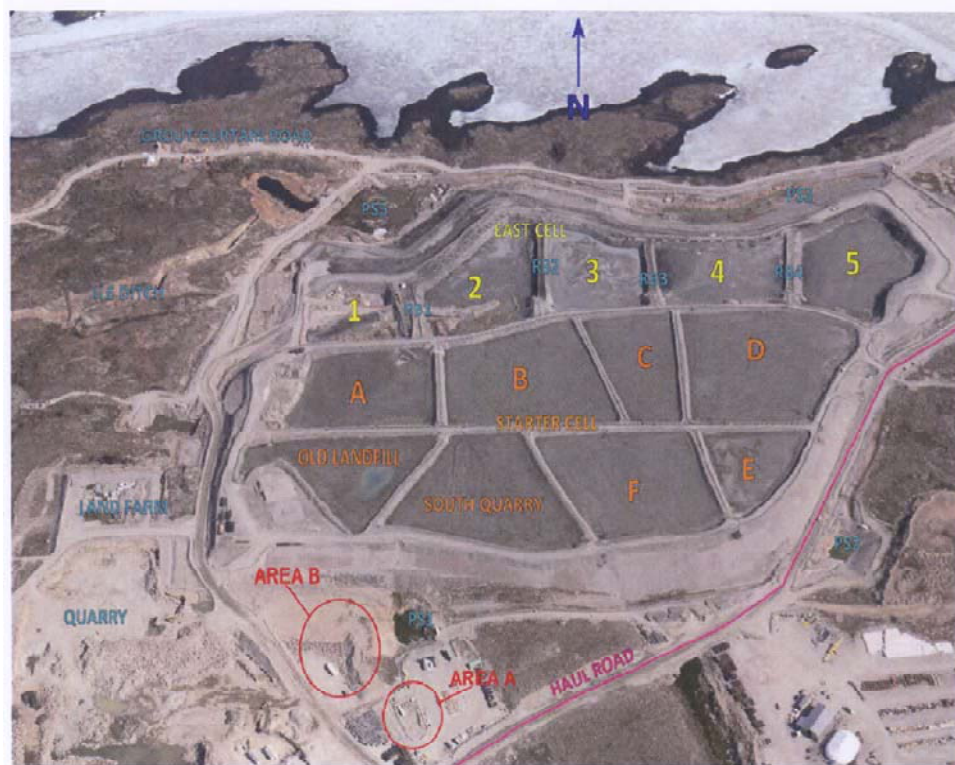
Photo 10. Site Layout – Existing Landfarm, Area A and Area B

Both HWCFs (Area A and Area B) are bermed and lined containment area. The Area A and B facilities have not been designed to contain seasonal water accumulation due to precipitation events. As such, snow removal and water accumulation from precipitation is considered a maintenance item to be managed by De Beers according to the existing Snap Lake Waste Management Plan.
