# April 2018 Environmental Update for SLEMA Board

Zhong Liu  
April 30, 2018

## 2.1 Water Licence Inspection on April 13, 2018

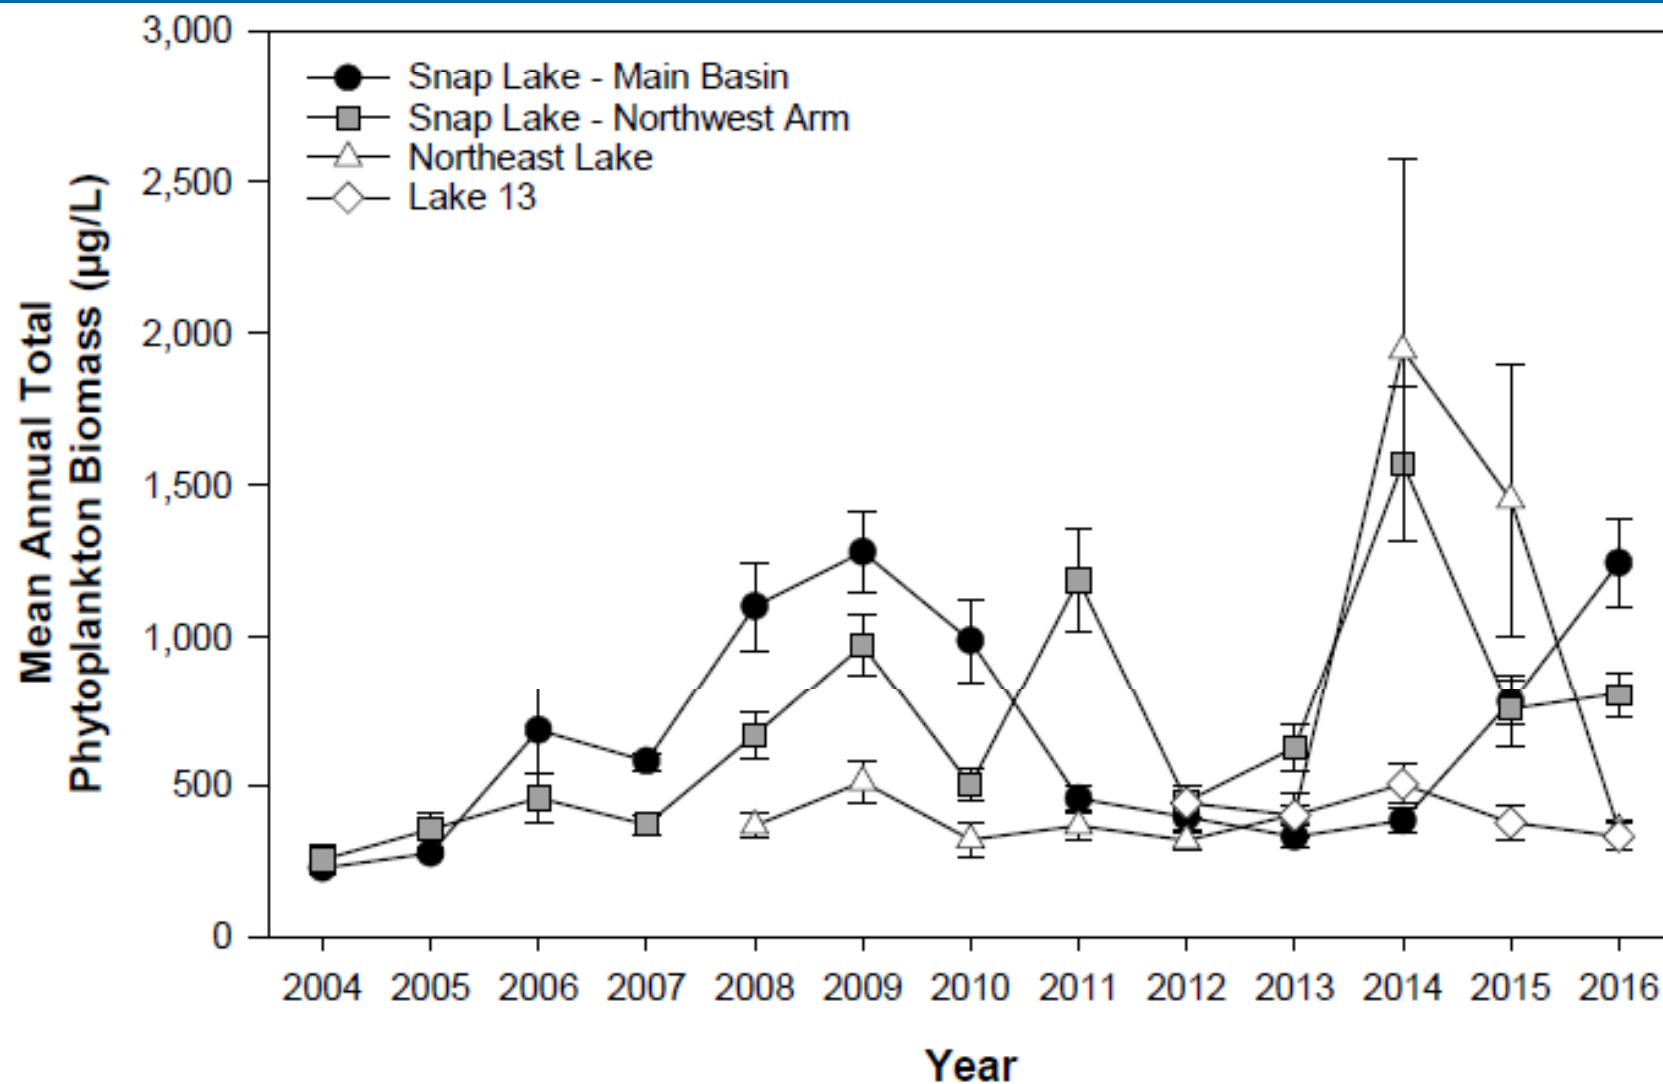
# Time Series Plots of Mean Annual Total Phytoplankton Biomass in Snap Lake, Northeast Lake, and Lake 13, from 2004 to 2016

- Notice of exceedance of the Action Levels related to nutrient enrichment for phytoplankton biomass
  - “As per the response framework an action plan will be developed to assess the exceedance, this will be submitted by May 31, 2018.”

- Data of phytoplankton biomass in 2017 are not available yet, and are expected in May while Aquatic Effects Monitoring Program 2017 Annual Report will be submitted

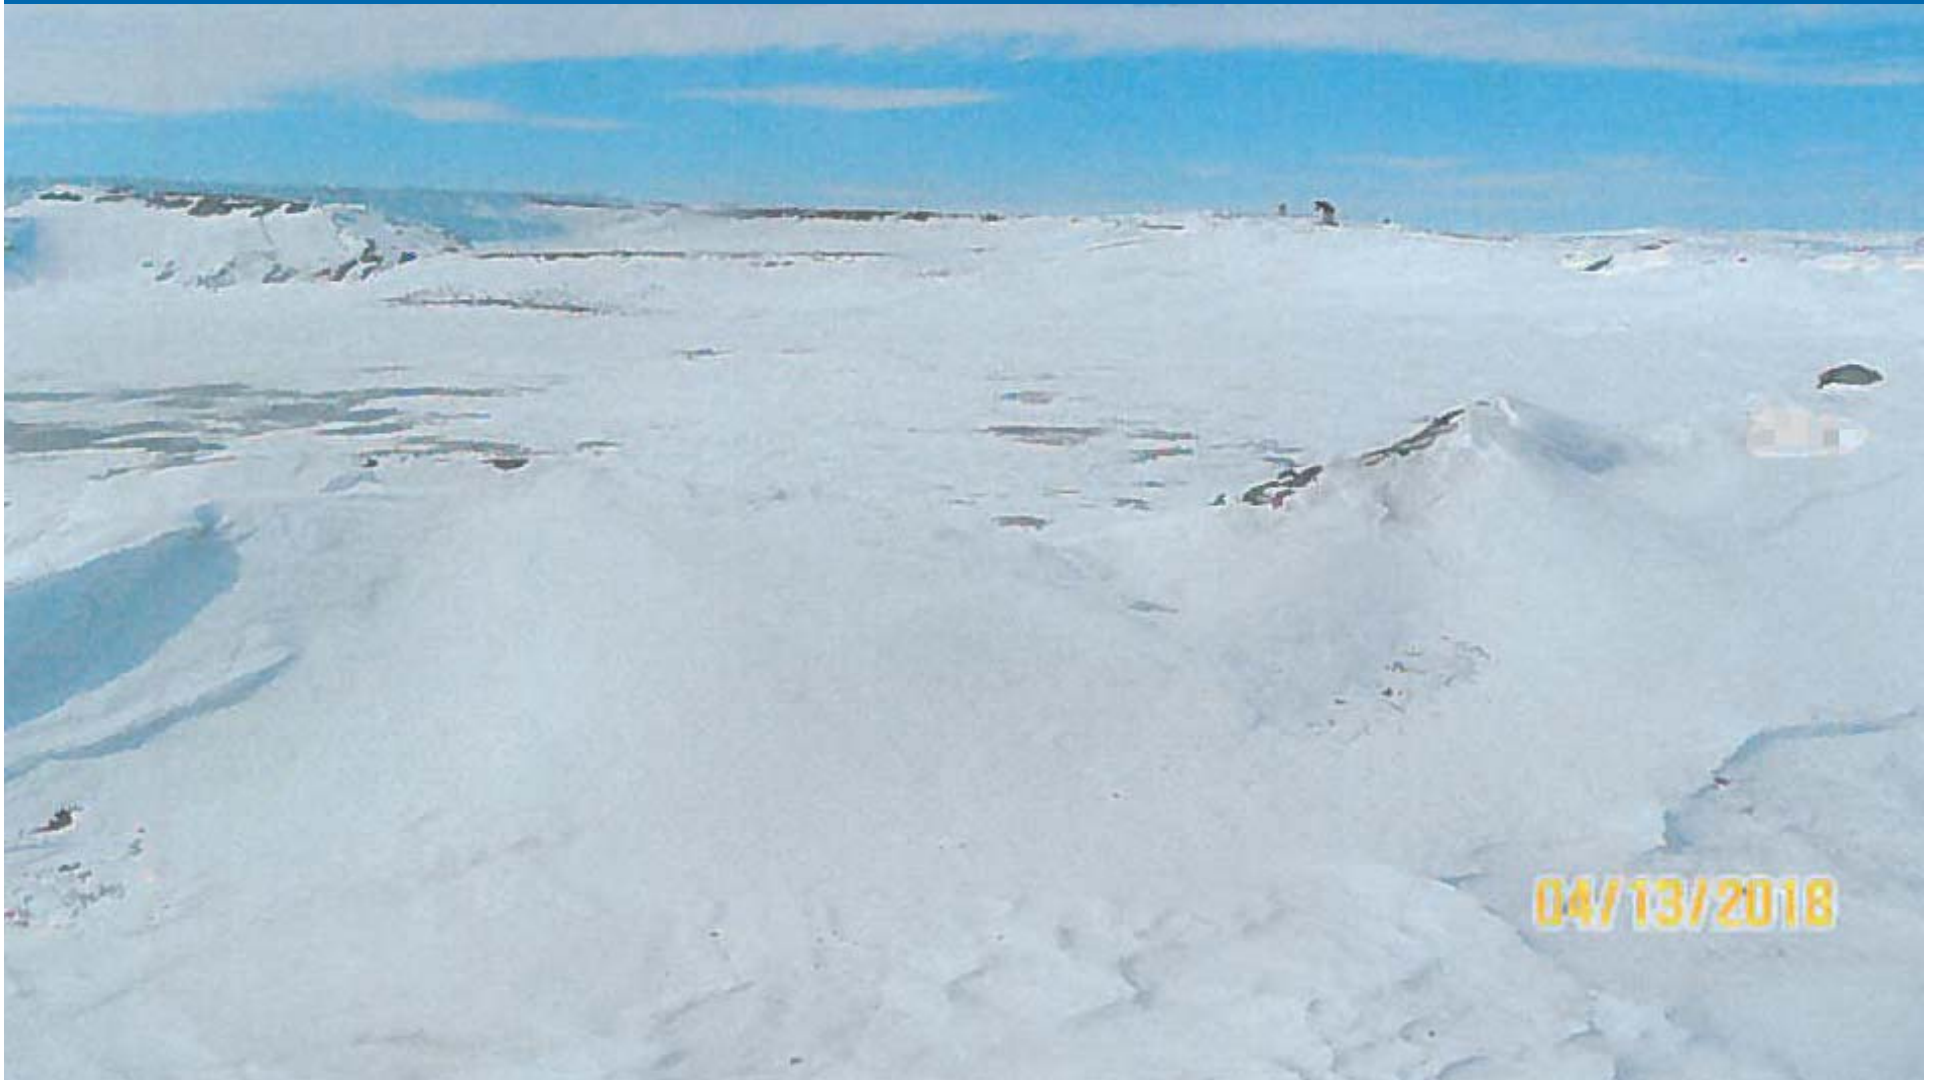
No cracking or slumping or bulging  
of the tailings surface was noted in  
the Cell 5 of the East Cell

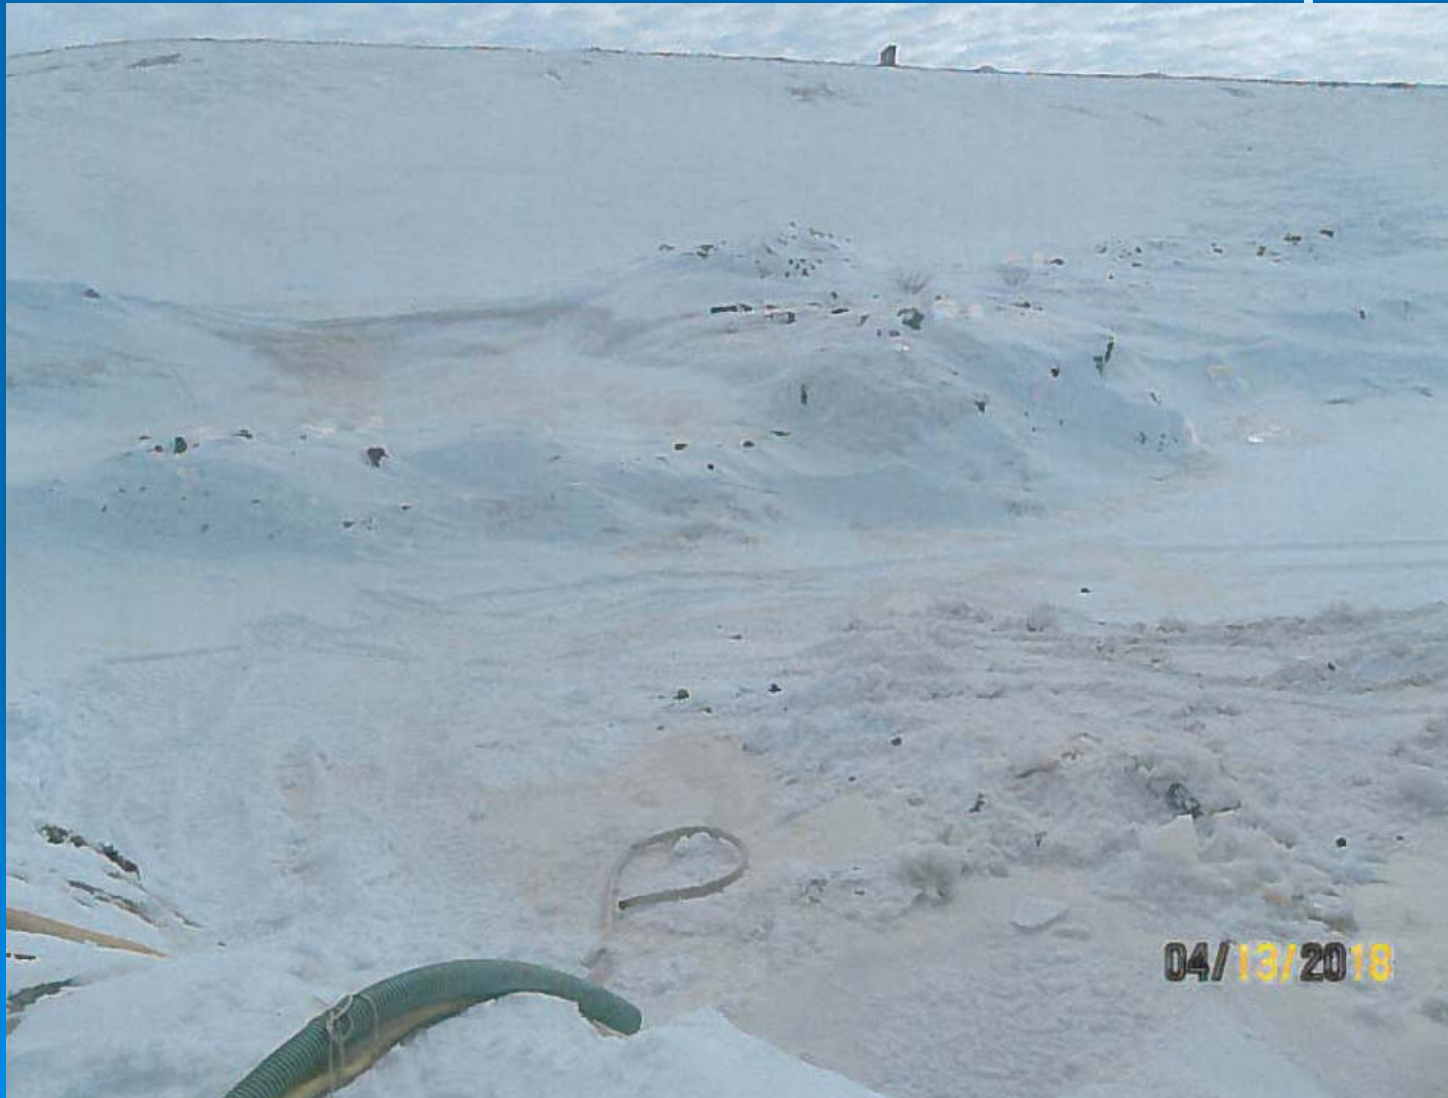
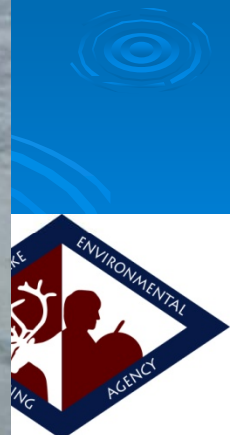
Efforts to remove ice to maximize storage capacity and facilitate pump intakes at the east end of Sump 5

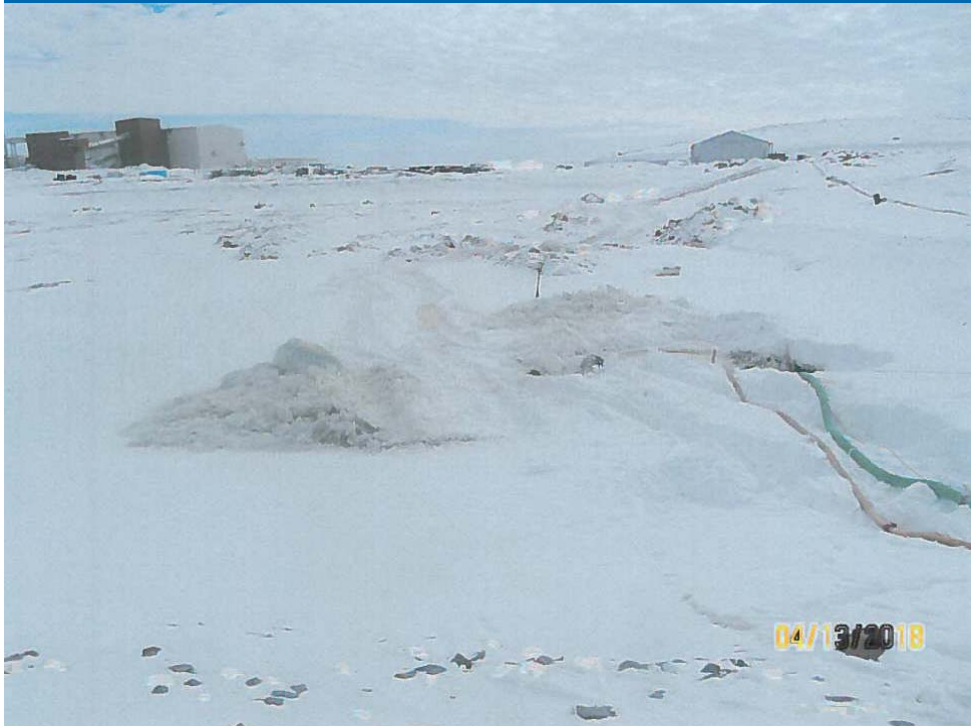
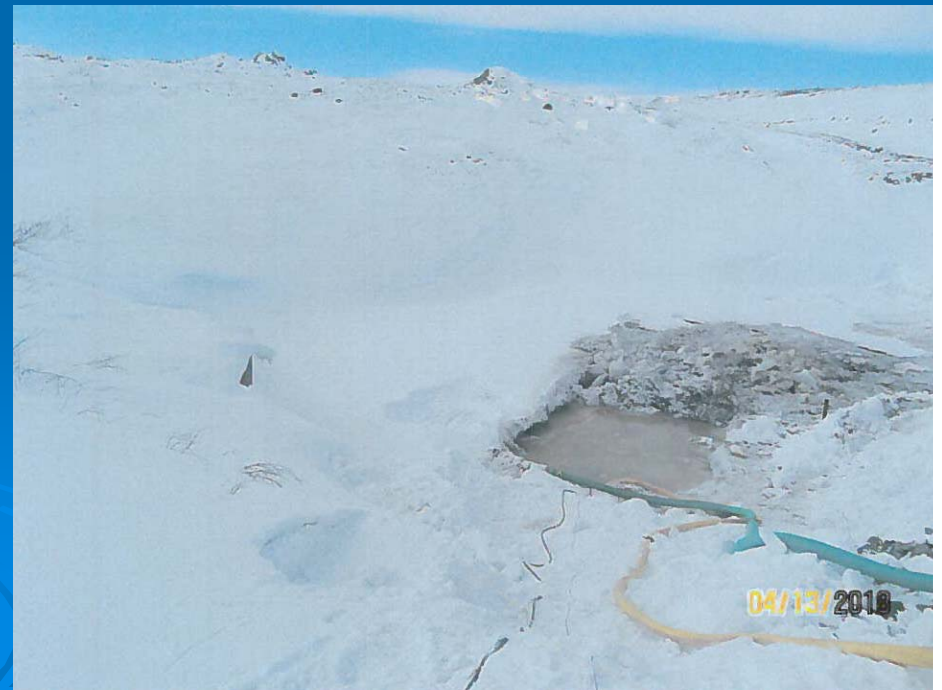
Dewatering-wells have been maintained of late to enable de-watering o Sump 3 (left) and Sump 2 (right) when the forthcoming freshet arrives

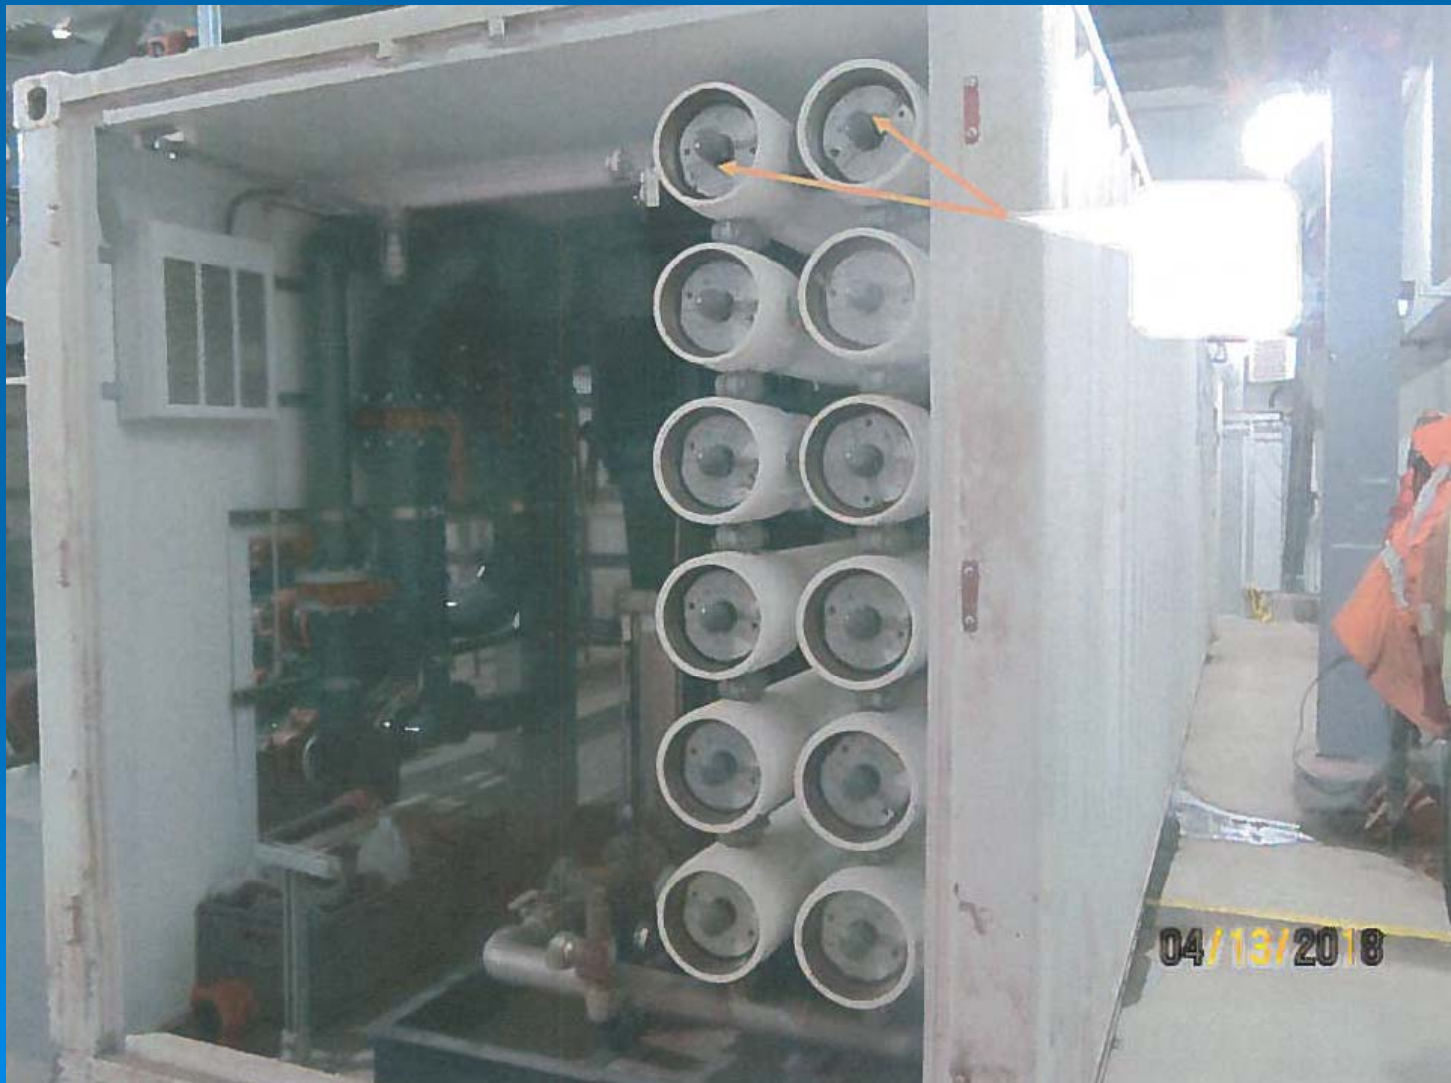
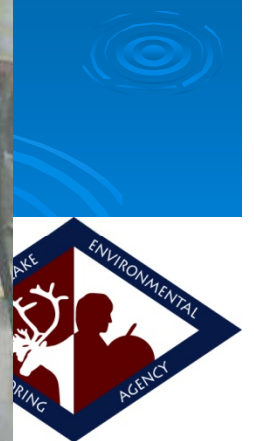
# Reverse Osmosis (RO) filters and treatment components

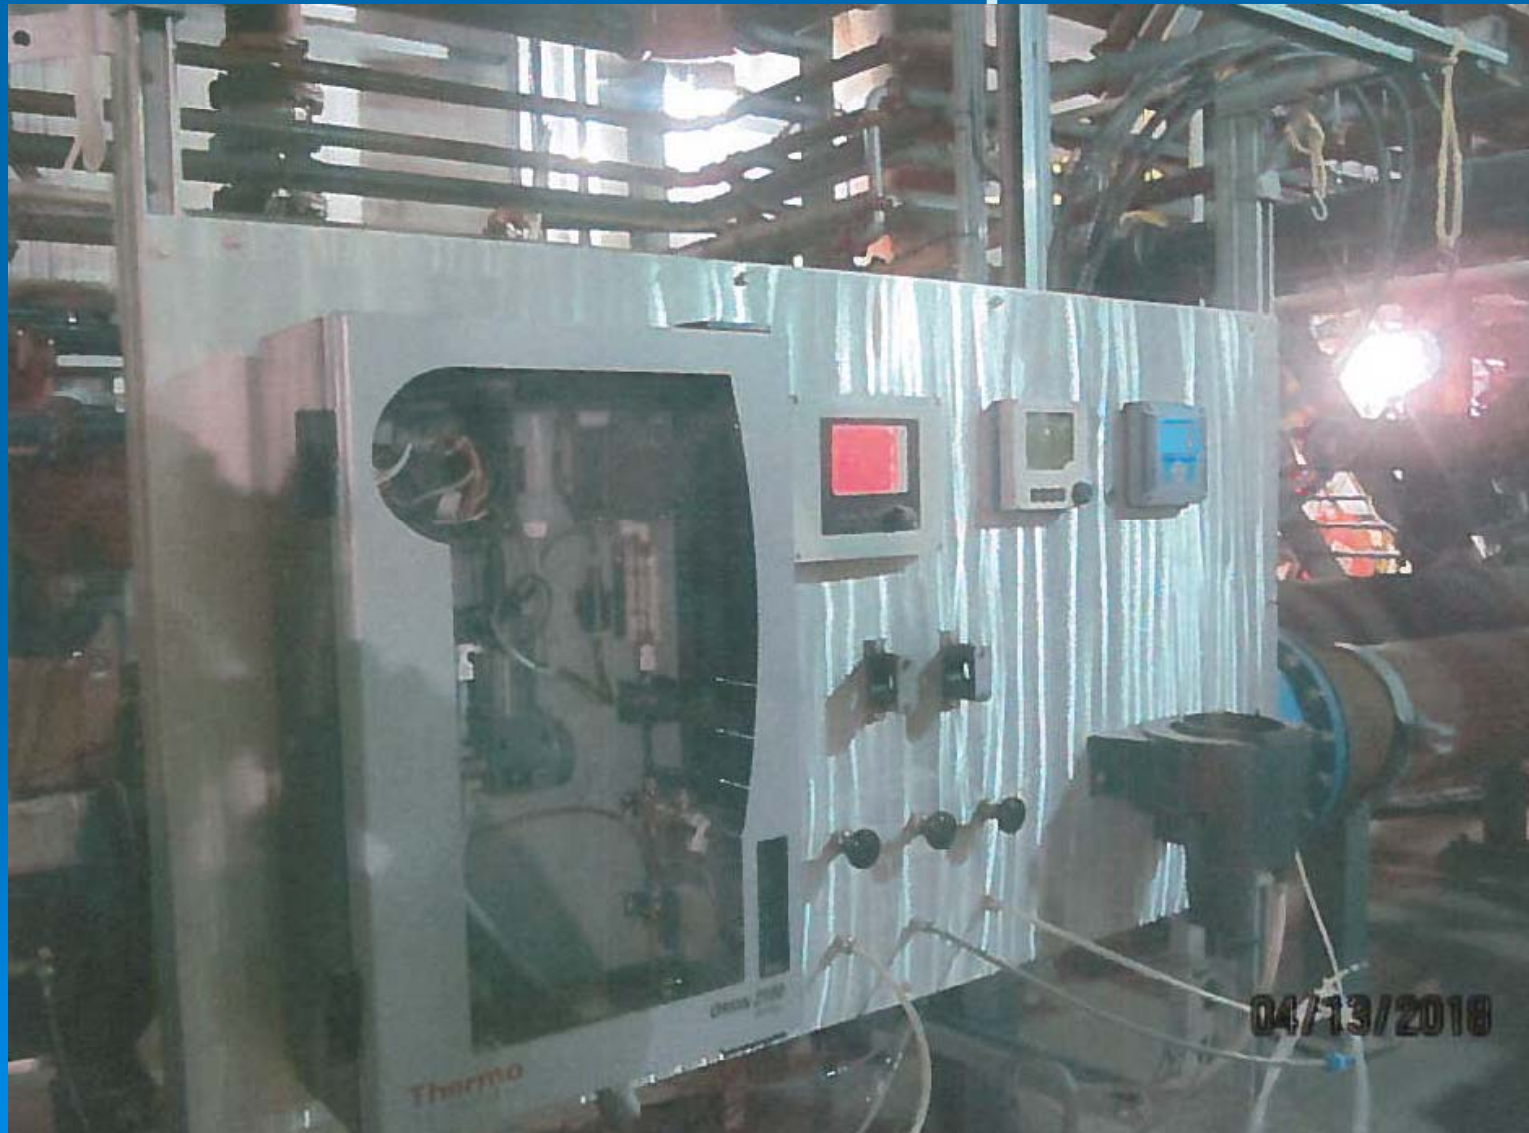
# Metering to be installed for the new RO unit in April 2018

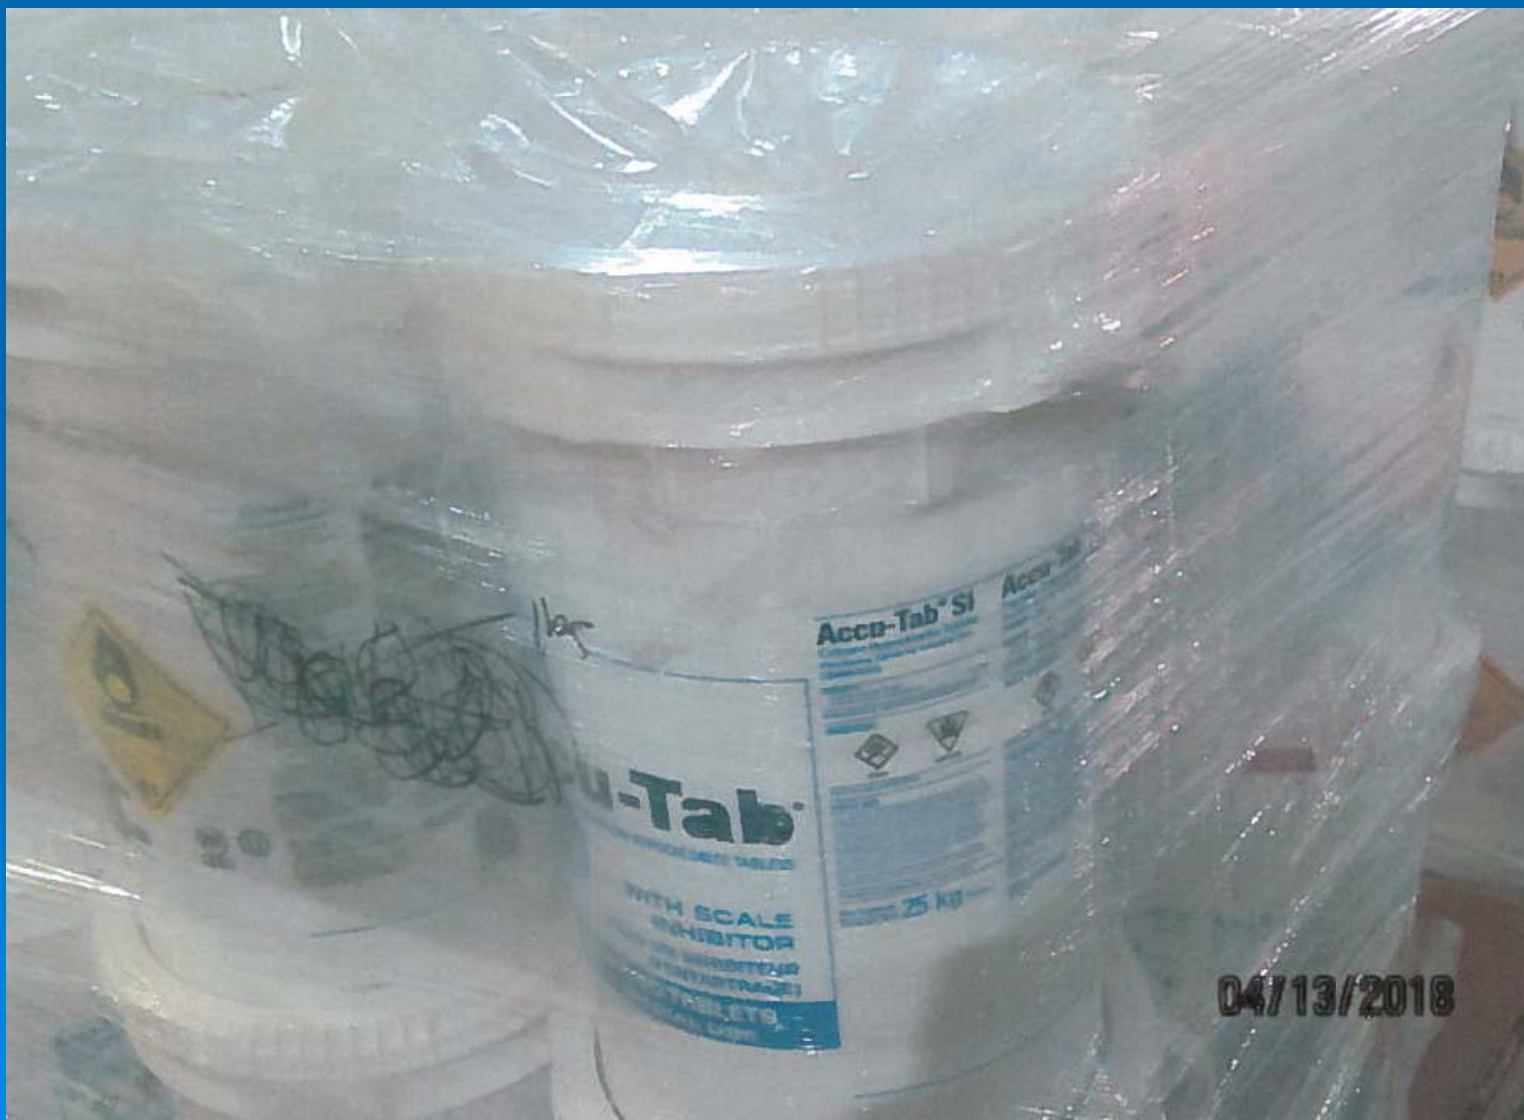
# Scale Inhibitor chemical scheduled to be used in the new RO unit

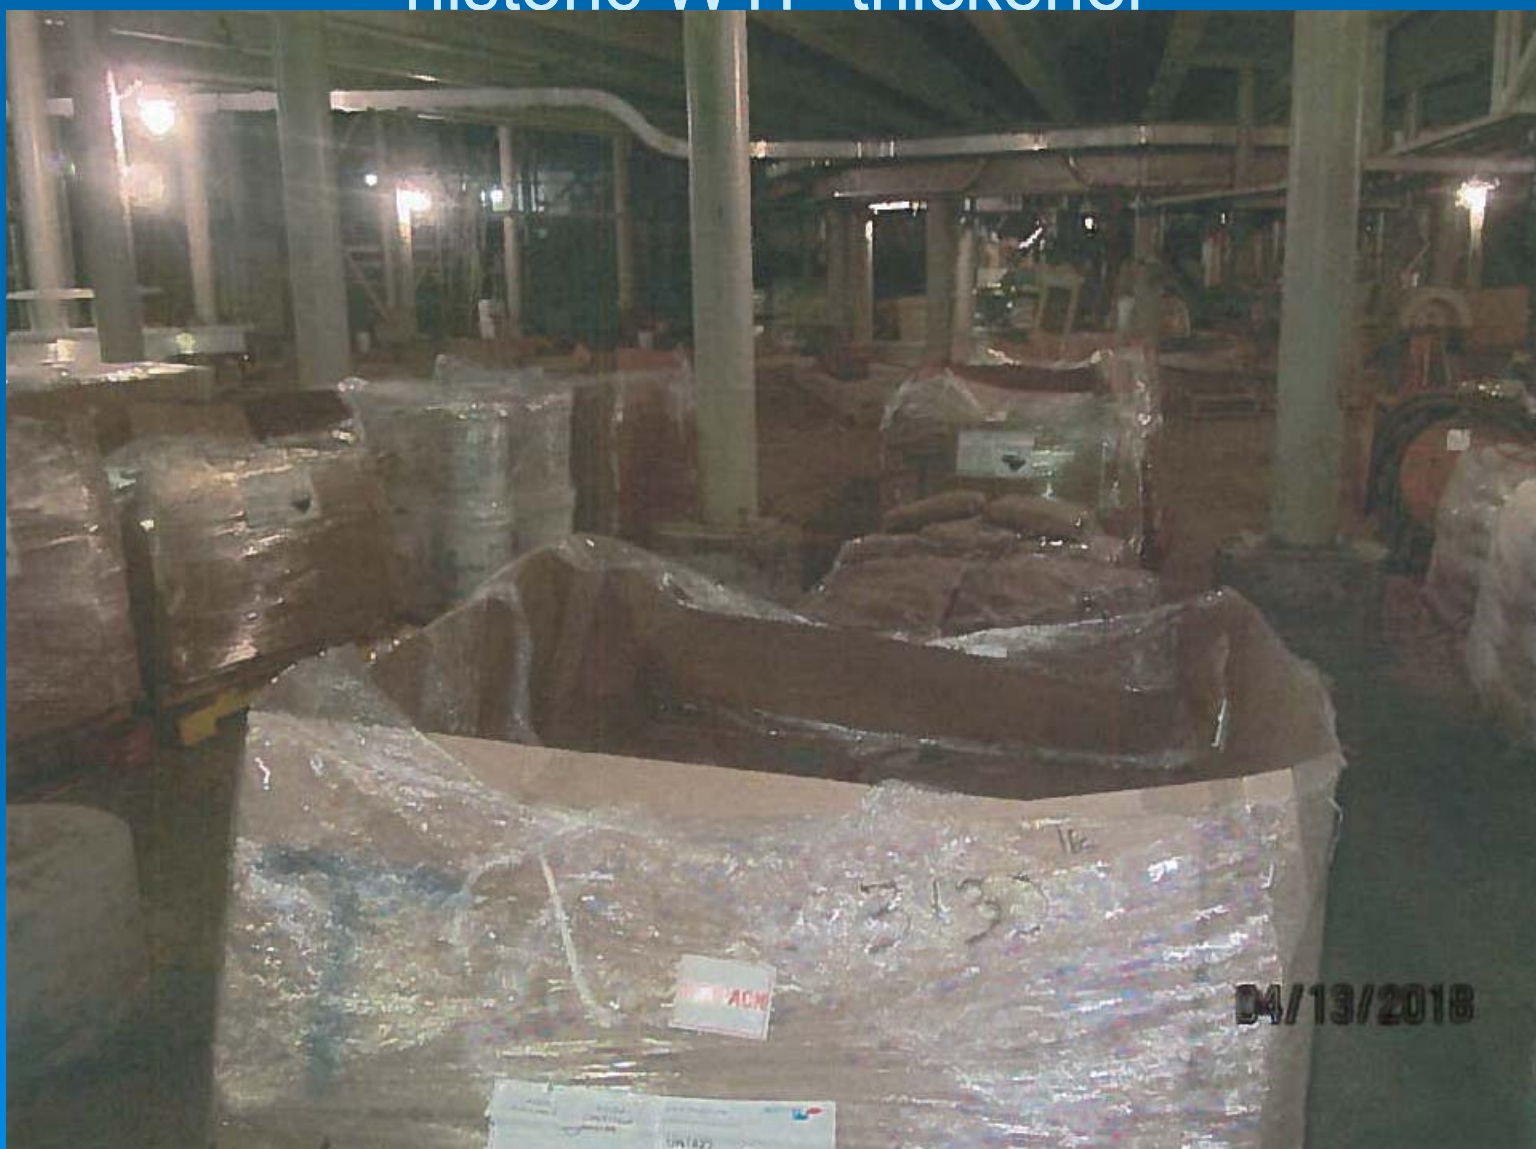
Bags of Caustic Soda (foreground) and Hydrochloric Acid (background) stored under the historic WTP thickener

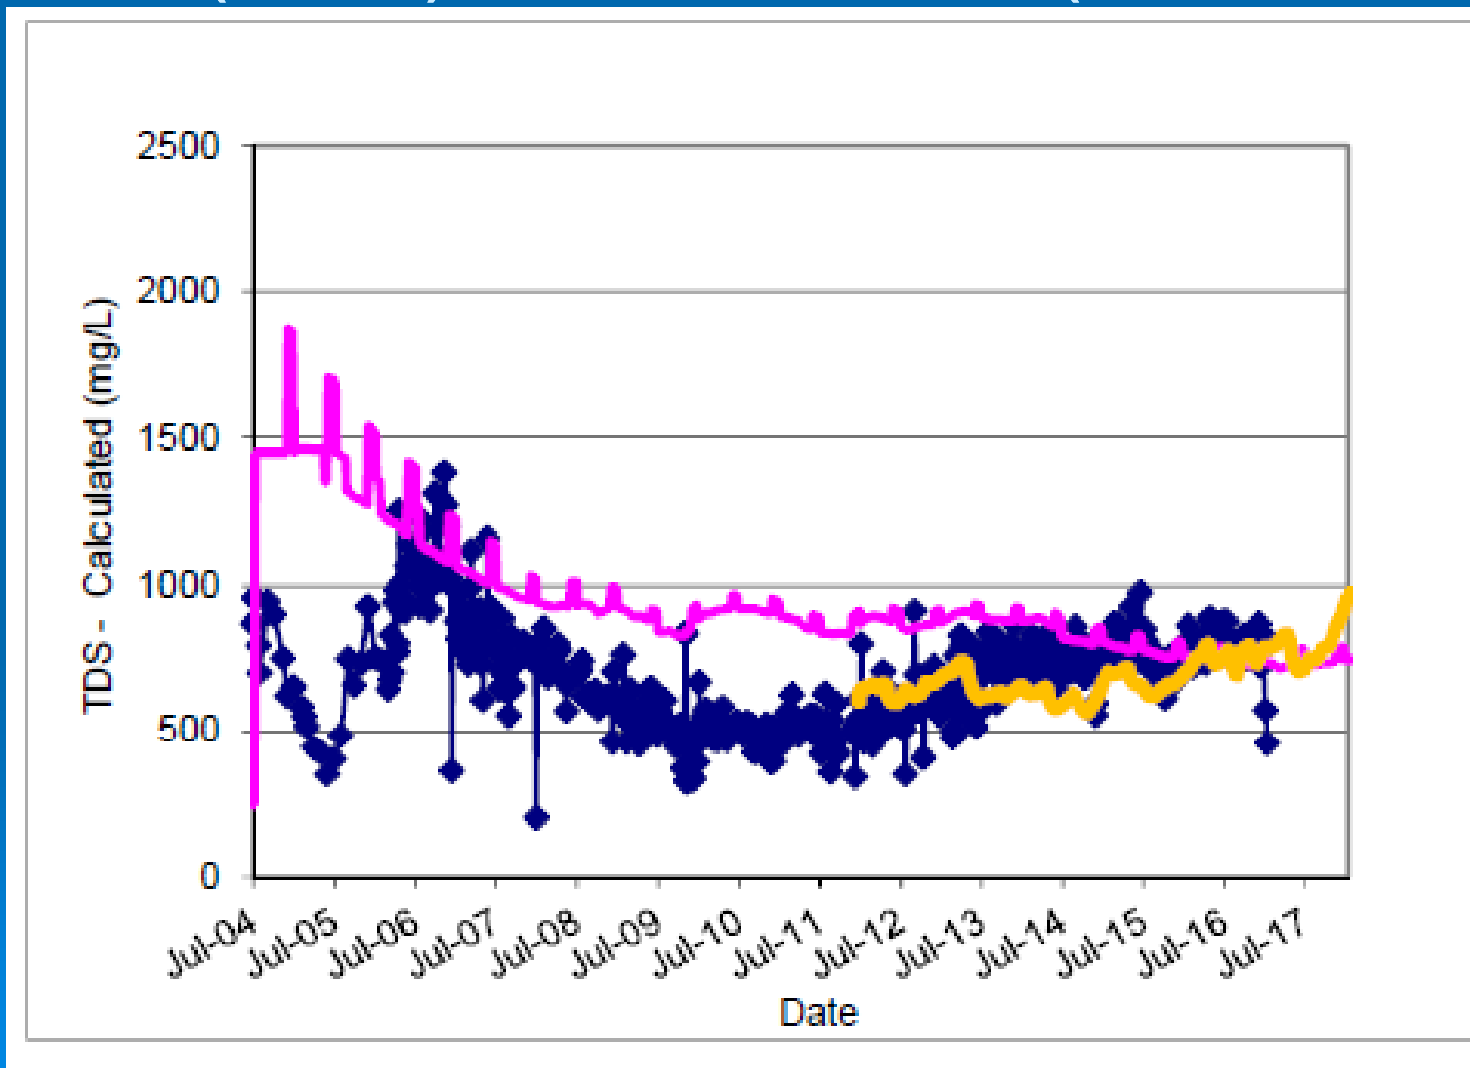
# Concentrations of Total Dissolved Solids (TDS) in Minewater (SNP 02-01)

Monitoring Values

2002 EA Predictions

2013 Base Case Site Model Predictions

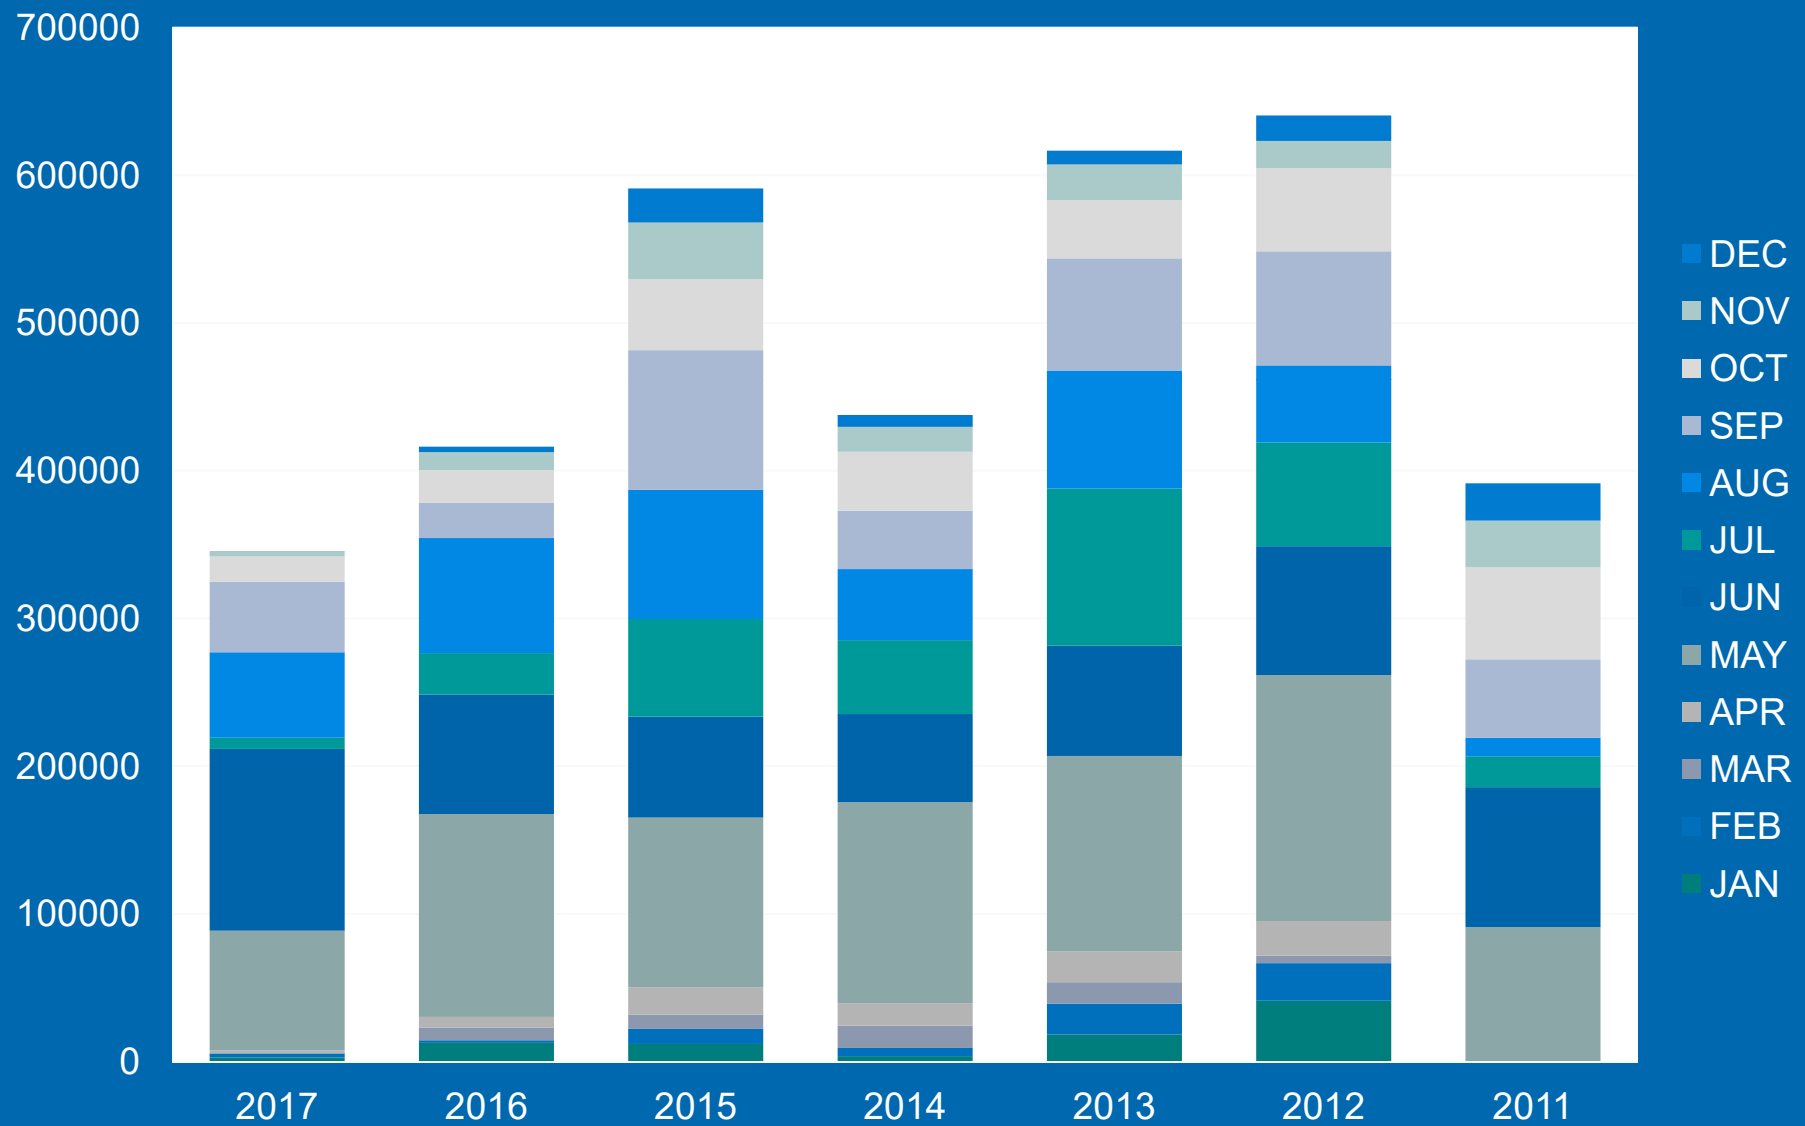
# Annual Runoff and Seepage from the North Pile, m<sup>3</sup>

- North Pole runoff and seepage amount changes from year to year, ranging from 300,000 m<sup>3</sup> to 700,000 m<sup>3</sup> per year
- Runoff and seepage amount peaks during freshet period (May) and then goes down
- For the past three years Permanent Sump 5 (PS5) receives more runoff and seepage from the North Pole than other sumps

- Seepage and runoff should be actively managed from May to October
- For better understanding of the seepage and runoff quality, It is recommended that De Beers regularly takes samples from each of the active sumps

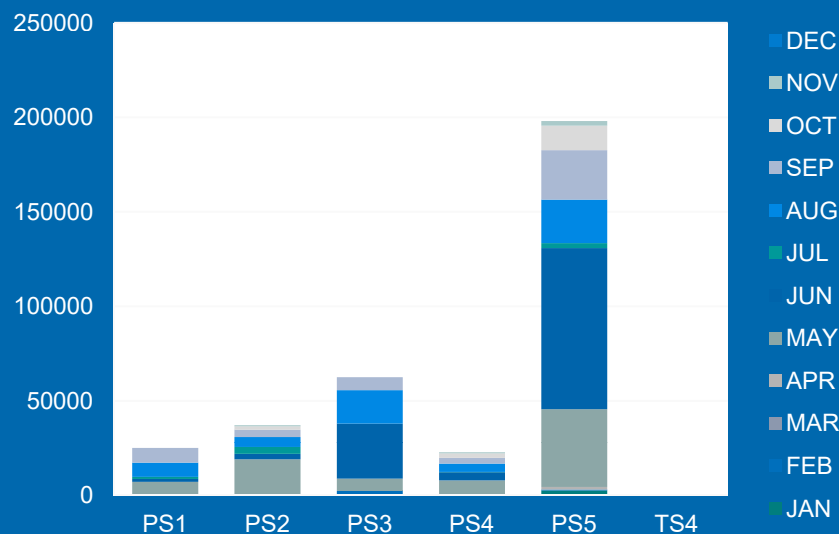
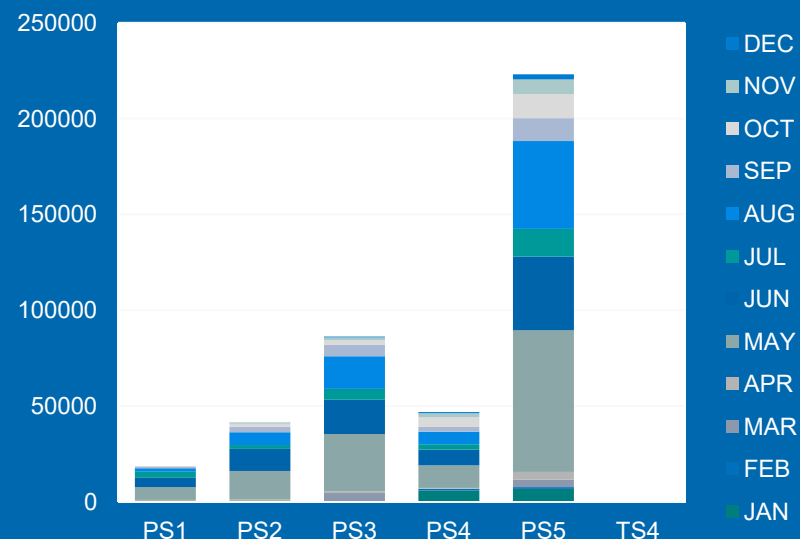
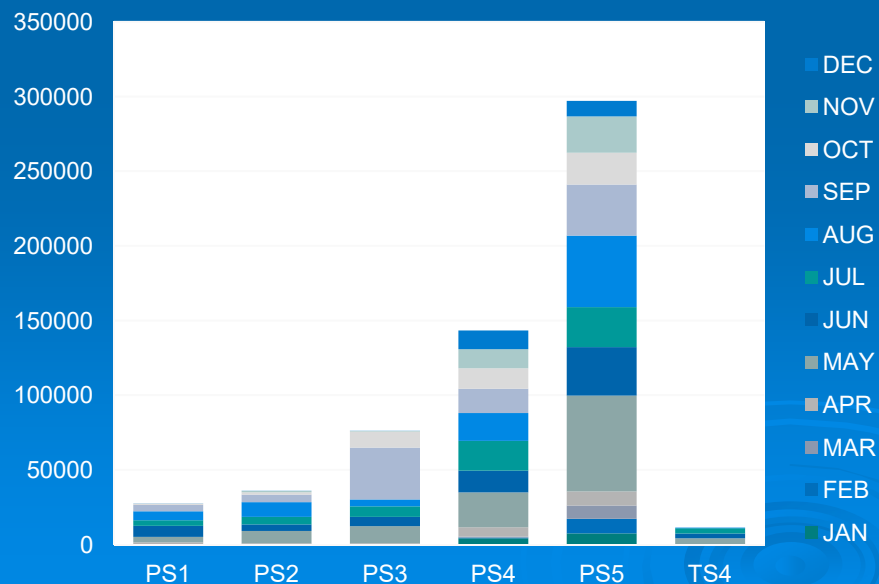
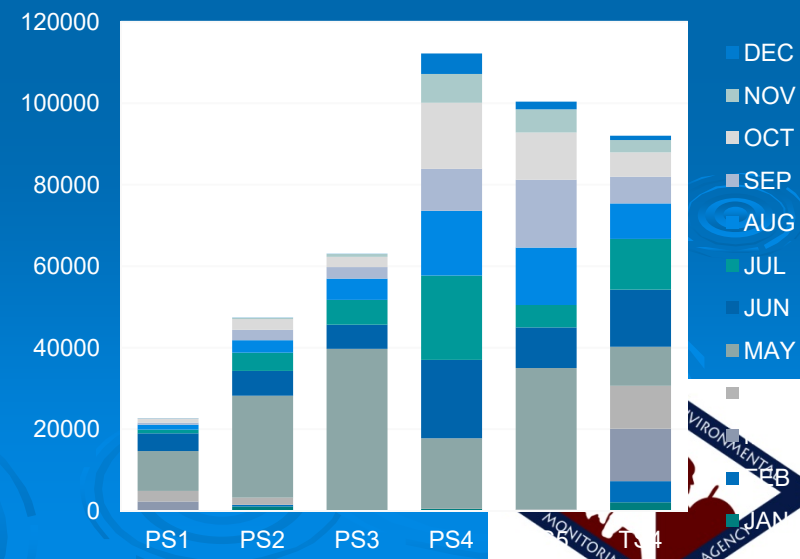
**Water Reporting to Sumps from North Pile  
(m<sup>3</sup>), 2017**

**Water Reporting to Sumps from North Pile  
(m<sup>3</sup>), 2016**

**Water Reporting to Sumps from North Pile  
(m<sup>3</sup>), 2015**

**Water Reporting to Sumps from North Pile  
(m<sup>3</sup>), 2014**
