November 2018 Environmental Update for SLEMA Board

November 30, 2018

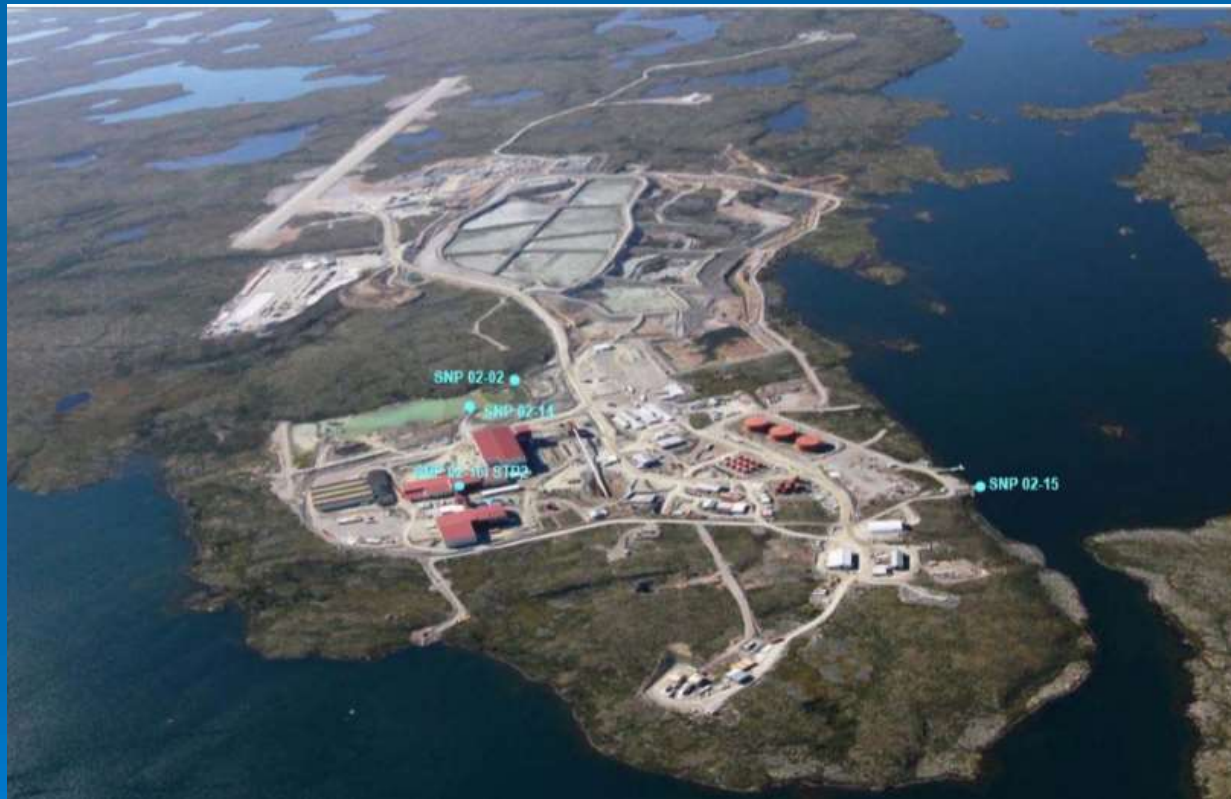
Fig 1. Location of sampled SNP Monitoring Stations

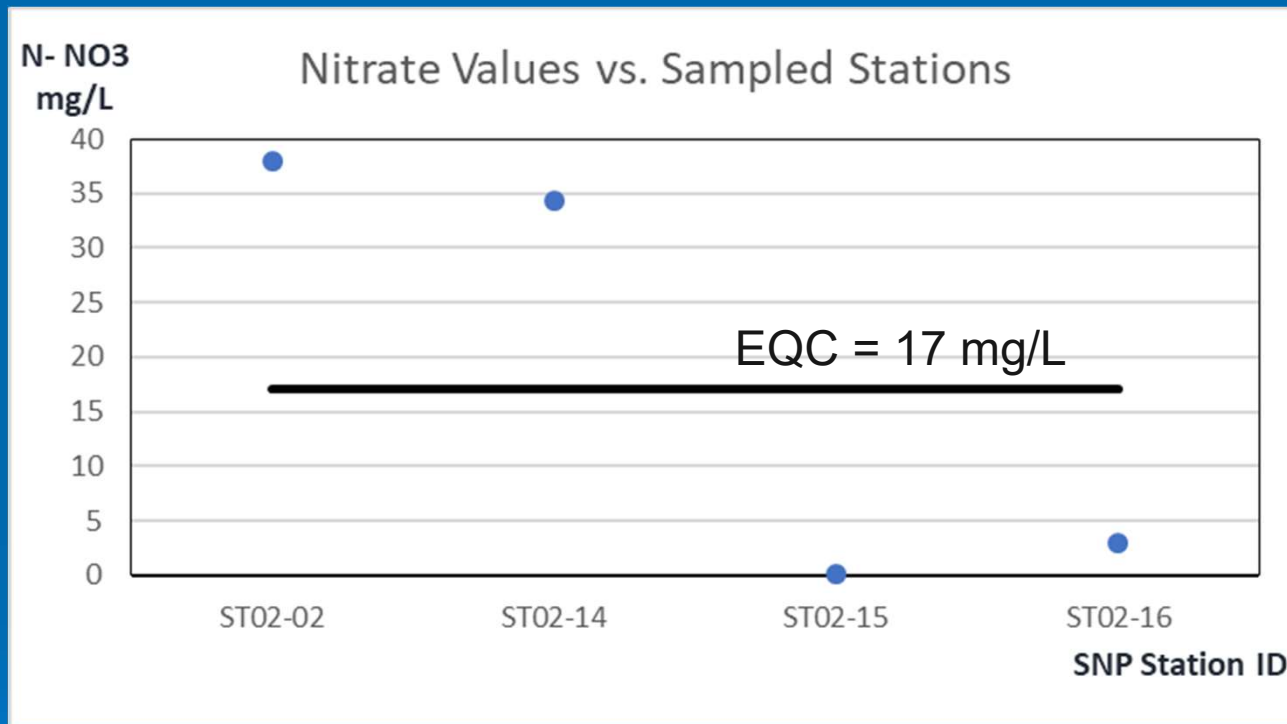
Fig. 2. Reported nitrate values for SNP stations

- Nitrate reported values are exceeding the prescribed Water Licence EQC (17 mg/L) for two monitoring stations:
- ST02-02 North Pile Drainage Collection Ditch, and
- ST02-14 Water Management Pond

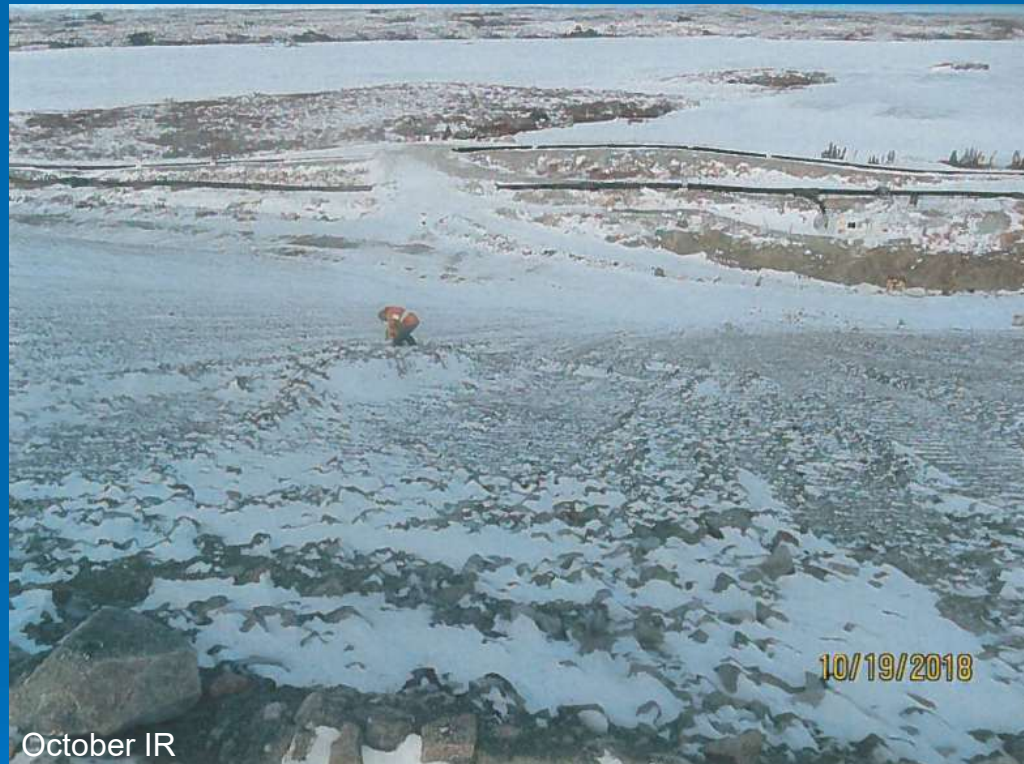
Fig 4. Piezometer Measurement, East Cell Embankment, Cell 4. The snow free embankment should help cold air to permeate and freeze the embankment

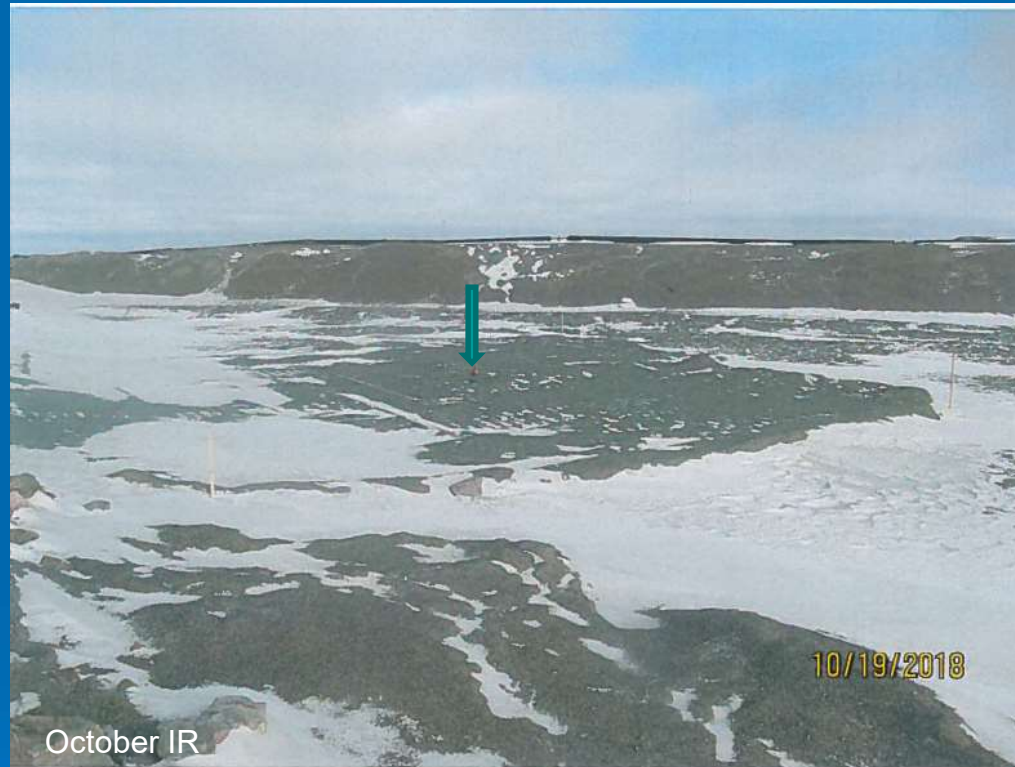
Fig.5 East Cell Cover Consolidation Test Pad, Cell 4. Note the prism, red marker in the middle of the test cell for exact measurement of settling of the cover over time

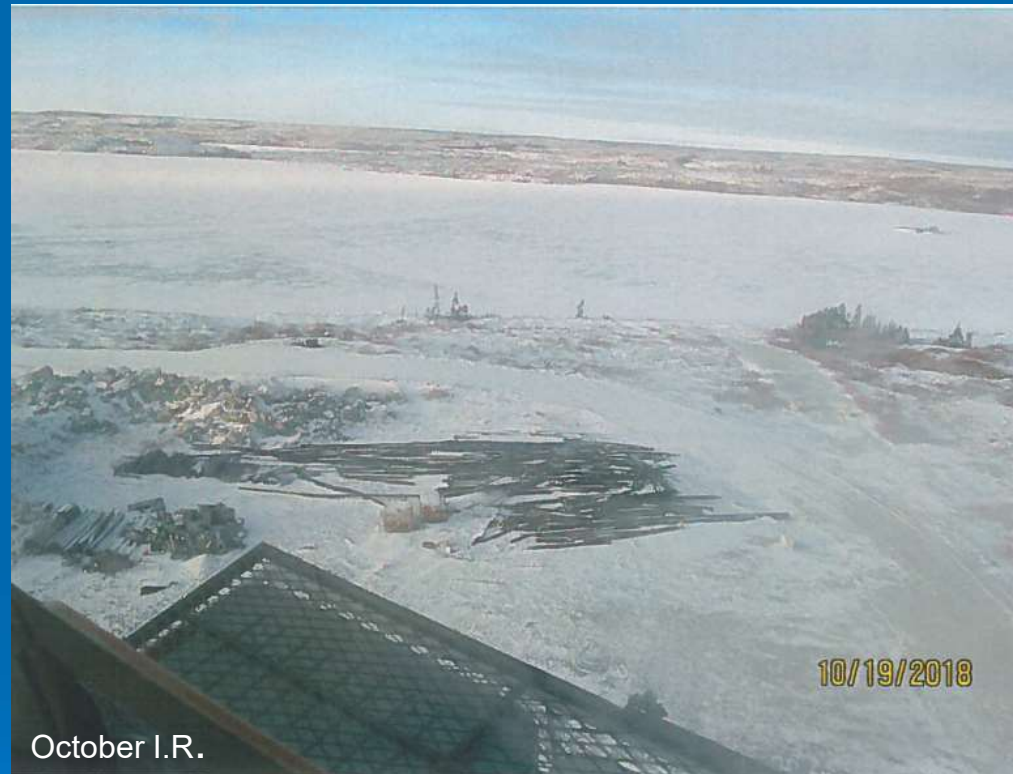
Fig. 6 Stockpile of Slurry (Liquid Tailings) Deposition Piping. It was removed from the East Cell and is ready to be backhauled on the winter road

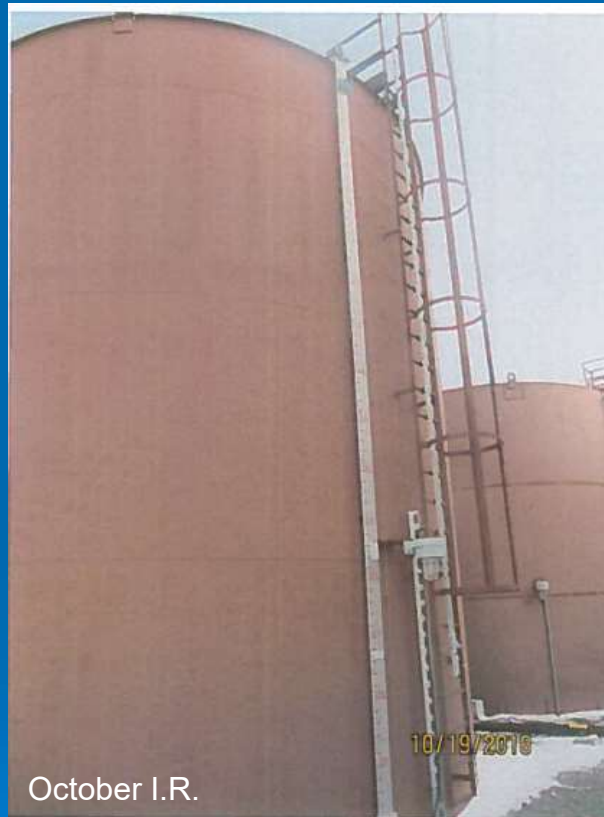
Fig 8. View of 333,000 L Tank (Empty). At least 4 of the 12 tanks in this landfarm contain significant volume of diesel
